# Fatigue of HSFG bolted joints: effects of design parameters

Autor(en): **Cullimore, M.S.G.**

Zeitschrift: **IABSE reports = Rapports AIPC = IVBH Berichte**

1.1 This project, commissioned by the UK Transport and Road Research Laboratory, in the context of the drafting of a new Code of Practice for the Design of Steel Bridges (BS5400) I11, examined the effects on the fatigue strength of friction grip bolted connections of variations of the design parameters : steel plate strength, surface finish, bolt tension, and mean stress. The displacement stability of the joint and the effects of the number of bolts in the line of the load were also investigated.

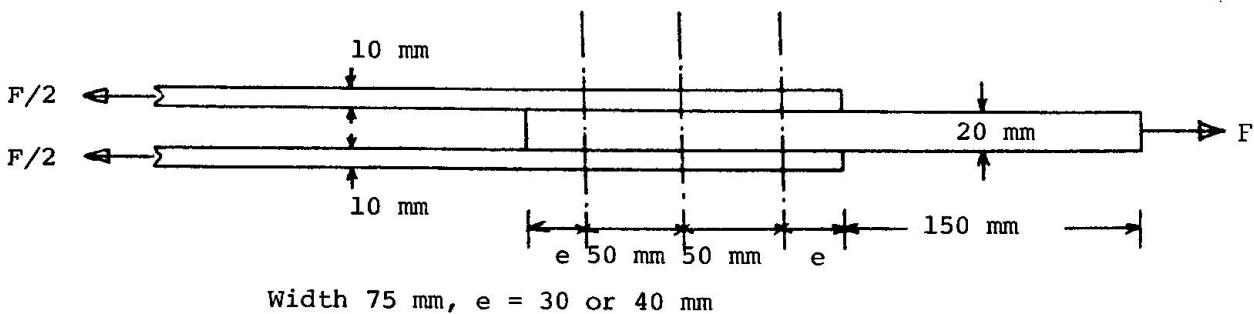
Fig. 1. Standard Fatigue Test Piece

The test piece for the basic test, shown in Fig. 1, was made of BS.4360 Grade 50 steel with three M20 bolts, tightened to 190 kN, the tension specified in BS.4395 Pt. 2. The bolts were a special load indicating type which enabled the bolt tension to be monitored continuously throughout the test. The contact surfaces of the joints were grit-blasted with chilled iron grit G34.

3 x 20 M HSFG Bolts

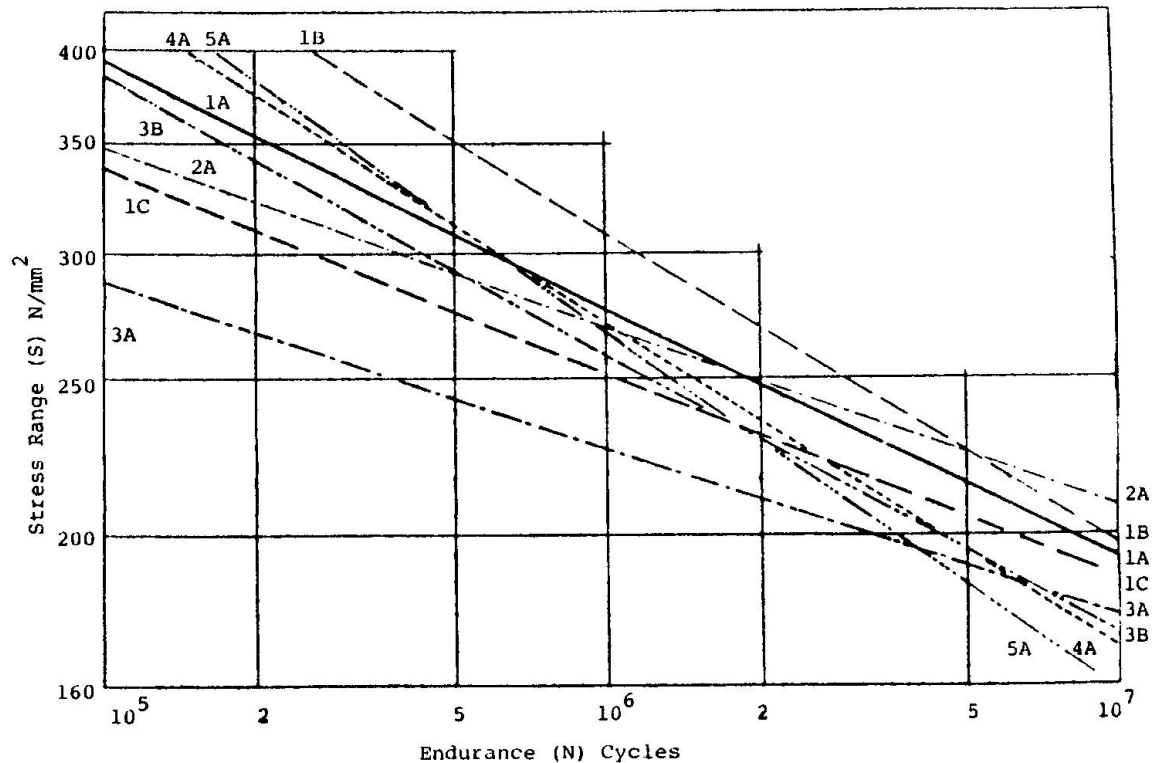
Fig. 2 Fatigue Tests Results S-N Mean Lines

These results are summarised graphically in Fig. 2. The values of the coefficients m and K in the equation :-

2.3.1 Mean stress - A reduction in mean stress gives a marked improvement in the life for a given stress range, especially at the higher stress range.

**2.3.2 Surface finish** - The mill scale surface joints had a very much lower life at the higher stress ranges than the shot blasted ones. The effect, however, appears to be reversed at stress ranges below about  $220 \text{ N/mm}^2$ . The effect of the zinc epoxy primer was to reduce the fatigue life for all the stress ranges used.

**2.3.3 Plate strength** - The higher strength Grade 55 steel gave a consistently inferior fatigue performance to the Grade 50 steel. The fatigue strength of the lower strength Grade 43 steel joints was poorer than either. In the latter case, the maximum stresses in the area of the first bolt were approaching the yield strength of the material.

**2.3.4 Bolt tension** - For lives above one million cycles joints with the higher bolt tension had a better fatigue strength than those with the lower tension.

**2.3.5 Edge distance** - Increasing the edge distance did not produce the expected improvement in performance. The consistency of these results was, however, poorer than for the standard test so that it could be that the increase from 30-40 mm is insufficient to cause a significant change.

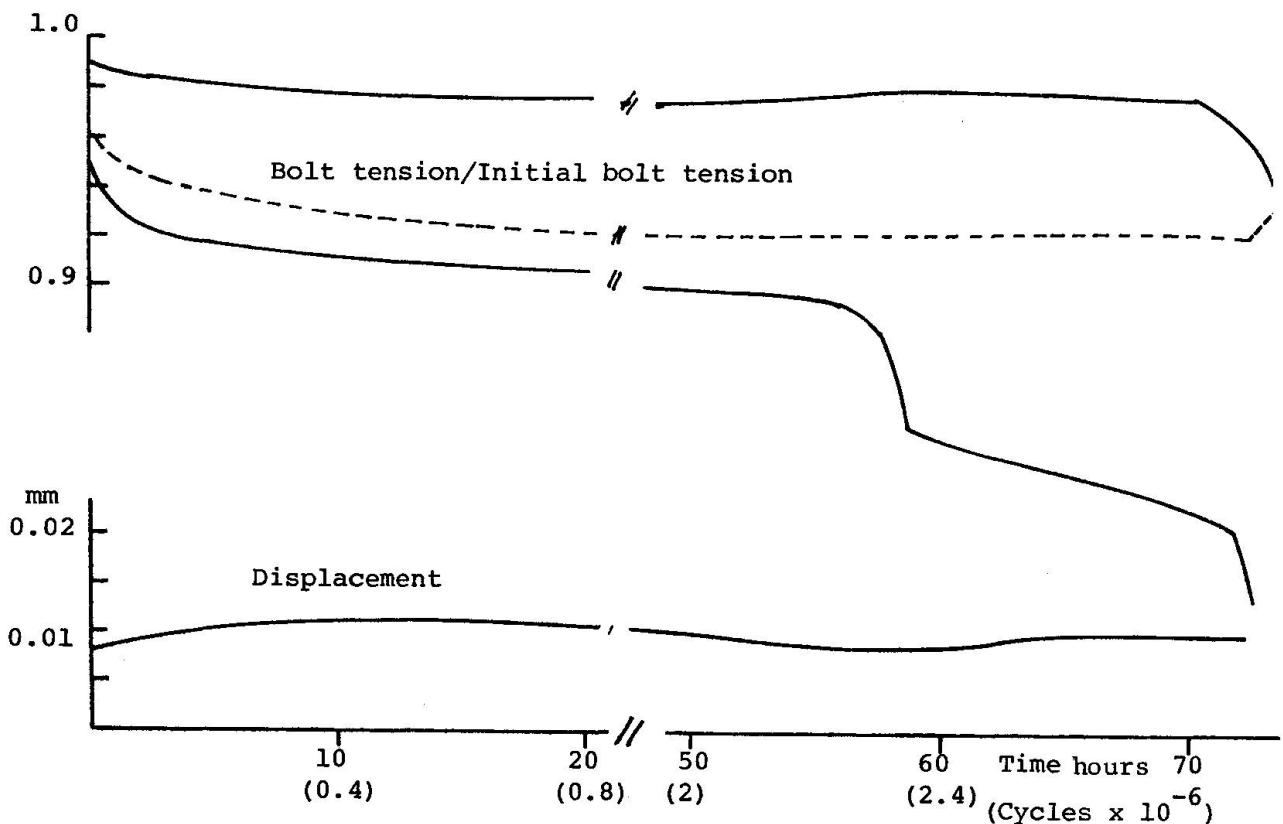
Fig. 3 Fatigue Test - Joint Stability

The results of measurements of bolt tension and displacement monitored continuously throughout a typical test are shown in Fig. 3. The load displacement loop was not closed on the first cycle, giving a small irrecoverable displacement. This got smaller with each succeeding load cycle until complete stabilisation (loops of constant size) was obtained after about 50,000 to 70,000 cycles. The bolt tensions show the expected relaxation with time [5]. Failure in this case was by cracking of the cover plate and washer, which probably accounts for the loss of bolt tension in the bolt there (lower of three curves) after about 58 hours. After the initial increase, the displacements show very little change.
