Session 3: Rehabilitation and repair of bridges

Rehabilitation and Repair of Bridges

Experiences with Orthotropic Steel Deck and Cable Stayed Bridges

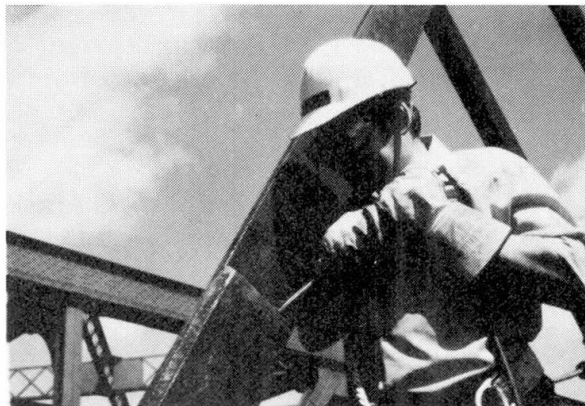
Figure 19 Peening welds

One technique, we have used, is to peen the ends of shallow cracked welds (Figure 19) to prolong their life. In other cases, replacing poorly installed rivets with high-strength bolts can prolong the life of a connection.
