Session 3: Rehabilitation and repair of bridges

Zeitschrift: **IABSE reports = Rapports AIPC = IVBH Berichte**

Rehabilitation and Repair of Bridges

Experiences with Orthotropic Steel Deck and Cable Stayed Bridges

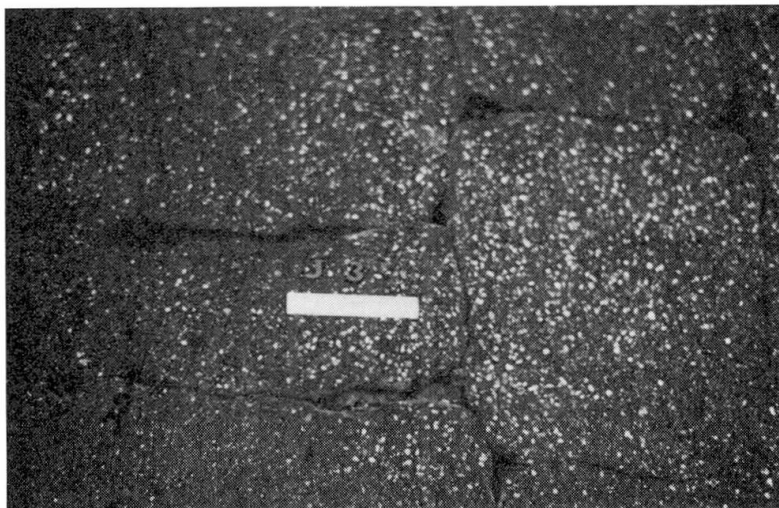
Cracking of the surfacing may loosely be grouped under the two categories of cracking over elements much stiffer than the orthotropic plate, e.g. webs of main girders, box girders, stiffening girders, etc. and cracking due to insufficient bond to the insulating layer or to the steel plate. When cracks have formed, water may penetrate and this causes corrosion of the steel which gradually spreads under the surfacing away from the cracks. This results in loss of adhesion which, in turn, leads to the formation of a series of parallel cracks as demonstrated in Fig. 3.

Fig. 3 Severe Cracking of the Surfacing

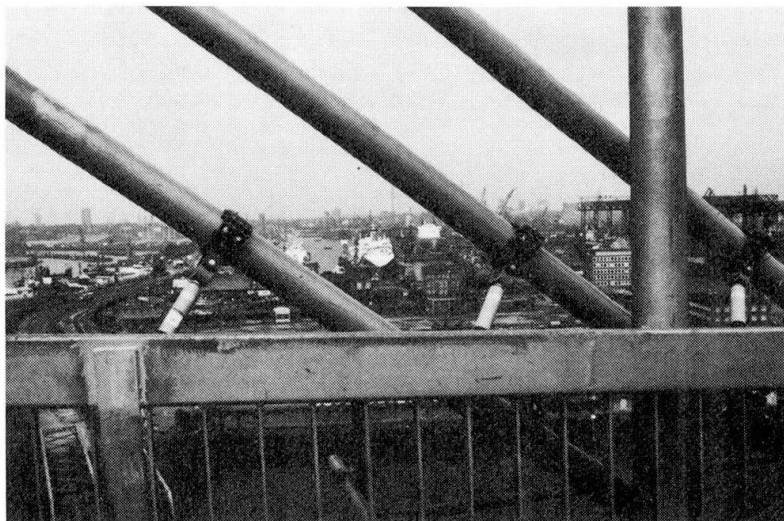
It stands to reason that damping devices should be installed wherever dynamic effects can be presumed to have adverse effects on the life expectancy of cables or where the behaviour of an existing bridge suggests that damping devices are installed as a rehabilitation measure. Fig. 8 and 9 present examples of possible solutions for the installation of damping devices as a rehabilitation measure. The spring-type dampers as shown on Fig. 9 were fixed to stiffened hand rails.

Fig. 9 Spring Type Damper

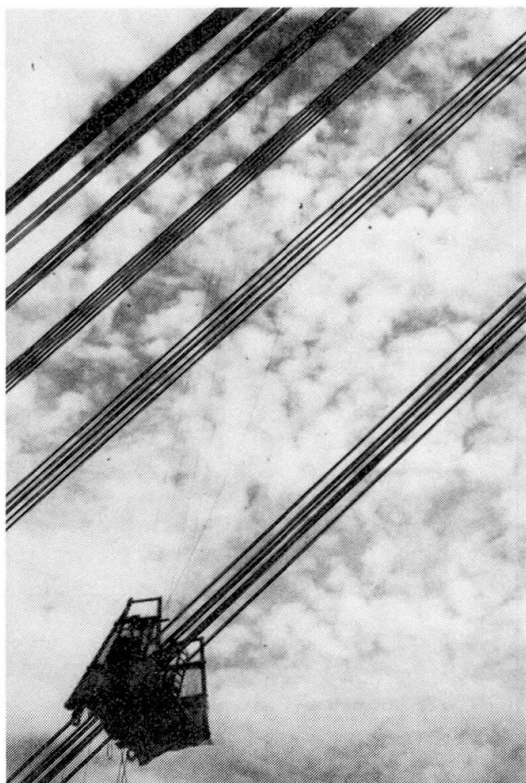
The development of an appropriate procedure and sequence for the inspection of all parts of a cable is important. In the past, the importance of a thorough and complete inspection of cables was often not acknowledged to the required extent by all designers of cable stayed bridges. Even an appropriate access to cable anchorages and cable sockets has not always been provided for in the design. Access to the free cable length between bridge deck and tower must also be possible and would normally require a special type of traveller. Fig. 10 shows a possible solution to this problem.

Fig. 10 Inspection of Cables

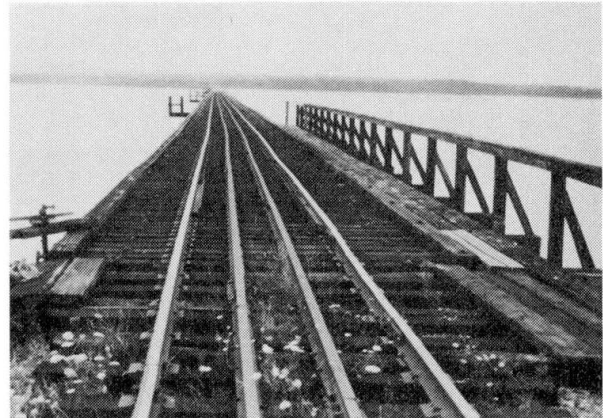
Figure 5 shows a structure over which operations have ceased. This structure became unsafe recently. To rehabilitate it to new condition would cost \$7. million dollars, to fix it to last until the next spring ice movement would cost over \$400,000. The saving to the railway by using the bridge was of the order of \$40,000 before considering any maintenance expenses. I must say that the initial damage to the structure was caused by the action of others who changed the ice conditions. Should the structure be rehabilitated, they will probably be held liable. Nevertheless, we have found another way to adequately serve our customers and are not throwing away money which can be better spent elsewhere.

Figure 5 Moved by ice
