Rehabilitation and repair of bridges

Zeitschrift: **IABSE reports = Rapports AIPC = IVBH Berichte**

Rehabilitation and Repair of Bridges

Robert A.P. SWEENEY
Regional Engineer
CN Rail
Montreal, PQ, Canada

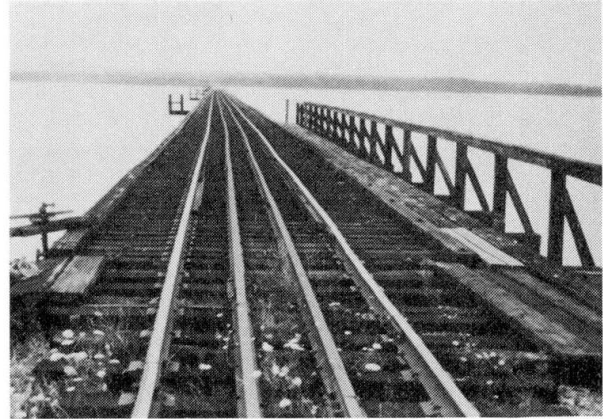
Figure 5 Moved by ice

Figure 5 shows a structure over which operations have ceased. This structure became unsafe recently. To rehabilitate it to new condition would cost \$7. million dollars, to fix it to last until the next spring ice movement would cost over \$400,000. The saving to the railway by using the bridge was of the order of \$40,000 before considering any maintenance expenses. I must say that the initial damage to the structure was caused by the action of others who changed the ice conditions. Should the structure be rehabilitated, they will probably be held liable. Nevertheless, we have found another way to adequately serve our customers and are not throwing away money which can be better spent elsewhere.

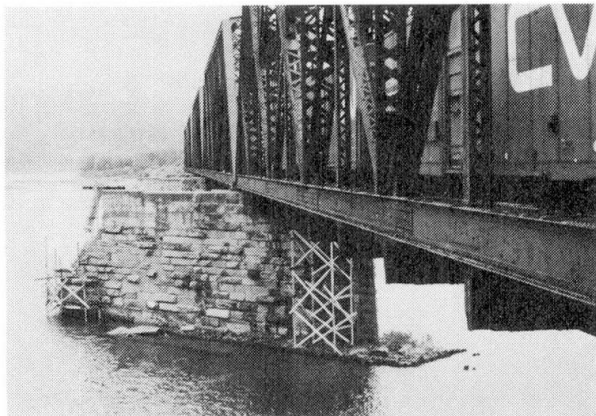
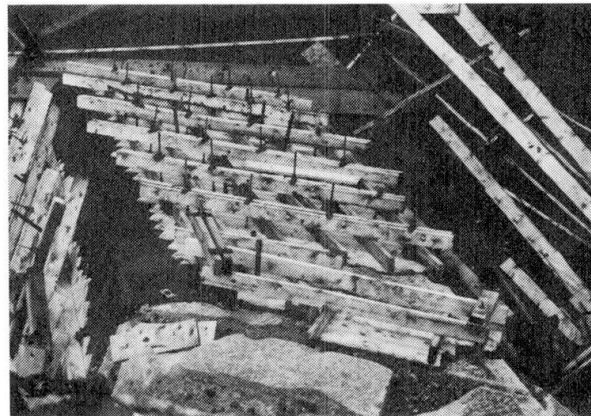
Figure 9 Repair to pier

The simple preventative step of keeping stone masonry properly pointed will usually avoid subsequent more costly repairs caused by movement of stones. Once a structure is permitted to loose a stone or two, it becomes costly and technically difficult to repair (Figure 9).

Among the most common techniques are placing bags filled with cement or concrete as a form and either placing tremi concrete or placing aggregate and pumping grout. Larger jobs require extensive forming and reinforcing adequately dowed to the existing structure.

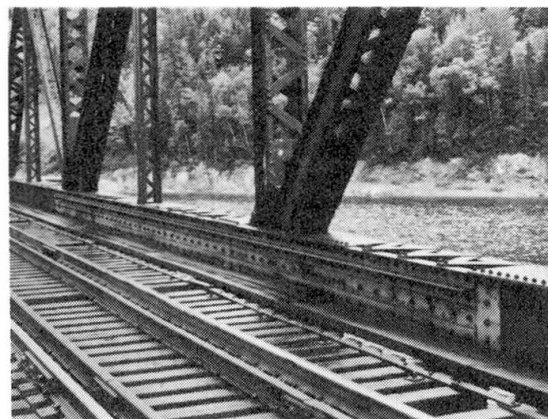
Figure 12 Member spliced

In the case of yielded, buckled or cracked members, it is possible to splice around the failed part in such a way that all load can be carried by the splice. The repair shown in Figure 12 shows a splice around members that cracked after being exposed to a very severe fire. The extent of locked in residual stresses was of such concern that a significant part of the member was spliced.

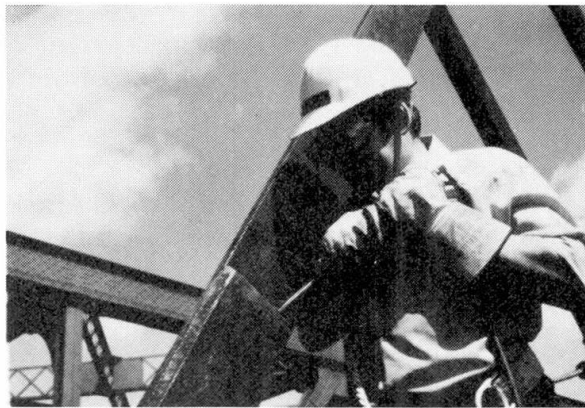
Figure 19 Peening welds

One technique, we have used, is to peen the ends of shallow cracked welds (Figure 19) to prolong their life. In other cases, replacing poorly installed rivets with high-strength bolts can prolong the life of a connection.
