Rehabilitation and repair of bridges

Zeitschrift: **IABSE reports = Rapports AIPC = IVBH Berichte**

Rehabilitation and Repair of Bridges

Robert A.P. SWEENEY
Regional Engineer
CN Rail
Montreal, PQ, Canada

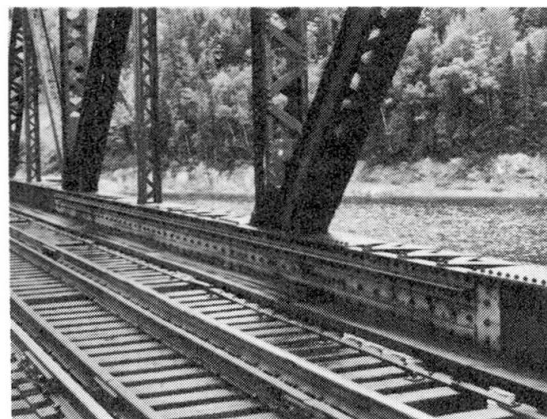
Figure 12 Member spliced

In the case of yielded, buckled or cracked members, it is possible to splice around the failed part in such a way that all load can be carried by the splice. The repair shown in Figure 12 shows a splice around members that cracked after being exposed to a very severe fire. The extent of locked in residual stresses was of such concern that a significant part of the member was spliced.
