Session 2: Rating and evaluation of remaining life of bridges

Zeitschrift: **IABSE reports = Rapports AIPC = IVBH Berichte**

SESSION 2

Rating and Evaluation of Remaining Life of Bridges

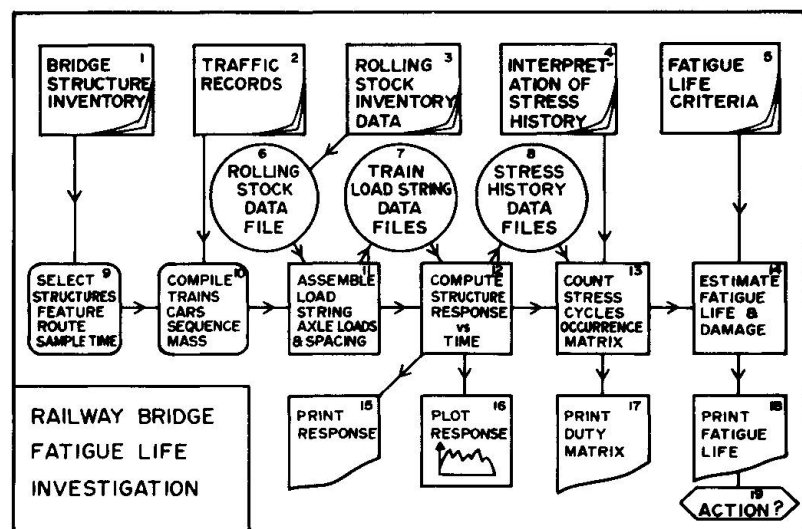
Fig. 4 Bridge Fatigue Life Flow Chart.

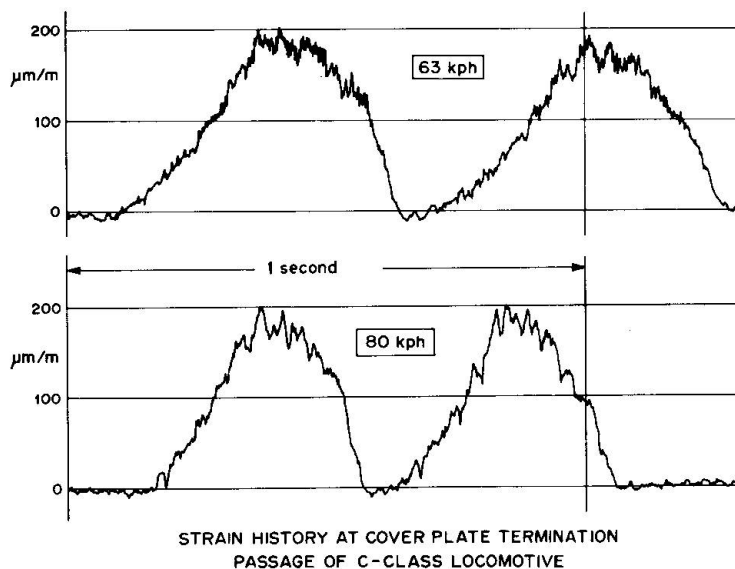
STRAIN HISTORY AT COVER PLATE TERMINATION
PASSAGE OF C-CLASS LOCOMOTIVE

Fig. 6 Measured Response to Locomotive.

Two methods of measurement were employed in this study. In the first, dynamic traces of the of the strain at the ends of the coverplates were made for the locomotive previously used in static calibrations traversing the bridge at various speeds. Two such traces are shown in Fig. 6. Superimposed on the quasistatic response, which is not amplified, is a vibration associated with the suspension of the locomotive. This vibration adds on about
