Zeitschrift: IABSE reports = Rapports AIPC = IVBH Berichte
Band: 46 (1983)

Artikel: Strengthening of wooden ceiling constructions
Autor: Postulka, Josef
DOI: <https://doi.org/10.5169/seals-35880>

Strengthening of Wooden Ceiling Constructions

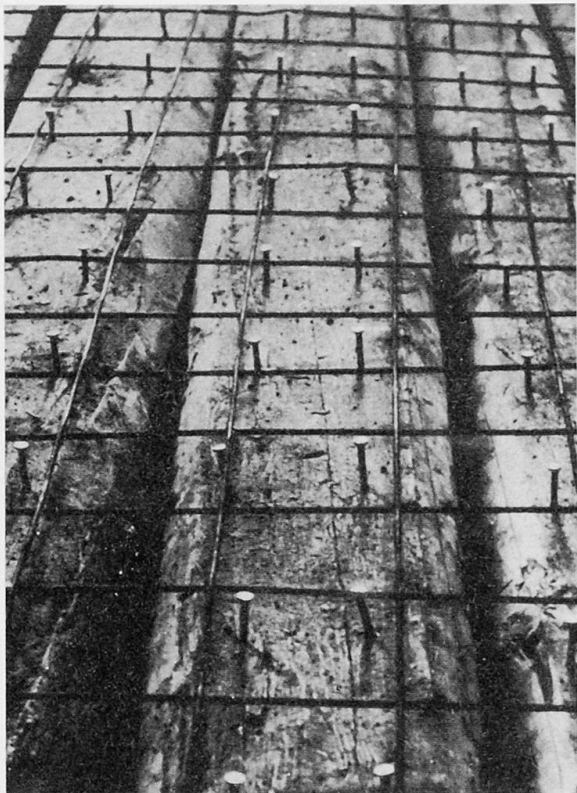
In figure 3 are the wooden beams tightly together, and in figure 4 there is the same ceiling under strengthening operation. The surface of the old wooden ceiling gets coupling elements such as steel nails driven in distances fixed by statical analysis. The nails stick out of the surface cca 40 mm.

Fig. 4. The strengthening of a wooden ceiling under construction

The nails are driven in by an electric percussion drill with a special inserted tool head in order to let the nails stick out of the surface with 40 mm. Fig. 4. Over the nails we lay down the wire net and the concrete slab can be made.

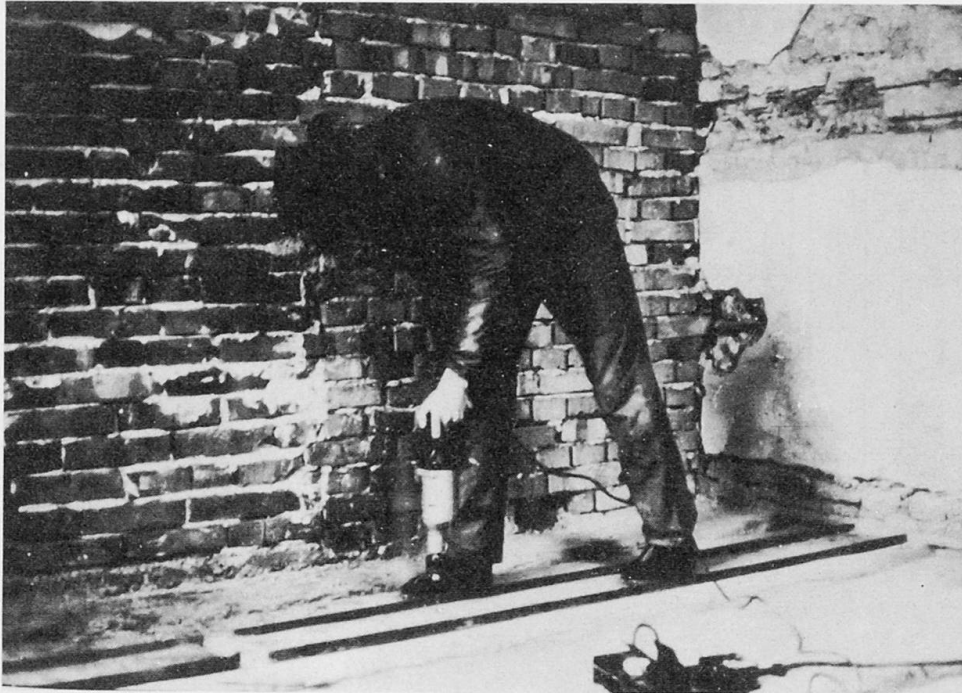
For the rough drilling we use a drilling template made of a thin perforated steel sheet. Fig. 6. The perforation of the template is made in distances ordered by the statical analysis.

Fig. 6. Rough drilling with a drilling template

After cleaning of the ceiling surface and after the chemical protection of wood by penetration it is necessary to rough drill the holes for the nails in the upper surface of the wooden ceiling. The depth of the holes has to be more than a half length of the nails driven in.
