Zeitschrift: **IABSE reports = Rapports AIPC = IVBH Berichte**

## Built Up Roofs – Wind Uplift Resistance

### Germund JOHANSSON

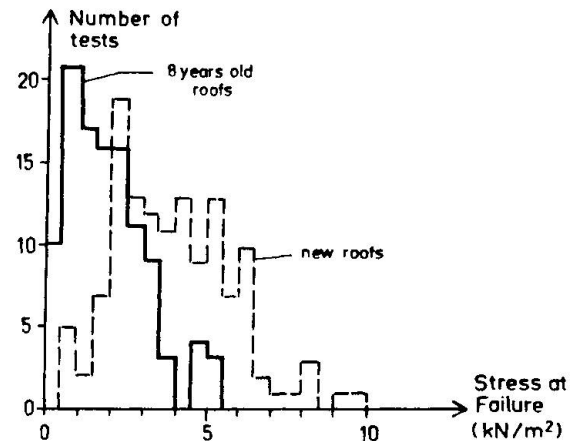
Fig.4 Measured strength of roofs with glass wool and mineral wool - comparison between old and new strength.

Eight years later, in the beginning of the 1980's, 13 of the roofs have been re-tested using the same equipment and the same technique. Some of the other roofs were "not available" for tests or they had blown off or they had been destroyed by fire. The results from the tests are a little bit frightening - there is a very large strength reduction. In table 1 some of the results are shown. After eight years the mean strength is reduced to about 50% of the original strength. The two histograms in fig.4 correspond to the measured strengths at all the roofs in table 1. The field tests show that for a new roof the fracture usually occur in the lower part of the insulation or between the insulation and the steel deck. Older roofs nearly always break in the upper part of the insulation just under the roofing felt.
