Built Up Roofs – Wind Uplift Resistance

Germund JOHANSSON

Assist. Prof.
Chalmers Univ. of Technology
Göteborg, Sweden

SUMMARY

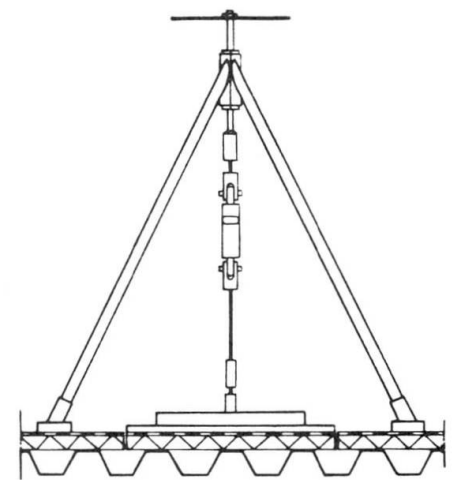
Fig.2 Test equipment for wind uplift testing

The test equipment used consists of three main parts - a stand with lift outfit, a frame to be attached to the specimen and a dynamometer between the stand and the frame, fig.2. The stand is made of aluminium and wood. The lifting force is achieved via screw in the top of the stand. A 22 mm thick slab of chipboard was bonded with hot asphalt to the surface of the roofing felt. The width of the chipboard slab is 500 mm and the length is governed by the pitch of the steel sheet. After having glued the board slab and screwed the frame to the slab, the insulation and the roofing felt were cut along the slab lines. The test method is easy to handle but it has some disadvantages - the test surface is disturbed by cutting and by gluing with hot asphalt. However, some test roofs which showed very low strength have later blown off during storms and the roofs with high values for the strength have not done so.
