# Quality assurance and safety in highway construction

Autor(en): **Vogler, Otto M.**

Zeitschrift: **IABSE reports = Rapports AIPC = IVBH Berichte**

Band (Jahr): **51 (1986)**

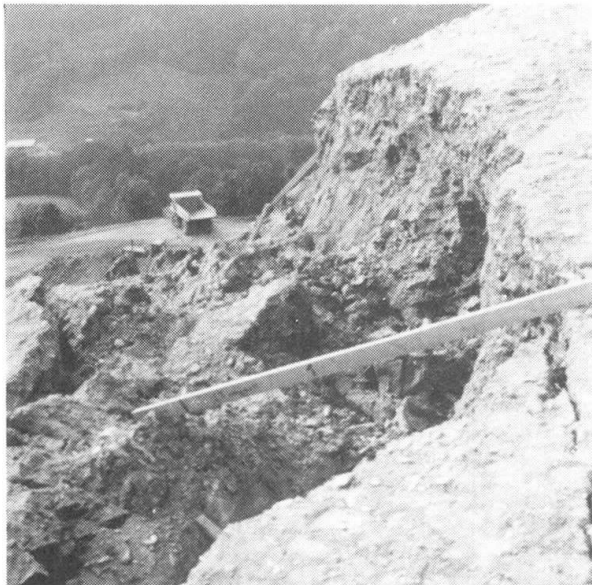
**Fig. 5:** Loosened Rock Masses  
Gliding Off.  
Height of Slope: 50 m

Accordingly, slope movement became apparent in many of the cuttings during excavation. In many locations, cracks (width: several decimeters) occurred at a distance of 200 m from the road. In other places, the movement could be detected only with the help of careful slope-indicator measurements. Slope indicators can also be used to determine the depth of the gliding layers and the speed of the gliding movement. In one location, 29,000 m<sup>3</sup> of material moved towards the road level, more or less suddenly, after the slopes had remained in balance for two months and after landscaping had begun.
