**Artikel:** Construction of cable-stayed bridges in Honshu-Shikoku bridges project  
**Autor:** Matsuzaki, M. / Ohnmachi, T. / Yasuda, M.  
**DOI:** <https://doi.org/10.5169/seals-40347>

# CONSTRUCTION OF CABLE-STAYED BRIDGE

Honshu-Shikoku Bridge Authority

## Construction of Cable Stayed Bridges in Honshu-Shikoku Bridges Project

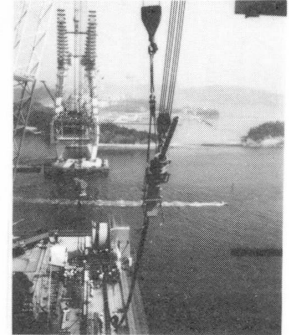
Erection of cable

Erection of large block

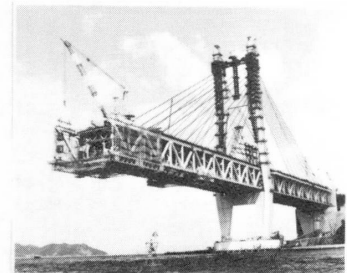
Regarding bolted joints, the pilot holes into which drift pins are driven during shop assembly are used in erection of main truss at the site to reproduce the figures in shop.

Erection of main truss

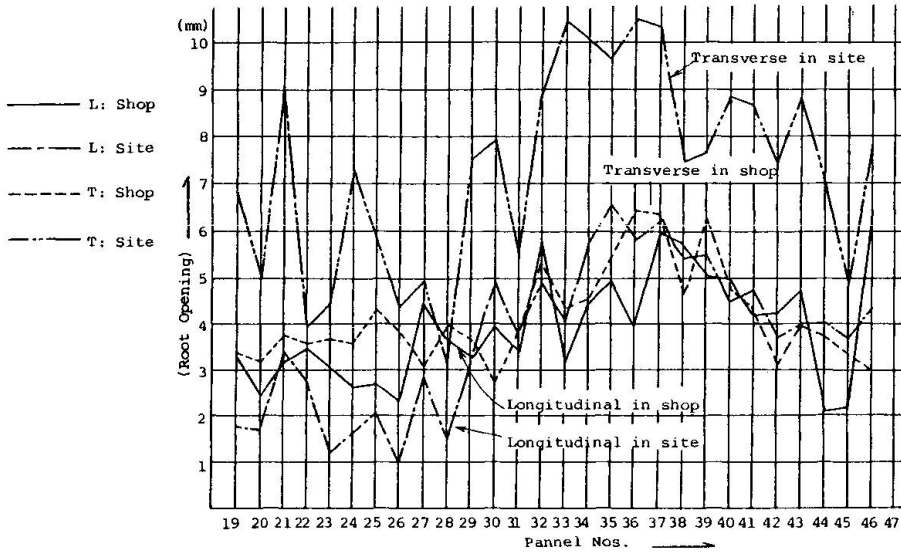
Fig. 1 Root Opening Difference between Shop Assembly and Construction Site

Fig-1 shows the root opening in the shop and on site.

Apparently the transverse root opening in the site bridge axis is larger than that in the shop. This is a result of the welding construction, because the drift pins and the temporary bolts at the bolt joints between the main girder and the steel deckplate were removed, releasing the residual stress caused by welding. Therefore the main girder camber was not greatly affected by the contraction due to the welding.

The longitudinal root opening tends to be smaller at site than in the shop, although the difference is small.

Also the longitudinal root opening did not appear to have any effect on the width of the main girder because stress releasing was performed as in the case of the transverse opening, with the floor truss keeping the width of the main truss.

- (2) Quality of welds (Fig-1)

33 - 46 show larger root openings than 19 - 32. This is due to the fact that the standard values of the root opening differ depending on the method of welding (Submerged arc welding-CO<sub>2</sub> gas automatic arc welding).

The transverse root openings in the direction at right angles to the bridge axis were larger at the site, but the results of X-ray tests show that the quality of welding was satisfactory, presenting no problems.

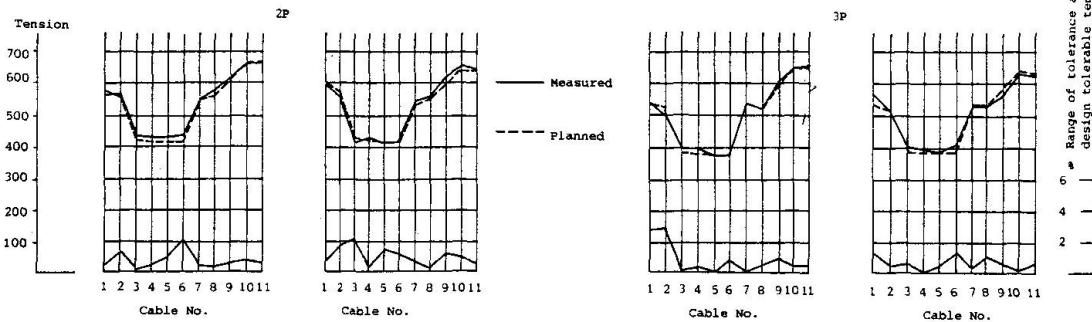
Fig. -3 Cable Tensions

Fig-3 shows cable tensions at each tier at the time of closure. The difference between the planned value and measured value according to the loading condition at the time was smaller than 5%, showing that the erection was performed with an extremely high accuracy.

However, as the allowed designed erection error was +5% of the allowable design tension at the time of completion, it is judged that the range of errors at this stage was to be made +2,8% of the allowable tension, taking into account the errors in the measurement. Therefore, shim plate adjustment was performed only on the cables at the 6th tier of the left side span, and at the 2nd tier and 1st tier on the right side of the center span.
