**Artikel:** Reinforcement of the Marghera-Venice overbridge  
**Autor:** Vento, Salvatore / Guadagnini, Luigi  
**DOI:** <https://doi.org/10.5169/seals-42810>

## **Reinforcement of the Marghera -Venice Overbridge**

The works of improvement and adjustment to suit the new Italian Highways and Bridges Standards here described, refer to the Marghera (Venice) Overbridge.

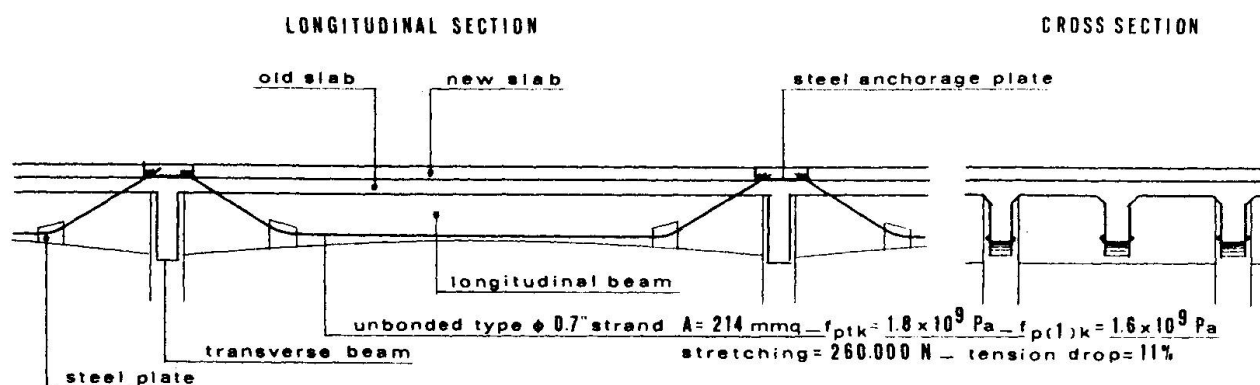
Each longitudinal girder is supported by two UNBONDED TYPE 0 0,7" strands (greased and sheathed with a high density polypropylene sheath) running along each side of the lower ledge of the beam. At the end of the beam the strands are shunted 30° upward by means of a u-shaped steel plate.

The anchorage consists in a steel plate positioned on the existing slab where the longitudinal beam connects with the traverse beam. This anchorage plate is supplied with a series of frustum shaped clamps having a threaded inside hole holding the strands.

The single wires of the strands are greased and protected by a polypropylene sheath and this one is protected by a second polypropylene sheath.

The longitudinal girders (completely unfit to shearing stresses and scarcely fit to bending) have been improved by partially prestressing the structure.

The stretching of both the strands of a beam is done simultaneously by means of an hydraulic jack from one side of the beam, in two periods with a 260.000 N force. Losses due to friction resulted nil.
