# Combatting road salt corrosion in concrete bridges - the way ahead

## Combating Road Salt Corrosion in Concrete Bridges – the Way Ahead

**Brian PRITCHARD**  
Director  
W.S. Atkins & Partners  
Epsom, Surrey, UK

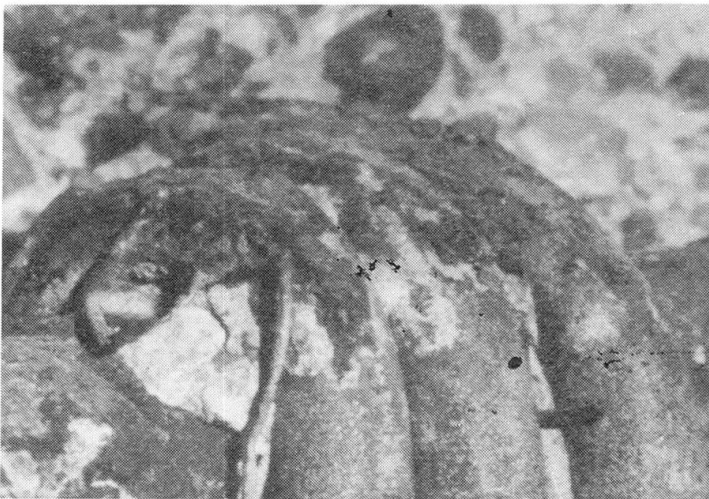
Fig. 1 Black Corrosion

Where the salt penetration is very random & there is not much free oxygen available at reinforcement or cable level, the lower ferric variety of corrosion develops. This is characterised by a local pitting of the attacked steel leading to a soft black corrosion deposit. With cover concrete of a reasonable strength, this deposit will not expand with sufficient force to break away the concrete. Typical local pitting black corrosion is shown in Figure 1. If more oxygen is present, the corrosion process is the more familiar variety with a general red surface rust. Inevitably the concrete cover is forced off by this harder & more expansive corrosion product, allowing more oxygen & moisture penetration along the bar, giving the more familiar progressive visible and red corrosion.

Thus, black corrosion is a potentially much more dangerous phenomenon as loss of reinforcement or prestressing cable is proceeding unseen under the surface. The accompanying reductions in structural integrity give no visible early warning such as cracking and spalling.
