SESSION 3

Interpretative Models and Decision Making

Dynamic Behaviour and Monitoring of Ancient Monuments

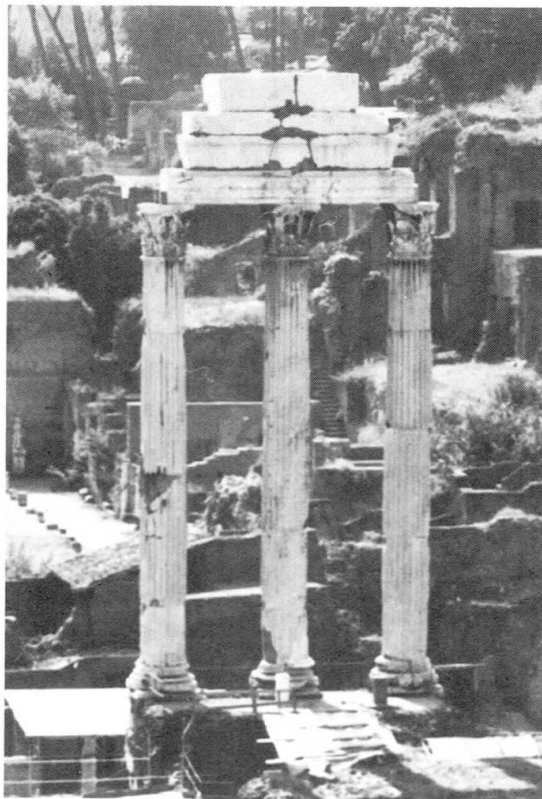
fig. 5 Tempio di Castore e Polluce: photo of the monument and of the Finite Elements model.

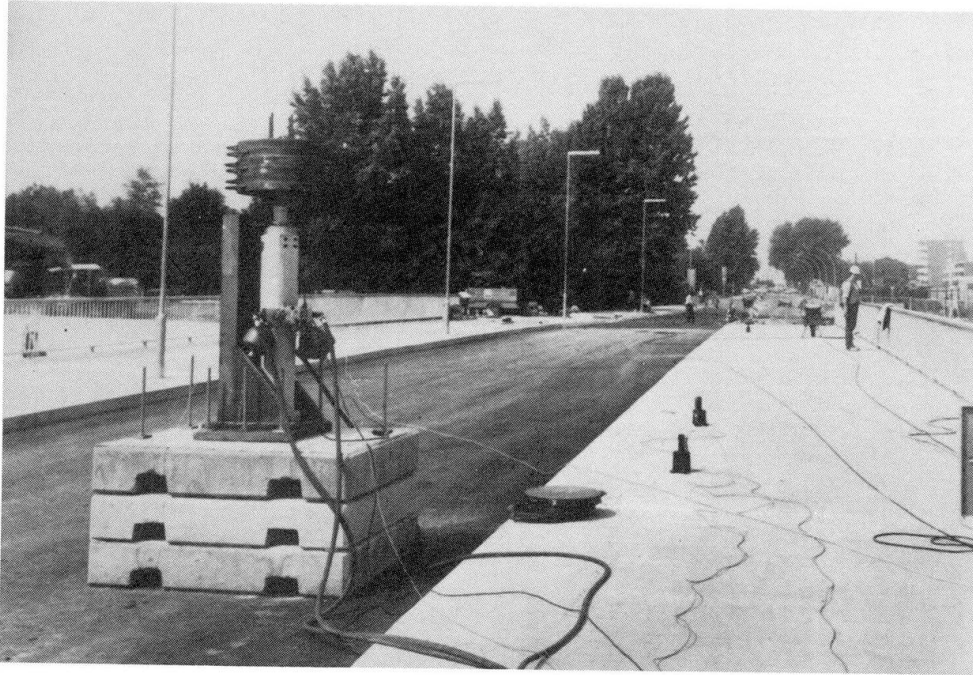
Fig. 3 Bridge Ulenbergstraße, hydraulic exciter (1st measurement)

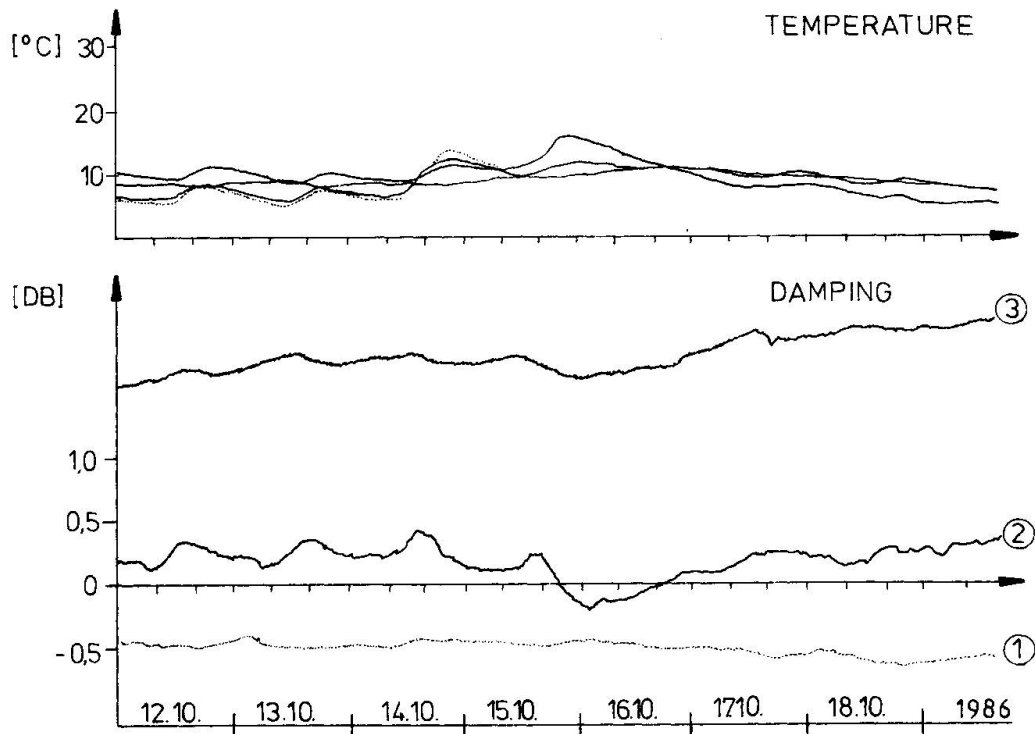
Fig. 7 Optical sensor monitoring on Bridge Ulenbergstraße

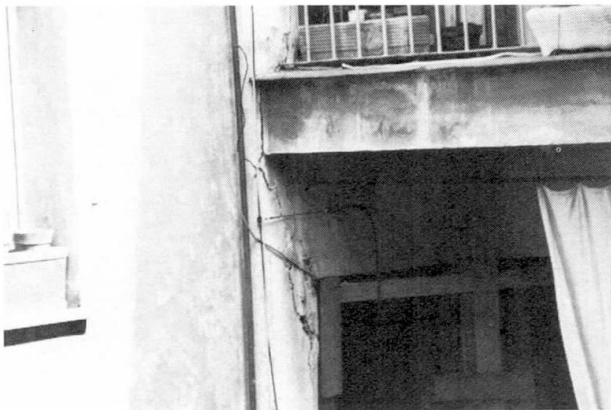
Fig. 8-11 Some of the most significant cracks on the masonry structures

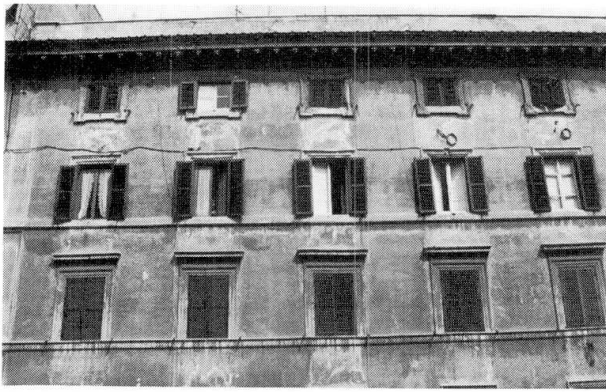
Fig. 12 Facade on Via Palestro with some of the installed instruments
