Zeitschrift: IABSE reports = Rapports AIPC = IVBH Berichte

Rubrik: Presentation Session 4c: Maintenance of structures

Durability of Masonry Strengthening by Injection Techniques

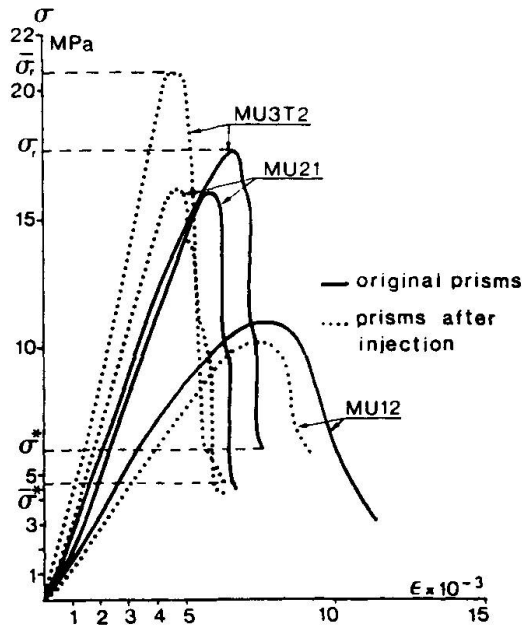
Fig. 1 Stress-strain curves for prisms injected with resin

The same experimental investigation was carried on four prisms injected with cement-polymer grout. At presently only some comments on the first results can be made:

- The strength $\bar{\sigma}_r$ of the injected prisms is still higher than the value σ^* at which the previous compression test was stopped, but it does not attain more than the 40% of the value σ_r originally reached by the prisms.
- The slope of the $\sigma - \epsilon$ curves of the injected prisms tends to be lower than the one given during the first compression test. Nevertheless after the value $\bar{\sigma}_r$ is reached a tendency is shown to a reduction in brittleness, if comparison is made to the original situation.

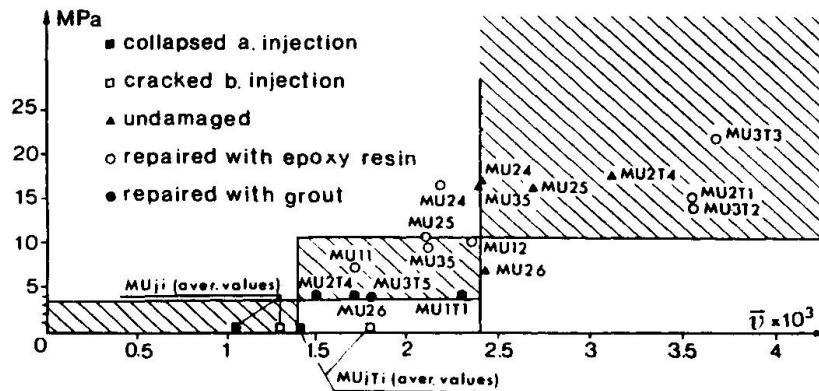
Fig. 2 Rough guide for quality masonry

Based on all ultrasonic velocity measures obtained on the prisms at the several phases considered (undamaged, damaged, injected, collapsed), a rough guide for the evaluation of the masonry condition can be stated, slightly different from that one proposed by other authors [6]:

- velocities of less than 1400 m/s indicate highly cracked masonry with very poor mechanical properties (less than 3,5 MPa compressive strength);
- velocities between 1400 and 2400 m/s

indicate a lower quantity of cracks and an appreciable compressive strength (between 3,5 and 10,5 MPa);

- velocities over 2400 m/s indicate masonry in a good normal condition. The average values measured at the various phases of the experimental work are reported in Fig.2 for all the masonry prisms: the positive grouting effects are clearly visible, particularly for the prisms injected with epoxy resin. The high value of velocity measured on MUjTi prisms is due to their content in sodium sulphate. Moreover a relationship, even if quite rough, has been noticed between

velocities and strength. The ratio between the masonry strengths in the undamaged condition and after injection (0.85 and 0.40 respectively for epoxy resin and resin modified mortar grouting) was found similar to the ratio between

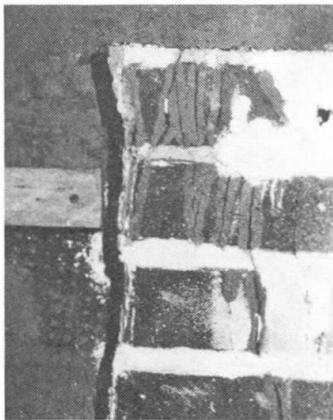
Fig. 3 Penetration of salts inside cracks and voids

The sodium sulphate was transferred and deposited by capillary rise inside voids and unfilled cracks and, sometime, caused a propagation of cracks. Injections cannot prevent the penetration and diffusion of salt solution inside the masonry if they do not fill all voids (Fig.3).

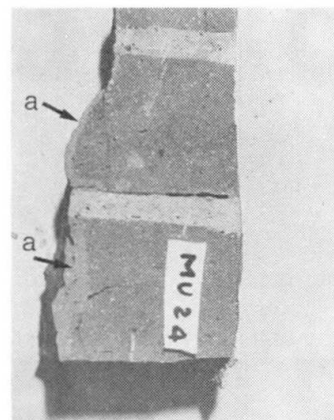
Fig. 4 Fracture along the boundary of the impregnated zone (a)

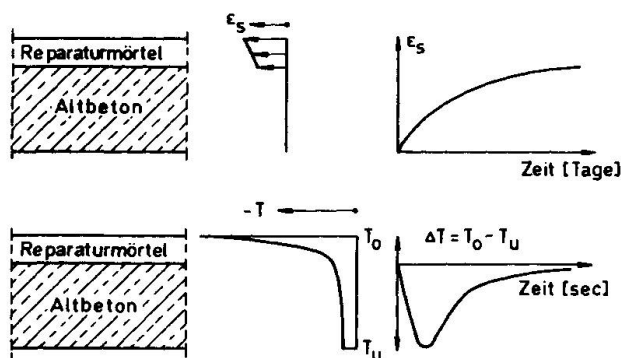
Fig. 1 Beanspruchung von Reparaturschichten

Als wesentliche mechanische Beanspruchung des Systems bestehend aus Reparaturschicht und Altbeton stellen sich jene Lastfälle heraus, die Zugspannungen in Reparaturschichten hervorrufen, insbesondere Schwinden der Reparaturschicht und schockartige Abkühlung des Bauteils, z.B. durch einen Gewitterregen auf eine erhitzte Oberfläche (s. Fig. 1).

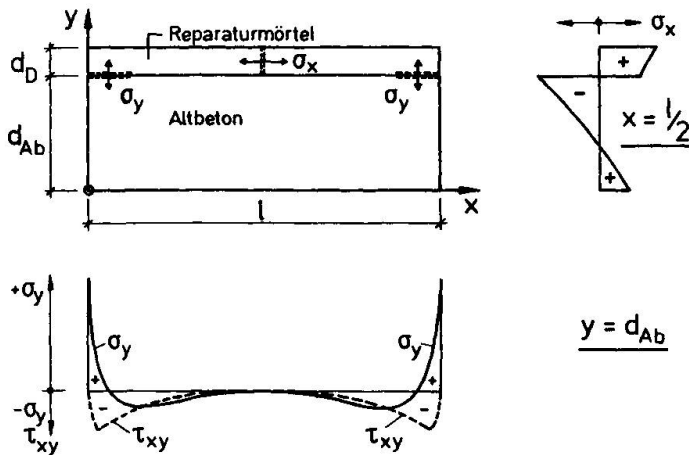
Fig. 2 Spannungen in Reparaturschichten

die Adhäsionsfestigkeit überschreiten und so zu horizontalen Ablösungen führen (Fig. 2). Daß es nicht zu einem Versagen der Reparaturmaßnahme kommt, liegt am spezifischen Verformungsverhalten zementgebundener Werkstoffe. Mit zunehmender

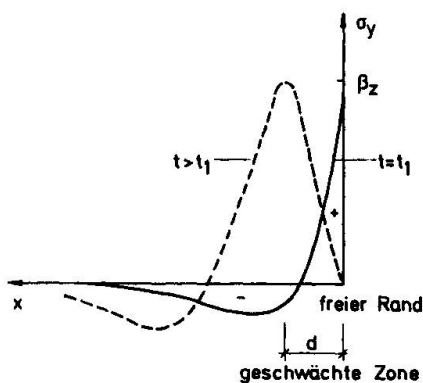
Fig. 3 Geschwächte Zone im Randbereich von Reparaturschichten

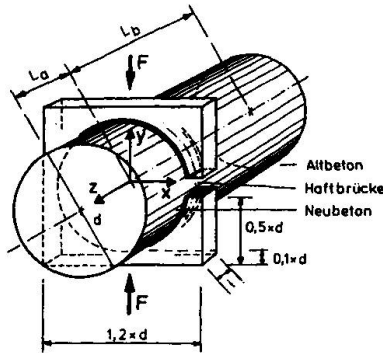
Fig. 4 Der modifizierte Spaltzugversuch

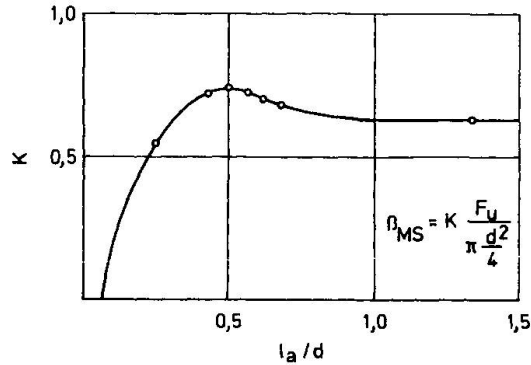
Fig. 5 Die modifizierte Spaltzugfestigkeit

K = Beiwert nach Abb. 5

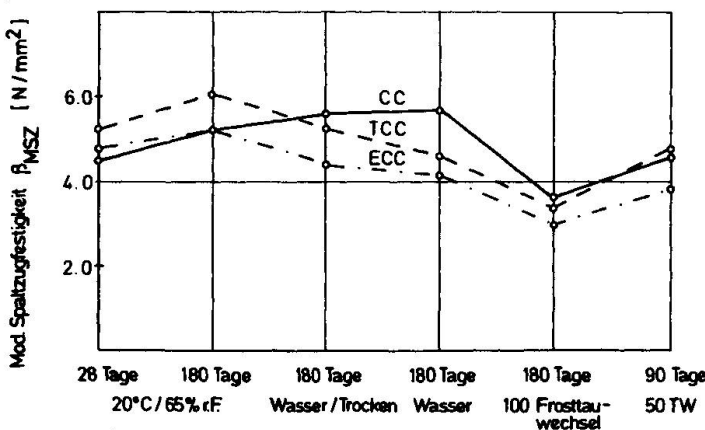
Fig. 6 Verbundfestigkeit von Reparatursystemen bei unterschiedlicher Lagerung

Im Rahmen von Laboruntersuchungen wurden hydraulische Reparatursysteme auf vorbereitete Betonplatten 300x300x100 mm aufgebracht. Als Reparatursysteme wurden rein hydraulische Mörtel mit Zementleimhaftbrücken (CC), thermoplastmodifizierte Mörtel mit thermoplastmodifizierten Zementleimhaftbrücken (TCC) und epoxidharzmodifizierte Mörtel mit Epoxidharzhaftbrücken (ECC) angewandt. Die Lagerung der Probekörper erfolgte bei 20 °C/65 % r.F. unter Wasser oder bei Frosttausalzbeanspruchung. Die Wirkung von Gewitterregen auf erhitze Betonoberflächen wurde durch Temperaturwechsellagerung simuliert. Zur Bestimmung der Verbundfestigkeit wurden u.a. modifizierte Spaltzugversuche durchgeführt. Die Ergebnisse sind auszugsweise in Fig. 6 dargestellt.

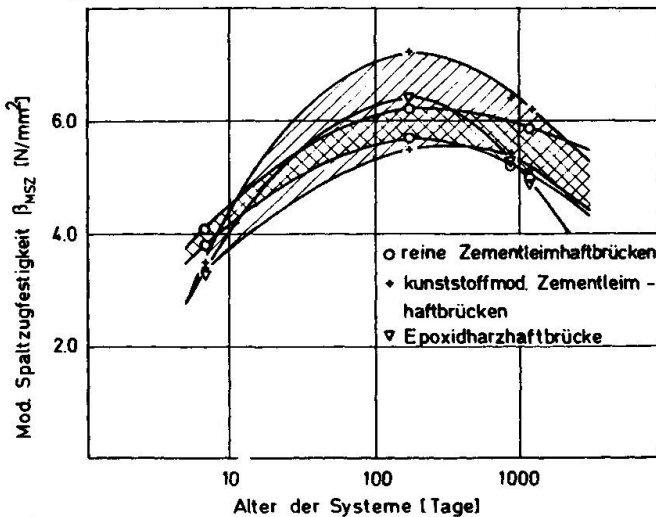
Fig. 7 Verbundfestigkeit der Reparaturssysteme in Abhängigkeit vom Alter

Im Rahmen von Feldversuchen wurden hydraulische Reparatursystem mit unterschiedlichen Haftbrücken zur Instandsetzung frosttausalzgeschädigter Betonfahrbahnplatten auf einer Bundesautobahn eingesetzt. Nach einer Oberflächenvorbereitung wurden rein hydraulische, organisch modifizierte hydraulische Haftbrücken sowie eine Epoxidharzhaftbrücke zusammen mit einem rein hydraulischen Ausbesserungsbeton ($w/z = 0,4$, Größtkorn 8 mm) aufgebracht. Im Alter von 7, 180, 900 und 1200 Tagen erfolgten u.a. modifizierte Spaltzugprüfungen an Bohrkernen im Labor. Die Ergebnisse sind auszugsweise in Fig. 7 dargestellt.

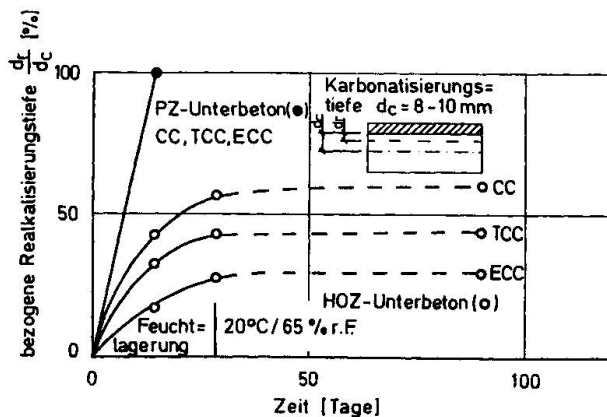
Fig. 8 Realkalisierungsfortschritt für unterschiedliche Reparatursysteme, Unterbetone und Lagerungsbedingungen

In experimentellen Untersuchungen wurden hydraulische Reparatursysteme auf karbonatisierte Oberflächen unterschiedlicher Betone aufgetragen. Nach 14, 28 und 90 Tagen wurde die Realkalisierungstiefe mit Phenolphthalein als Indikator gemessen. In Fig. 8 sind die Ergebnisse auszugsweise dargestellt.

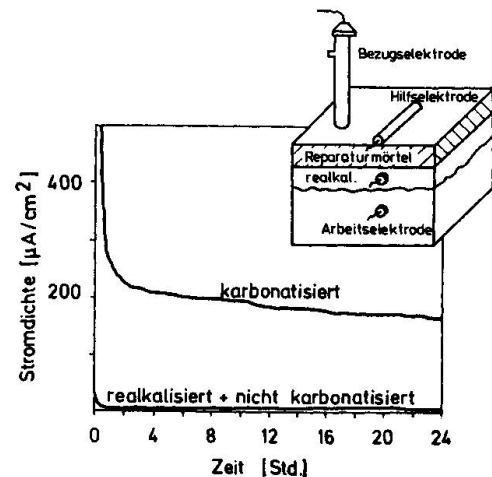
Fig. 9 Potentiostatischer Halteversuch an Stählen im karbonatisierten, nicht karbonatisierten und realkalisierten Beton

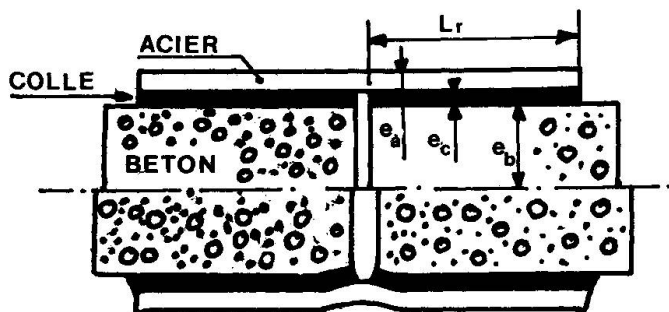
Qualitativement, la flexion locale des tôles a été mise en évidence à l'aide des mesures réalisées sur le renforcement du viaduc d'accès au Pont de Gennevilliers. Pour en quantifier les effets on peut utiliser un modèle simple qui, depuis la fin de la seconde guerre mondiale, a fait l'objet de nombreuses études. Il s'agit du joint à double recouvrement (cf. figure n° 1).

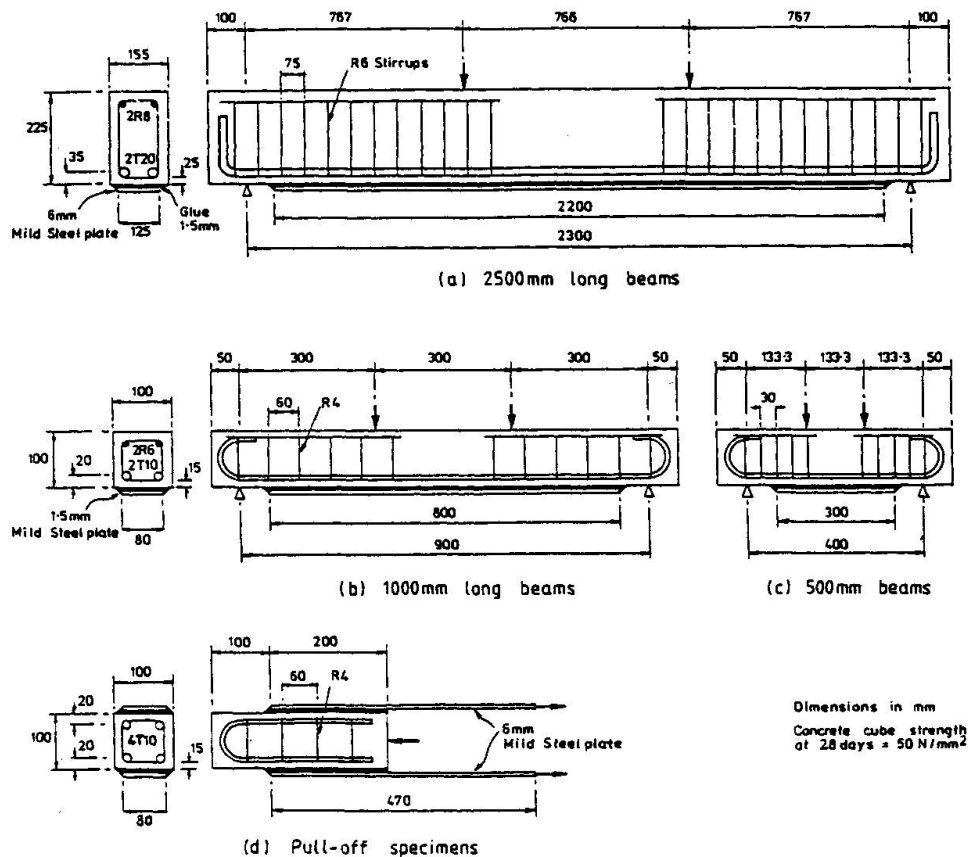
Fig. 1 Details of Test Specimens

Two sizes of beams are being used, as shown in Figure 1(a) and (b). The beams have been designed so that anchorage zone failure, rather than yielding of the steel plate, is likely to be critical. Two different epoxy resins have been used to bond the plates. Most of the beams were plated in the unloaded condition but two pairs of the 2500mm long and two pairs of the 1000mm long beams were plated whilst they were under a sustained load equal to 50% of the load capacity of the unplated beams. This meant that the concrete in the tension zones of these beams was cracked when the plates were applied. Unplated beams of each size are being used to provide a basis for comparison.

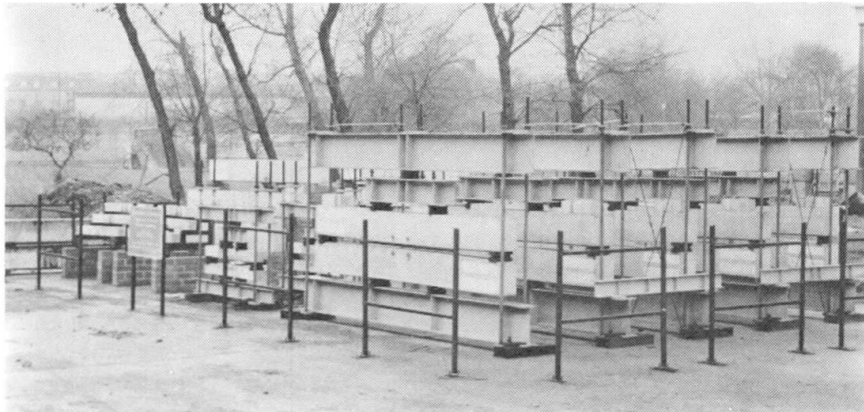
Fig. 2 External Exposure Site

The loaded beams are supported in pairs in purpose designed loading rigs and the unloaded beams are stored on racks. The overall layout of the exposure site is shown in Figure 2. The loaded beams were loaded to 50% of the load capacity of an unplated beam, as determined from the short term control tests. Strains at the midspan cross-sections of all beams are monitored at intervals using demountable mechanical gauges. The ambient temperature at which readings are taken is also recorded. At approximately 8 to 9 months after the initial loading the loads on the beams were checked, and were found to have reduced by 15% to 20%. The rigs were re-loaded to their original loads and this checking and re-loading procedure will be repeated at intervals throughout the test programme.

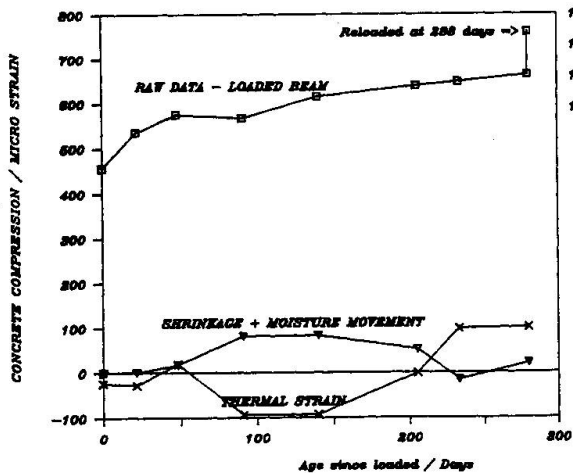
Fig. 3 Strain Data for Plated Beam

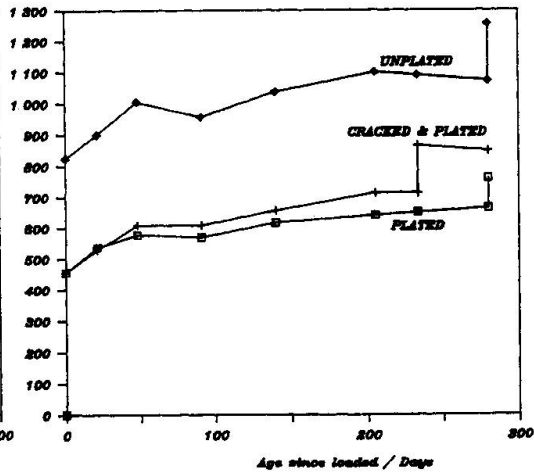
Fig. 4 Comparison of Three Beams

A comparison between the strain data for an unplated beam, a beam that was plated in its unloaded condition and a beam that was plated in the loaded, pre-cracked condition is shown in Figure 4. The data will be corrected to allow

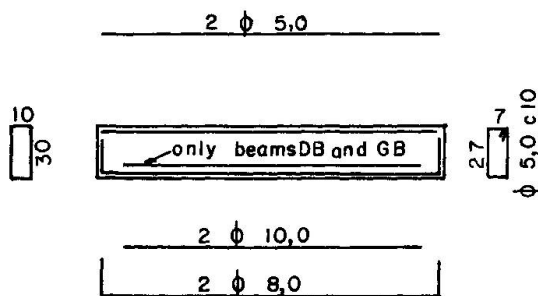
Fig. 1 Beam reinforcement

Twelve equal beams, 2.0 m in length each, were poured (fig. 1). Three of them were not strengthened (beams SB), and were used as a lower-bound limit. Three beams were strengthened with shotcrete (beams SH, fig. 2), and other three with glued mortar (beams MB, fig. 2). The remaining three were strengthened with epoxy-glued steel plates. For the beam in fig. 3.a (beam SP1), only epoxy was used to connect plate to concrete. For beam SP2 in fig. 3.c, U plates were used to connect steel plate to the beam, and for beam SP3 (fig. 3.b) bolts were used to assure a better connection between plate and concrete.

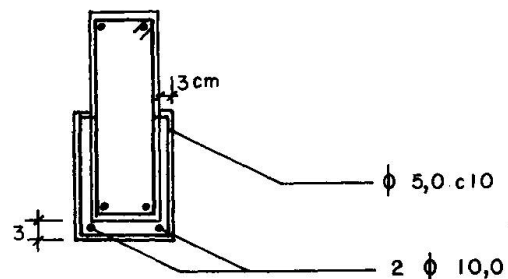
Fig. 2 Shotcrete and glued mortar

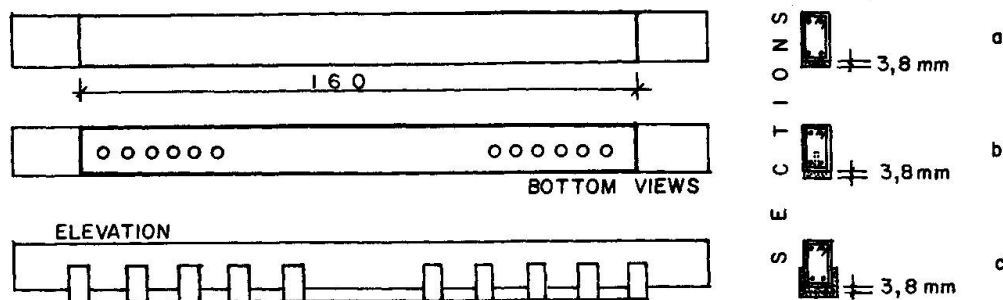
Fig. 3 Epoxy-glued steel plate strengthening

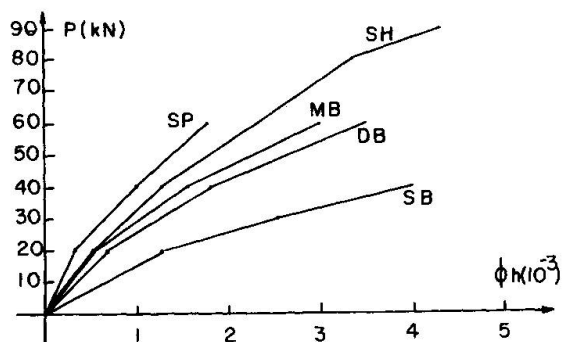
Fig. 4 displays "load x curvature" diagrams, and table 1 shows the design loads (P_d), the theoretical (P_u) and the experimental ($P_{u,exp}$) collapse loads (4). The listed values are total loads applied to the beam (sum of two concentrated loads).

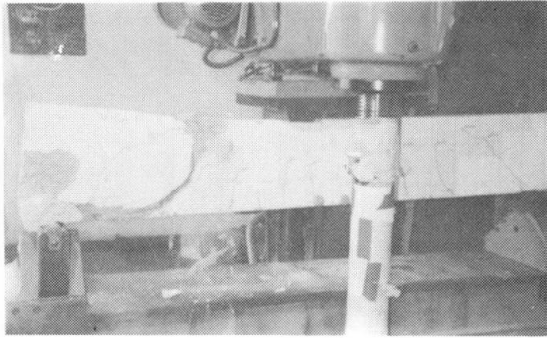
Fig. 5 Steel plate beam

- out rugous surface (fig. 6);
- Beams strengthened with glued mortar failed with 79% of the expected load;
- Beams strengthened with glued steel plates were the stiffest, followed by shotcrete strengthened beams;
- Beams strengthened with glued steel plates showed the best behaviour for crack width, with no cracks in strengthened region until the design loads were reached; nevertheless, beam SP1 collapsed soon after the first horizontal crack in the concrete cover occurred (fig. 5).

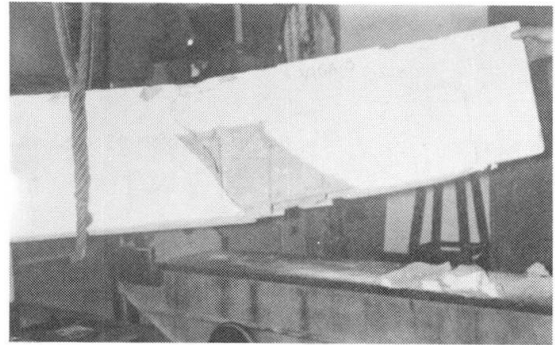
Fig. 6 Shotcrete beam

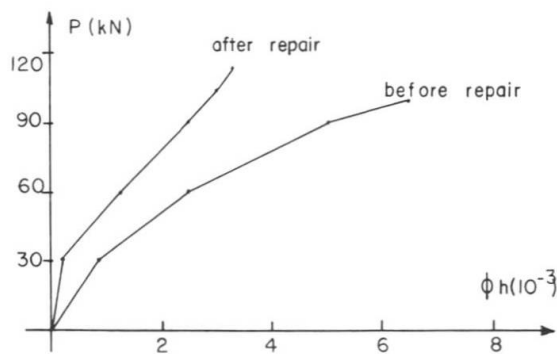
Fig. 7 Load x Curvature diagram

Beams were once more loaded, and fig. 7 shows "load x curvature" diagrams for tests before and after repair. Collapse loads before and after repair are presented at table 2, and a repaired beam before and after failure is showed at figures 8 and 9.

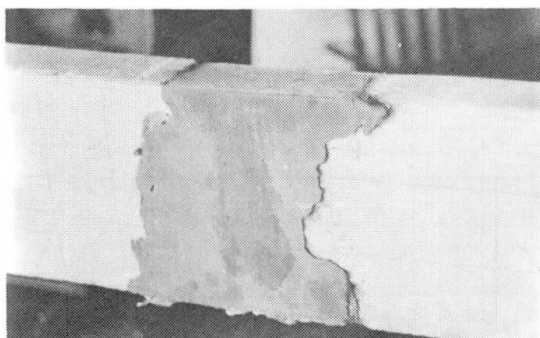
Fig. 8 Grout repaired beam

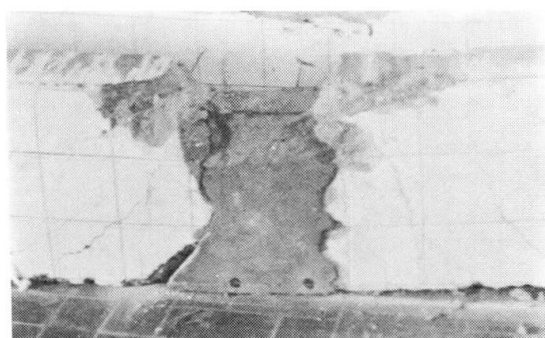
Fig. 9 Grout beam after failure

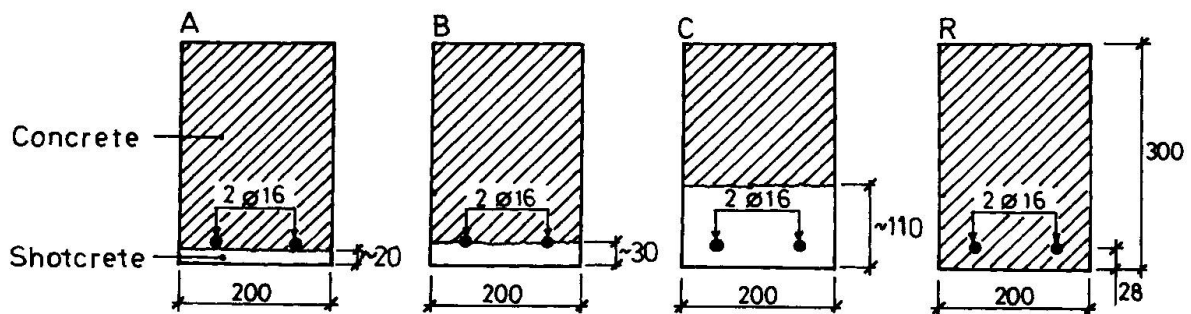
Fig. 1 Cross sections of specimens of type A, B, C and R.

In a second phase of test specimen preparation, the removed concrete was replaced by shotcrete to the level of the original slab thickness. The slabs were finally sawn into strips, resulting in beam specimens. The test specimens were designated A1, A2, A3 etc. The cross-sections are shown in Fig. 1 and material properties are listed in Table 1.

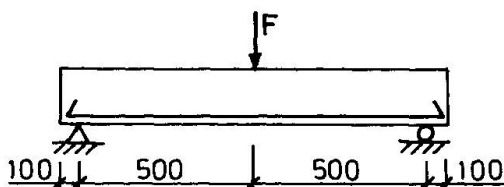
One beam specimen of each type was statically loaded to failure and two of each type were loaded by fatigue. All beams were simply supported on two supports and loaded by a central single load according to Fig. 2.

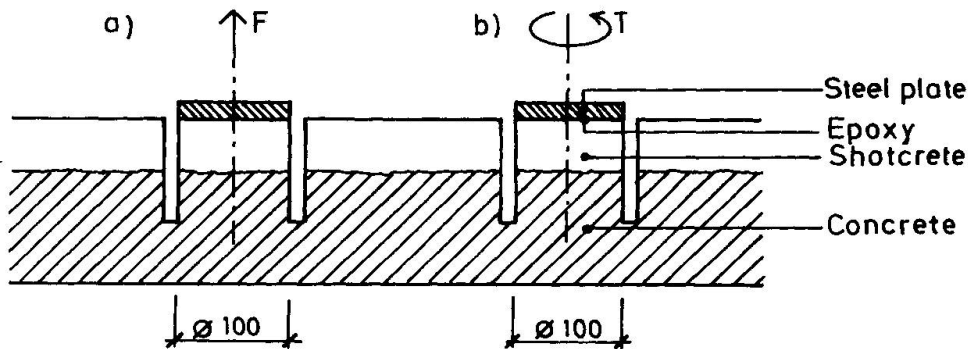
Fig. 3 Pull-off tests (a) and torsional tests (b) of cores

The tests were terminated with pull-off tests and torsional tests of cores according to Fig. 3. The results are shown in Table 5. Since no pure interface failure occurred it can only be stated that the tensile and shear strength of the interface cannot have been less than the failure values obtained. The failure stress was 1-2 MPa at tension (pull-off tests) and 3-4 MPa at shear (torsional tests). No differences dependent on the location of the interface in relation to the reinforcement plane could be determined according to these tests.

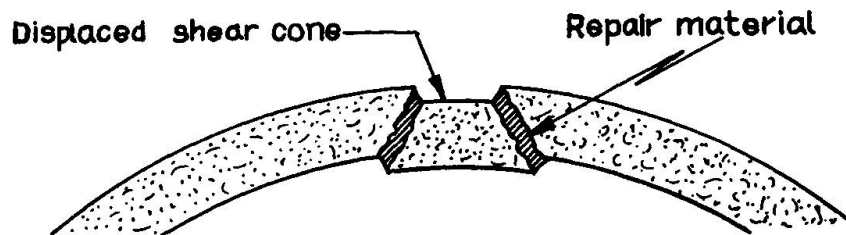
Figure 1. Sectional view of a dome repair

In that project concrete slabs and domes exhibiting an intermediate level of damage were repaired underwater using a variety of repair materials. These materials included epoxy resins of varying viscosities and cementitious grouts, some of which were modified especially for underwater placement. The method of repair was essentially to inject the repair material into the annulus between the displaced cone and the main body of the concrete. (Fig. 1.). The slab or dome was then tested by static loading through a steel platen placed on the repaired area.

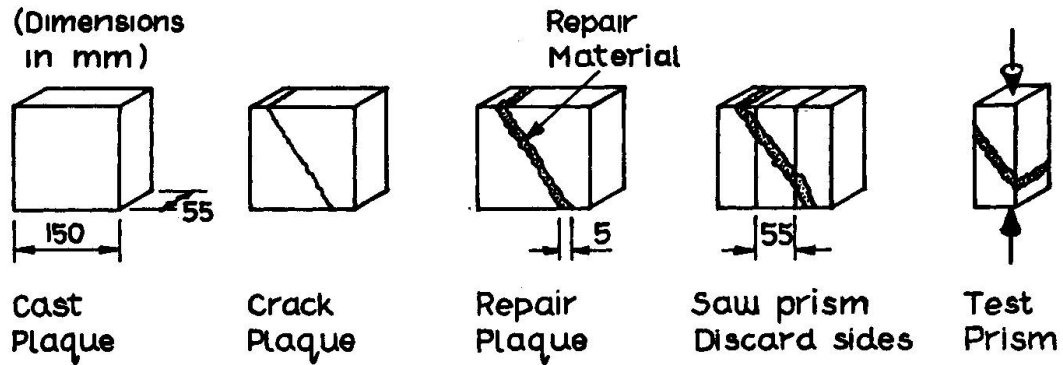
Figure 2 Resin bonded slant shear test method

The slant shear test method used for epoxy resins was an adaption of the existing British Standard and consisted of testing a resin bonded scarf jointed prism by loading in compression (Fig. 2). A special jig was developed which separated and held the two halves a fixed distance apart and, at the same time, acted as a shutter for the resin injected into the crack.

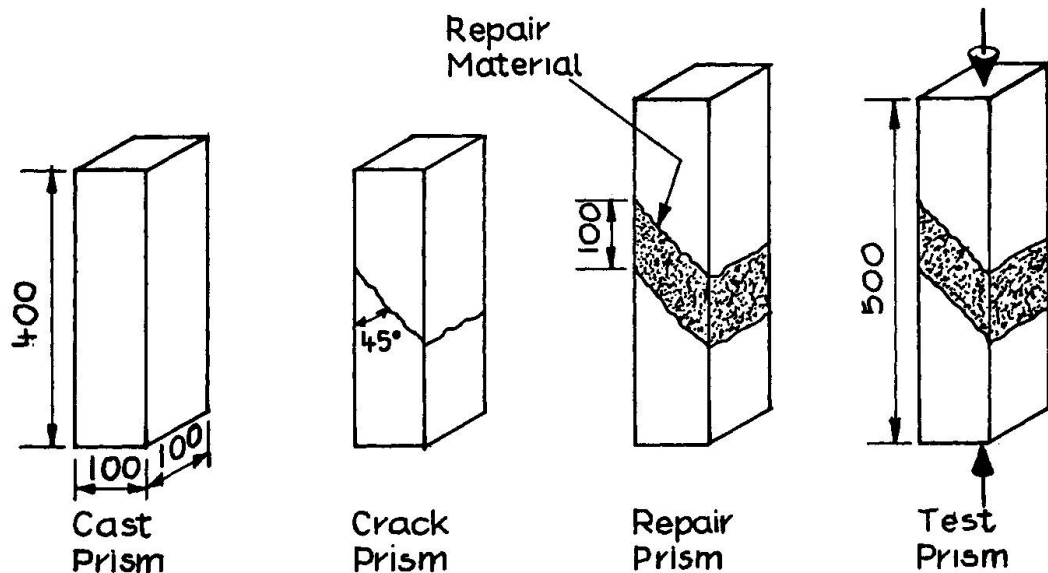
Figure 3 Cementitious grout bonded slant shear test method

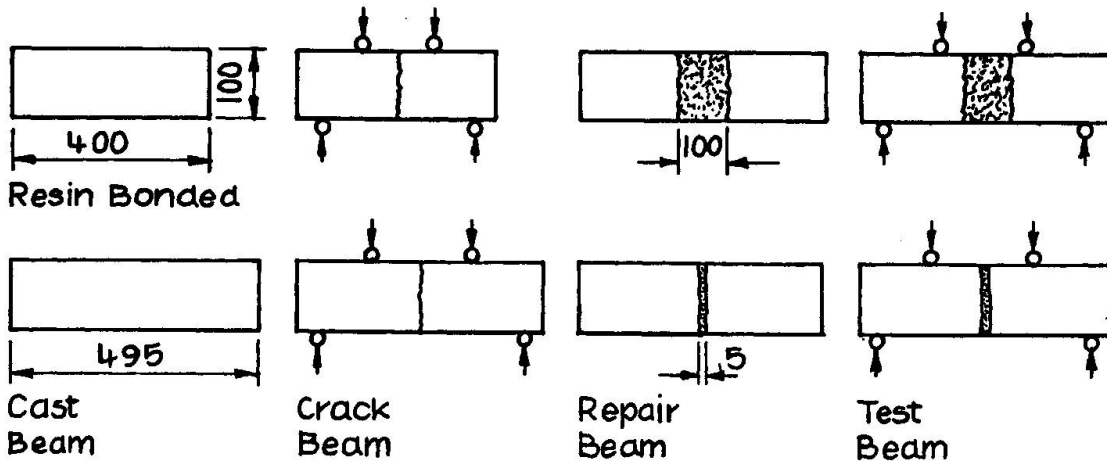
Figure 4 Flexural tests

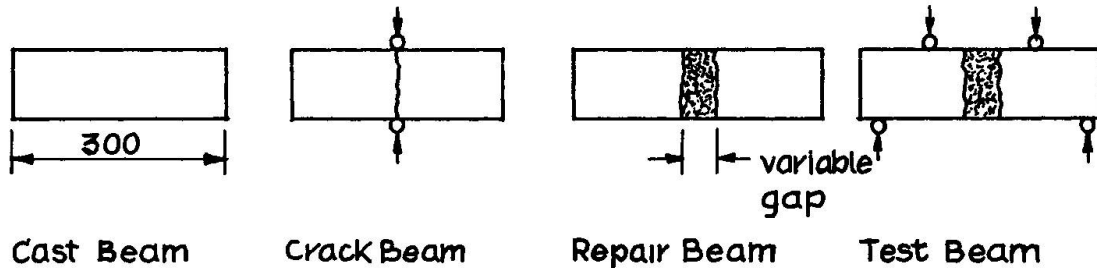
Figure 5 Recommended flexural test for resin or cementitious bonded beams

This flexural test would give a severe test of the bonding power of a repair material and would test the bond in a mode that is likely to be encountered by a repaired prototype structure. The test is based on the flexural tests described above and consists of casting a short beam of concrete, of a mix design as similar as possible to the marine structures being repaired, breaking that beam in a controlled manner, separating the two halves to a fixed distance, filling the gap with the repair material and, after curing, testing the resulting composite beam by four point flexural loading (Fig. 5).

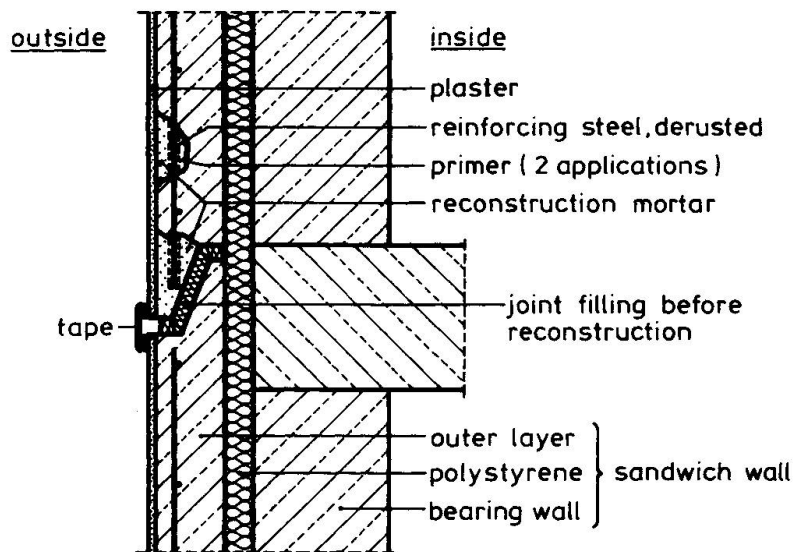
Fig.1 Konventionelle Instandsetzung geschädigter Betonoberflächen

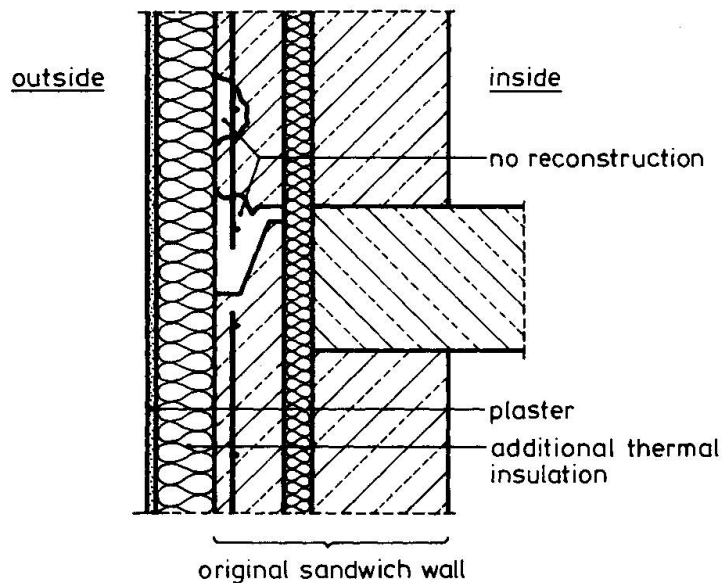
Fig.2 Stahlbetonaußenwand ohne konventionelle Betoninstandsetzung, aber mit nachträglich aufgebrachtem Wärmedämmverbundsystem

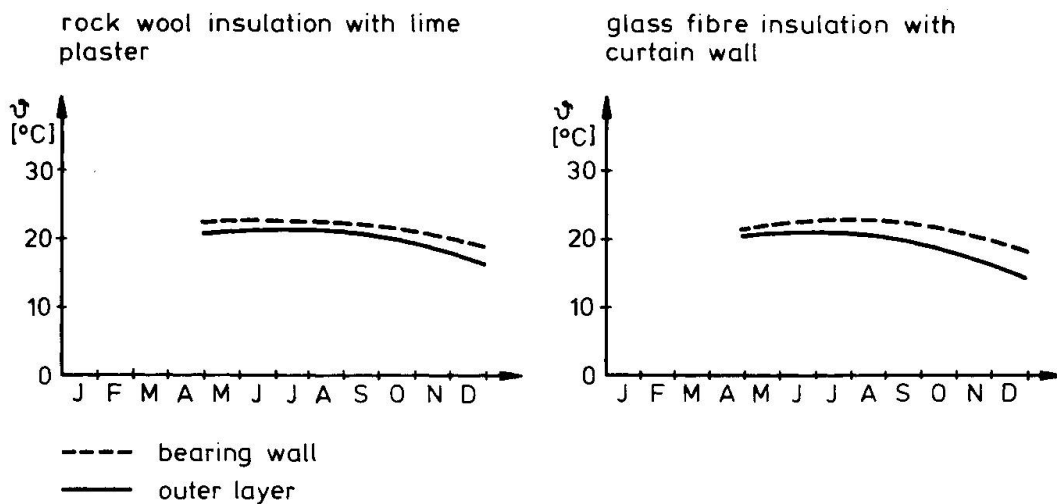
Fig.3 Temperaturverläufe in nachträglich wärmegeämmten Betonsandwichwänden, links mit mineralischem Wärmedämmverbundsystem, rechts mit Vorhangfassade (geglättete Meßwerte 1988)

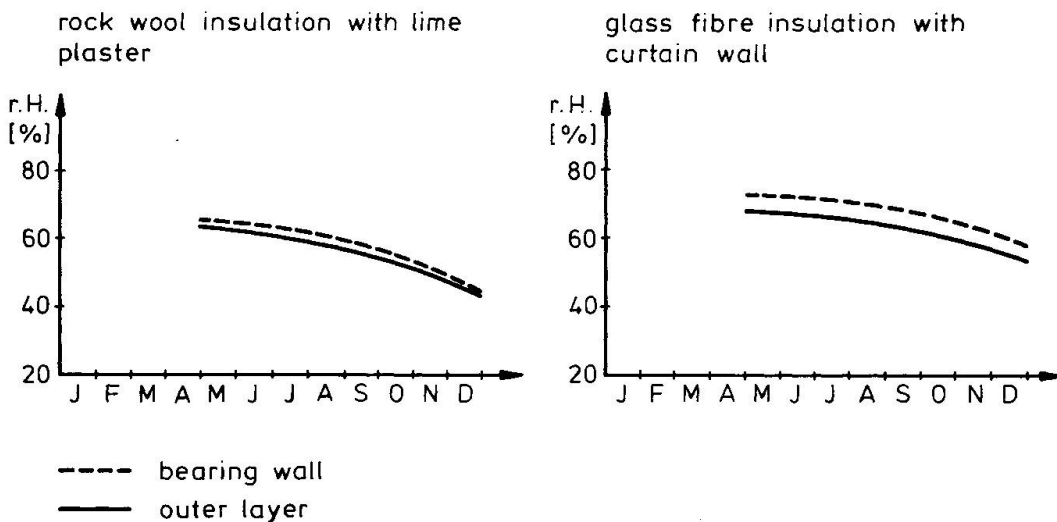
Fig.4 Verläufe der Gleichgewichts-Luftfeuchten in nachträglich wärmegeämmten Betonsandwichwänden, links mit mineralischem Wärmedämmverbundsystem, rechts mit Vorhangfassade (geglättete Meßwerte 1988)

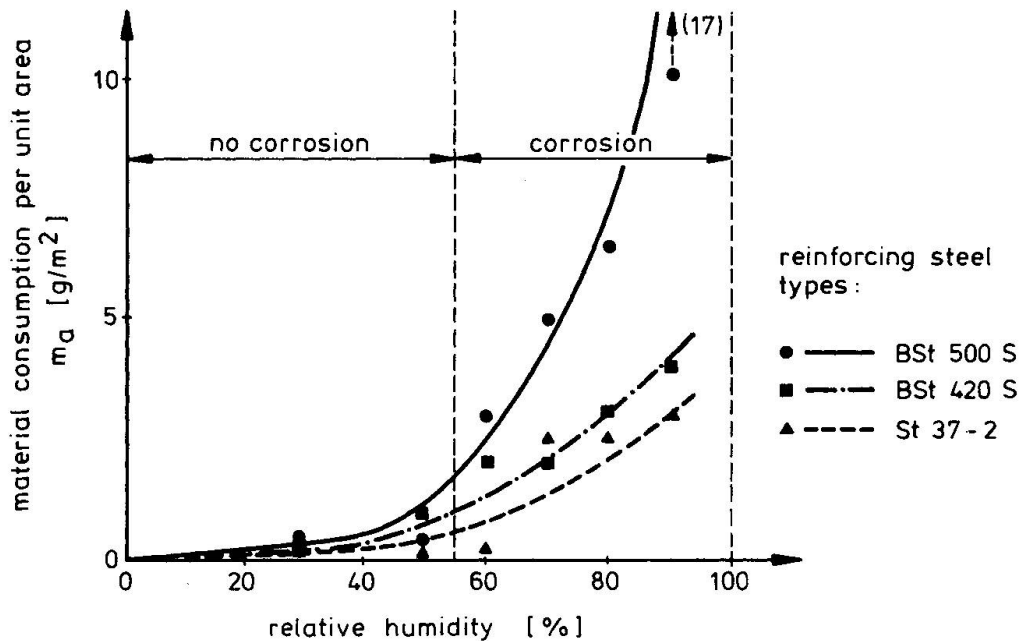
Fig. 5 Flächenbezogene Massenverluste m_a bei atmosphärischer Korrosion in Industrielatmosphäre nach ca. 40 Tagen Lagerung bei verschiedenen relativen Luftfeuchten

Daher werden z.Z. karbonatisierte Betonproben mit verschiedenen Betonstählen bei 60, 70, 80 und 90 % relativer Luftfeuchte klimatisiert, nach festgelegten Zeiten geöffnet und die eingebetteten Stähle auf ihren Korrosionsabtrag untersucht.
