Theme B: Behaviour of materials

Experimental and Theoretical Investigations of Existing Railway Bridges

Remaining Fatigue Strength of Corroded Steel Beams

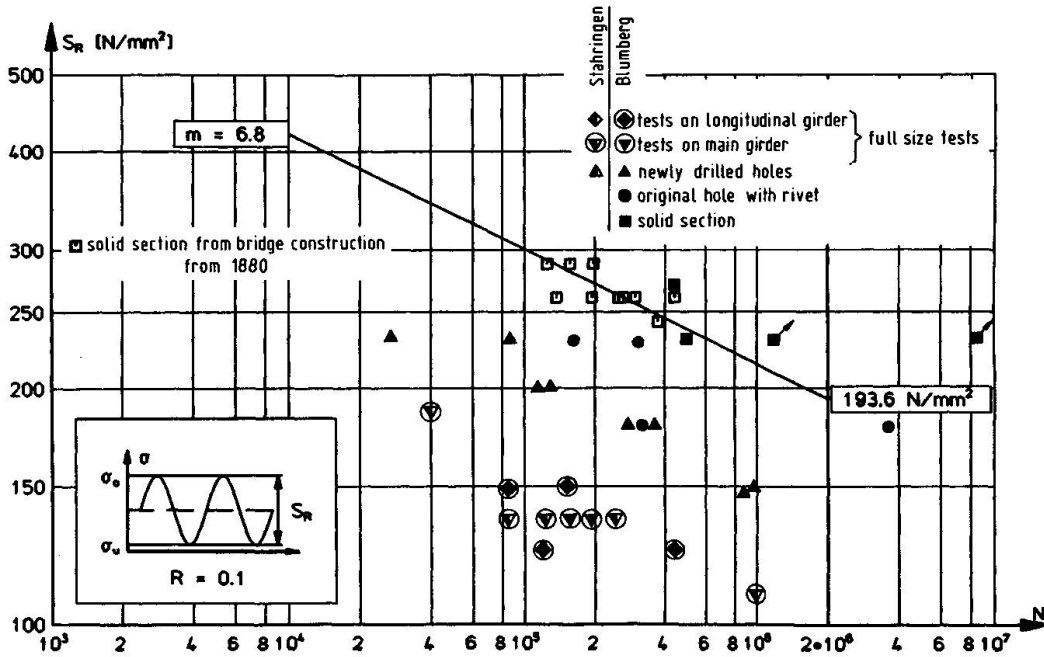
Fig. 14 Test results and data from [5], bridges dating from 1880, plain material

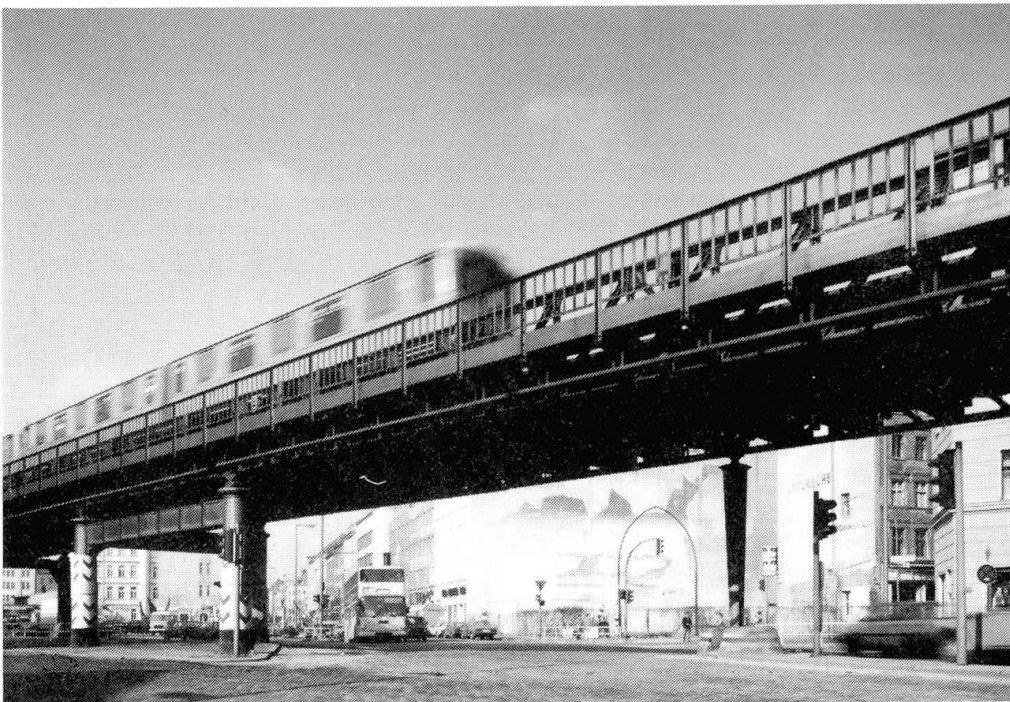
Figure 2.
Truss girder bridge of the Berlin Underground, built in 1902, replaced in 1989

Today, we perform cyclic loading tests on parts of the Berlin Underground Bridge shown in fig. 2, which was built in 1902.
