# Full-scale shear tests on two bridges

Zeitschrift: **IABSE reports = Rapports AIPC = IVBH Berichte**

Band (Jahr): **62 (1991)**

## Full-Scale Shear Tests on two Bridges

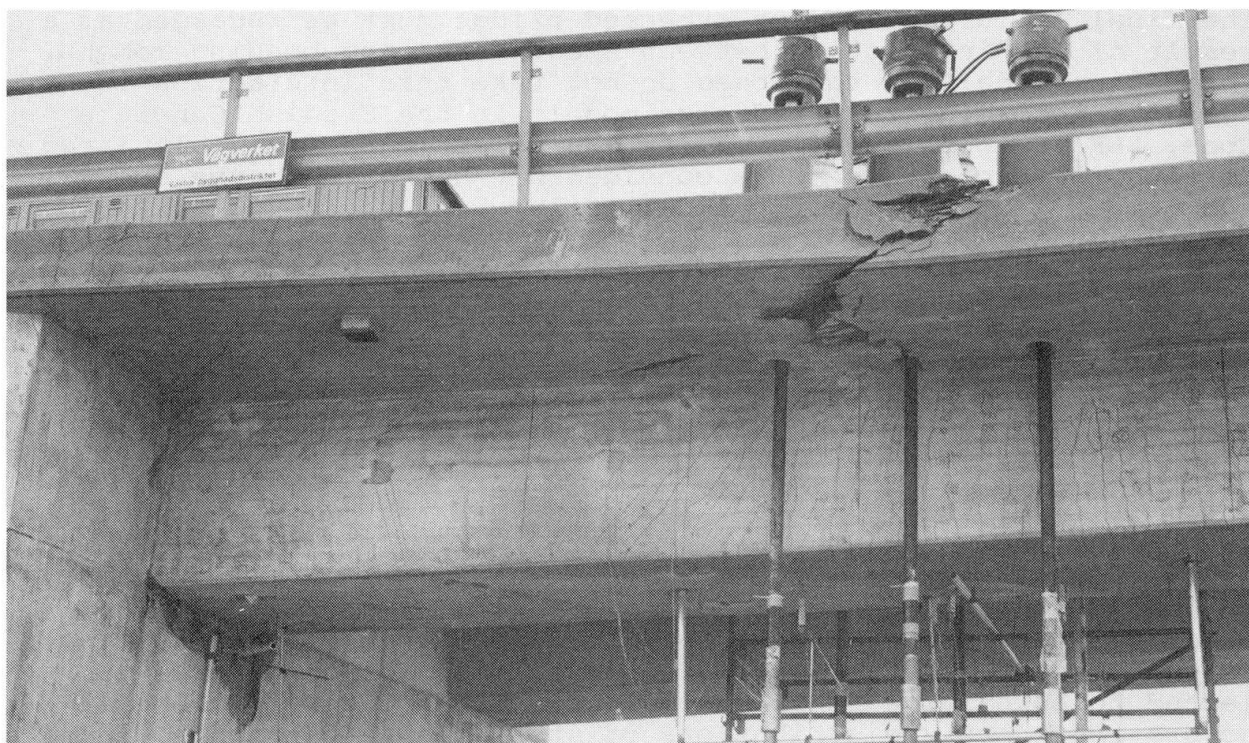
**Fig. 7** Failure in the prestressed bridge. Cracking, support failure and concrete compression failure at the top of the loading section can be seen.

The failure of the pre-stressed bridge was more complicated. Before the test this bridge was cut longitudinally between the two main beams and one of the beams was loaded about 4,75 m from one of the supports. After extensive cracking due to bending, together with a few shear-bending cracks, the support closest to the load unexpectedly failed at a load of 8,5 MN. The support failure led to a redistribution of the moment, with increasing moment in the loading section.

When the support failed, the load decreased to 6,0 MN. Further loading with the jacks led to large deformations and several inclined cracks in the shear span. The final failure occurred at a load of 6,3 MN, when the concrete at the upper edge of the loading section crushed due to compression (fig 7).

The final failure in the prestressed bridge must be regarded as a result of the interaction between shear force and bending moment. The design models in the codes do not take this interaction into account. According to the design models in the Swedish Concrete Code, BBK 79, both shear capacity and moment capacity, calculated as separate capacities, were considerably higher than the shear and moment in the bridge at final failure.
