# Diagnosis and strengthening of the Brunelleschi Dome

Autor(en): **Chiarugi, A. / Fanelli, M. / Giuseppetti, G.**

Zeitschrift: **IABSE reports = Rapports AIPC = IVBH Berichte**

Band (Jahr): **70 (1993)**

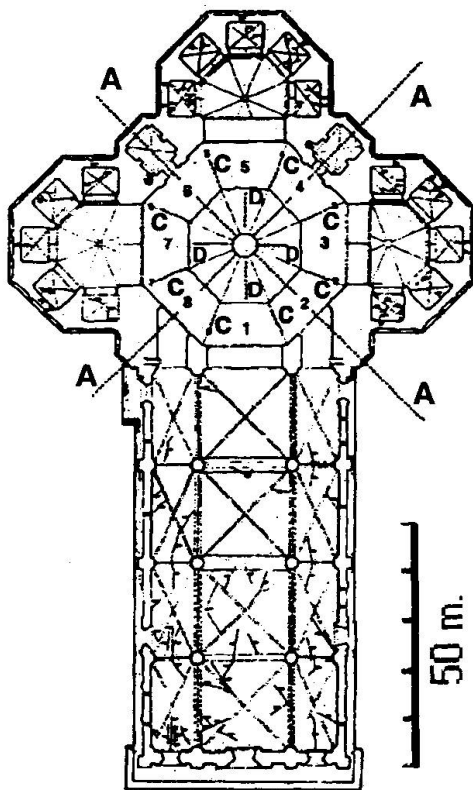
Fig. 1 Sides numbering and planar position of type "A, B, C and D" cracks.

After 1434 (the year in which Filippo Brunelleschi achieved the construction of the Dome of Santa Maria del Fiore), and after the erection of the skylight, carried out after Brunelleschi's death, no direct information is available until 1600 about mechanical problems in the Dome. Successively, several investigation campaigns are mounted concerning the cracks observed on some of the dome's panels, especially on the sides directly above the absidal pylons, and in particular in the South-East corner, panel n° 4; see figs. 1 and 2.

- "type A" cracks, subvertical, through the whole thickness. (panels with even numbering);
- "type B" cracks, subvertical, through the whole thickness, in the panels with odd numbering;
- "type C" cracks, penetrating only to a partial depth in the thickness, in the edges between adjoining panels;

- "type D" cracks, also penetrating only to a partial depth in the thickness, along the midline of the panels with odd numbering (see figs. 1 and 2).

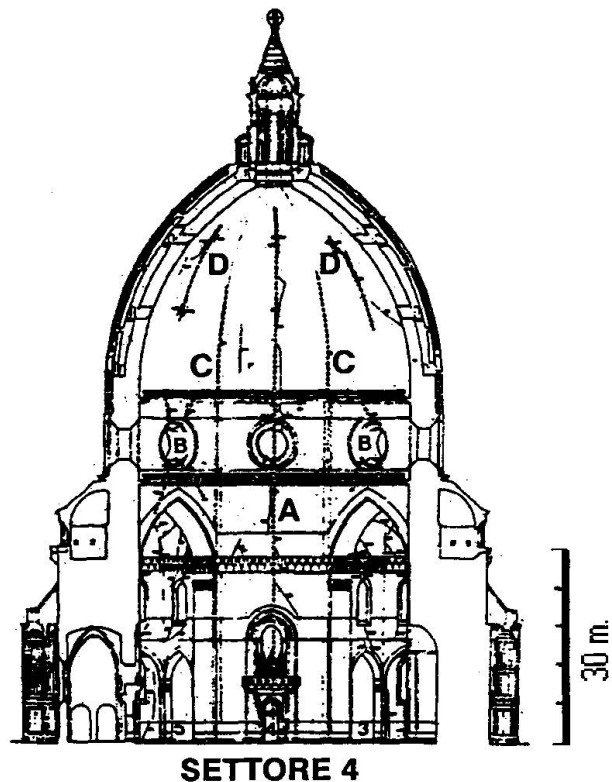
Fig. 2 Crack description summary with type "A, B, C and D" cracks.

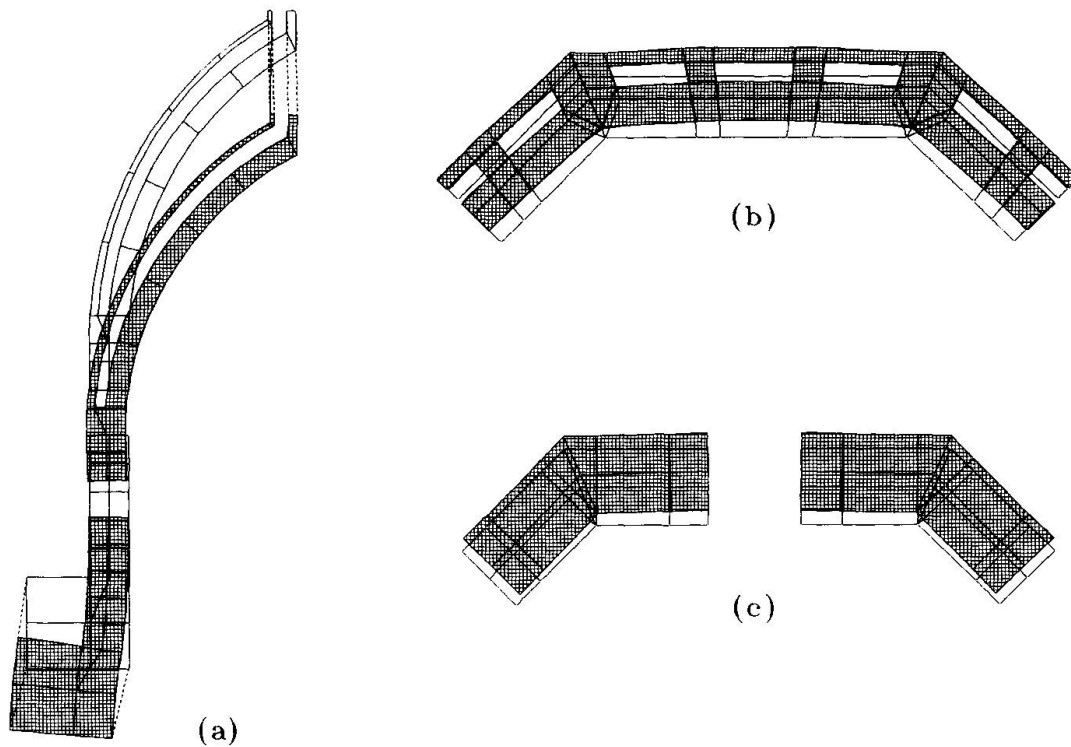
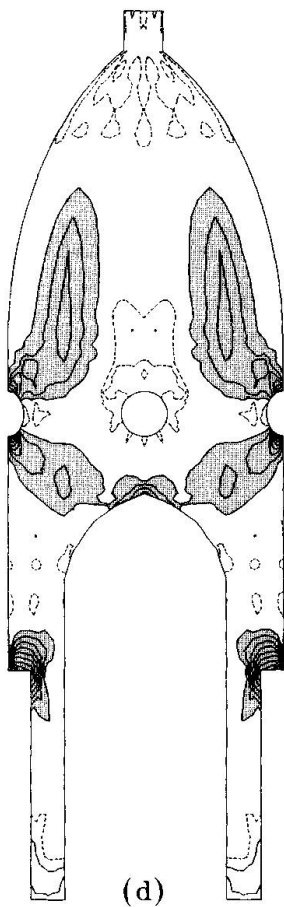
**Fig. 3** "First virtual model" undamaged structure:

- (a) deformed line of vertical section in centerline on even-numbered panel;
- (b) deformed line of section 3-3 at 66 m level;
- (c) deformed line of horizontal section on circular centerline window (note ovalization of opening on even-numbered panel);
- (d) stress distribution  $\sigma$  horizontal on intrados face (note tension increase around the circular windows of even numbered panel and above the keystone of arch). Tension zone shaded.

- "First virtual model" characteristic:

n° nodes 3286

n° elements 569

- Elements characteristic:

isoparametric hexahedrons with 20 nodes

isoparametric pentahedrons with 15 nodes

- Material characteristic:

modulus of elasticity: 50000 kg/cm<sup>2</sup>

Poisson's ratio : 0.1

Density : 0.0018 kg/cm<sup>3</sup>

In the process of mechanical identification of the structure a first virtual numerical model was built up, formed only by the following members: pylons, drum, dome. In this virtual F.E. model, 15 and 20 nodes isoparametric elements were used, with the same linear elastic constitutive law-throughout the structure. The first numerical analysis concerned the original (undamaged) virtual model under gravitational loads (deadweight).

A perusal of results clearly shows that the "parallels" just above the circular windows on the even-numbered panels undergo high levels of tensile stresses. Horizontal tensile stresses are found also in the drum, above the keystone of arches on the odd-numbered sides (see fig. 3 a, b, c, d).

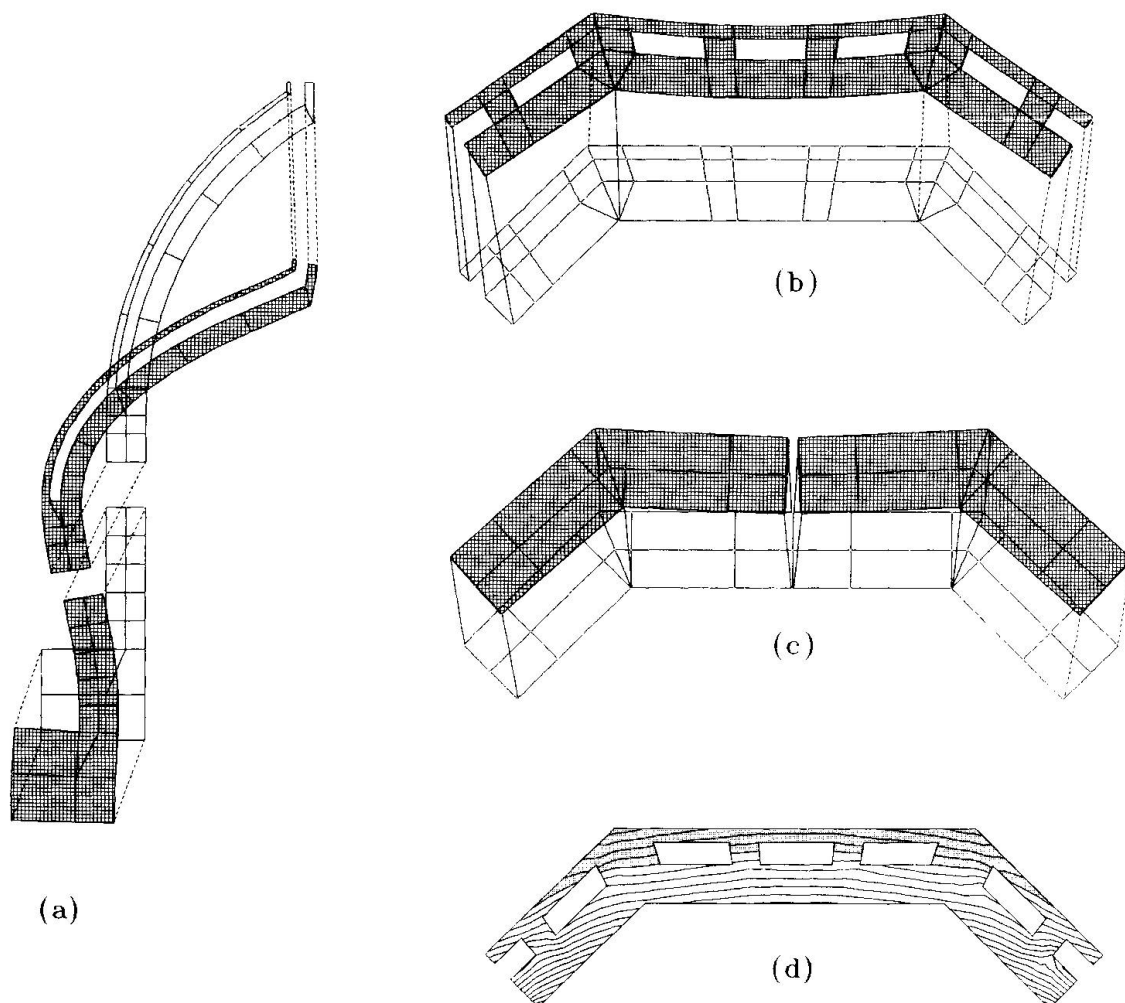
**Fig. 4** "First identification model" with type A and B cracks:

- (a) deformed line of vertical section;
- (b) deformed line of section 3-3 at 66 m level  
(note inflexion on the section plane);
- (c) deformed line of section under circular window  
(note opening crack B);
- (d) stress distribution  $\sigma_z$  vertical in section 3-3  
(note effects of bending with vertical tension  
localized in external panels with odd numbering).  
Tension zone shaded.

The results of the analysis carried out on this second model confirm the indications of the crack pattern, explaining in particular the origin of the cracks "type C and D". It is observed also that the external shell on the odd-numbered sides is subjected to vertical tensile stresses, whereas the highest level of vertical compressive stresses is found in the internal corners of cracks "type A".

This distribution of vertical stresses has been confirmed experimentally through another "continuous monitoring" operation using the flat jack technique (fig. 4 a, b, c, d; fig. 5 a, b, c).

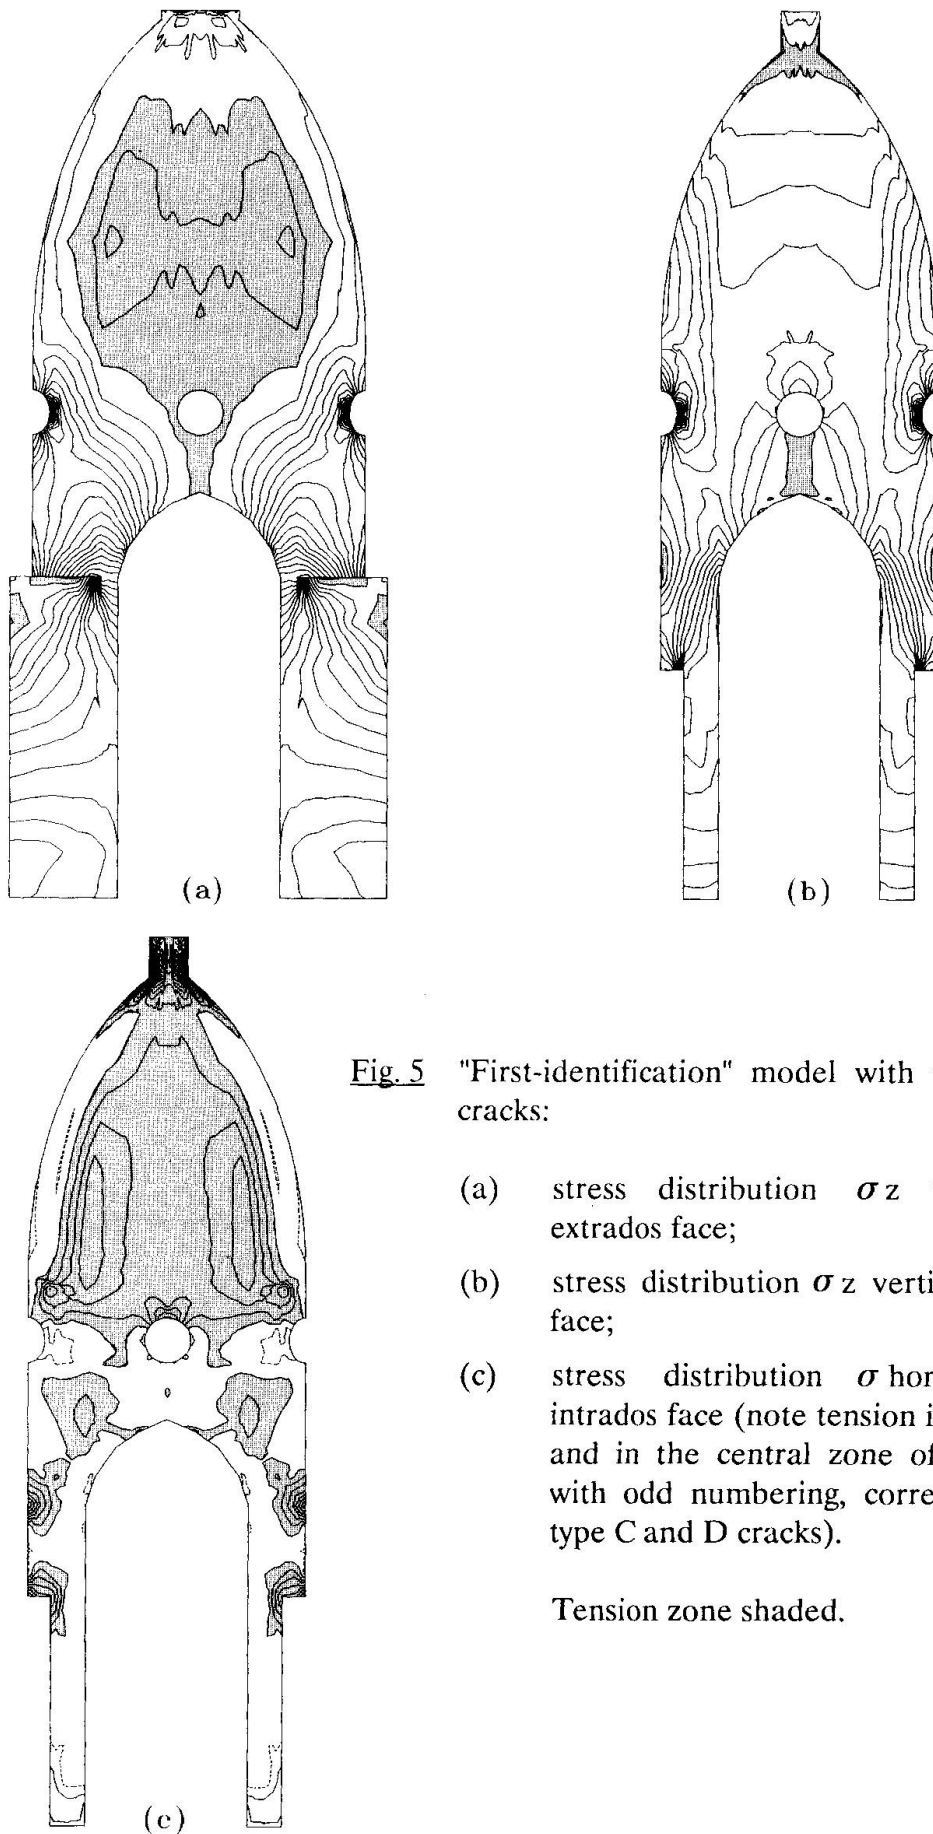
**Fig. 5** "First-identification" model with type A and B cracks:

- (a) stress distribution  $\sigma_z$  vertical on extrados face;
- (b) stress distribution  $\sigma_z$  vertical intrados face;
- (c) stress distribution  $\sigma$  horizontal on intrados face (note tension in the corner and in the central zone of the panels with odd numbering, corresponding at type C and D cracks).

Tension zone shaded.

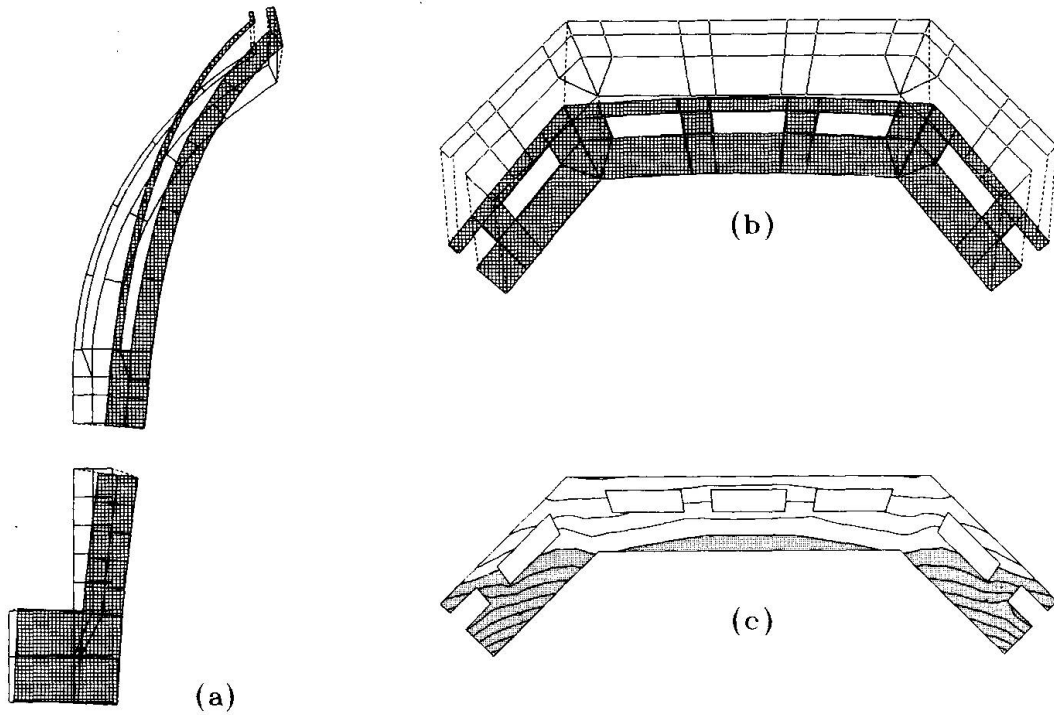
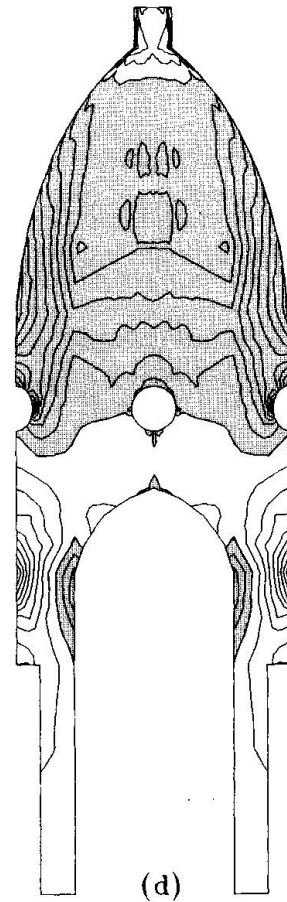
**Fig. 6**

"First identification model" under only strengthening effect:

- (a) deformed line of vertical section;
- (b) deformed line of section 3-3 at 66 m level;
- (c) stress distribution  $\sigma_z$  vertical in the section 3-3; with opponent distribution with respect to the dead-weight;
- (d) stress distribution  $\sigma_z$  vertical on intrados face;

Tension zone shaded.

The strengthening intervention could be effected through harmonic-steel cables placed at floor level in the first walking. The shape of these belts, pulled on at the midpoint of each side, would be octagonal; thus the interaction with the existing structure (apart from local effect) could be schematized by a system of radial forces, applied in the edges at the springing section of the dome.

Perusing the numerical simulation of this strengthening carried out on the "first-identification" model, one is surprised by the close-fitting antagonistic effect brought about by the intervention as against the dead-weight stress pattern (fig. 6 a, b, c, d).
