Artikel: Acoustic emission monitoring of bridges under heavy truck loading
Autor: Maliszewicz, Przemyslaw / Antoniak, Daniel
DOI: <https://doi.org/10.5169/seals-55186>

Acoustic Emission Monitoring of Bridges under Heavy Truck Loading

The paper reports test results of acoustic emission monitoring of two bridges under heavy truck loading. Measurement of the signals is compared with the results of calculation. Application of the acoustic emission as the method for early warning during passage of the vehicle along the bridge is shown in the paper. Post-test assessment of the stresses of structural members under heavy loading in comparison to the acoustic emission measured for normal traffic is presented.

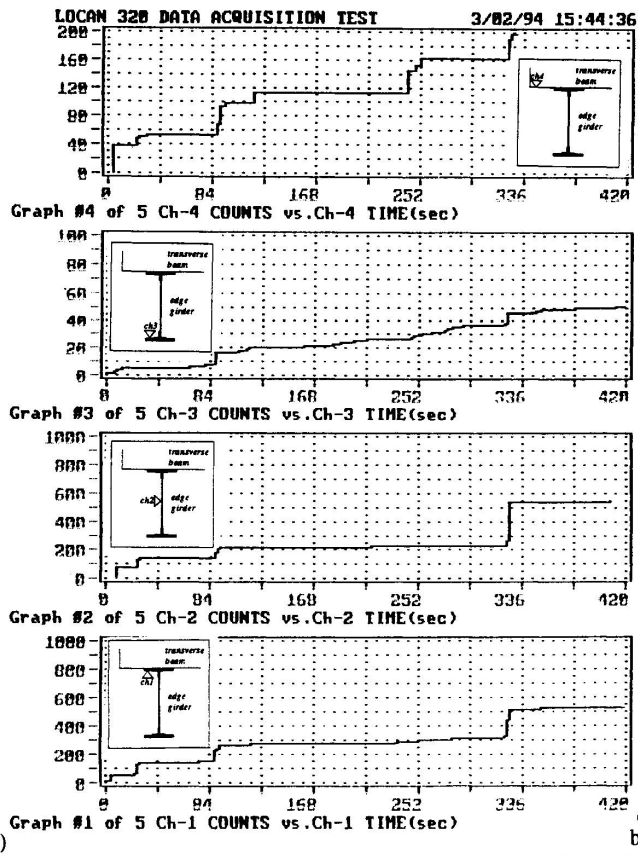
Fig.1 Comparison of number of AE counts measured for the bridge 1, a) under service load, b) under heavy truck load

Test results from measurement of AE signals generated by *bridge I* members are shown in Fig. 1 AE structure response under service load was compared with the signals emitted by the same members under passage of the heavy vehicle. Measurements were done with amplification of 40 dB and "floating threshold" 25 dB.

- AE was registered after the truck got to the secondary span indicating that friction in hinges was not the source of emission,
- the stopping of the truck during the passage along the bridge was accompanied by stabilization of number of AE counts (see fig. 1), especially in the web of the main girder and in transverse beam, in the flanges of the main girders AE rate also decreased, however at this level of loading the stopping of the truck caused exponential decreasing of AE,

- after the stopping further increase of AE is observed as the truck was approaching the middle of the bridge,
- the level of AE caused by heavy truck loading is an order higher than the one obtained for single vehicles in common traffic; numbers of AE counts measured in web, top and bottom flange of main girder are in the same range what shows similar effort of these elements; the number of counts registered in transverse beam is several times lower.

- it is significant the AE rate increases with growth of applied loading (see *bridge I*, Fig. 1),
- AE signal decreased quickly after the truck went off the bridge but the signal lasted still about 100 seconds at the level of tens of counts a second,
