Zeitschrift: IABSE reports = Rapports AIPC = IVBH Berichte
Band: 73/1/73/2 (1995)

Rubrik: Session A4: Concrete durability I

**Concrete Durability I
Durabilité du béton I
Dauerhaftigkeit des Betons I**

Application of Super-Workable Concrete to an Arch Bridge

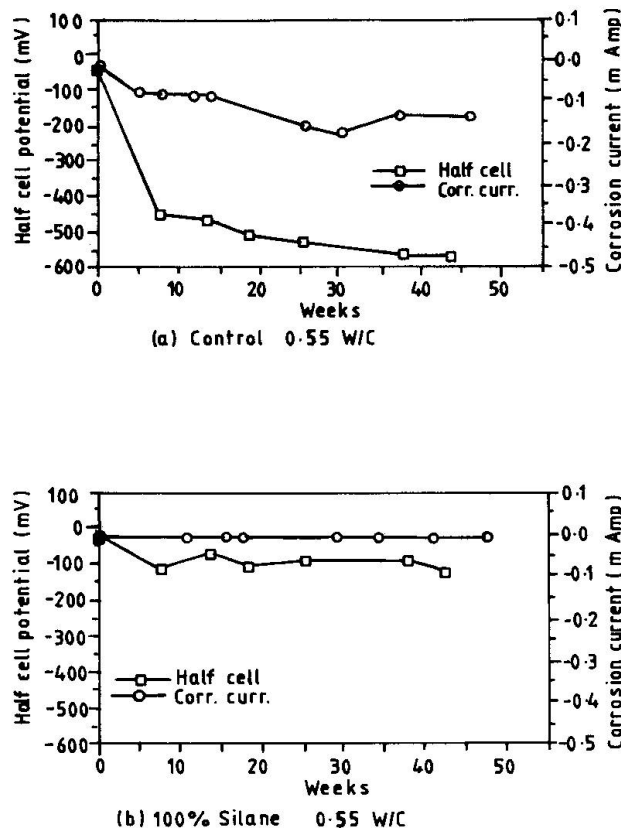
Figure 3. Corrosion at 25 mm cover in cyclic ponding test

For the control slabs, there was evidence of corrosion activity within the first 10 weeks. Figure 3(a) shows the half-cell and corrosion current readings for 0.55 water/cement ratio concrete. At the end of the test period, half-cell potentials were between -450mV and -600mV for all three concretes. The corresponding corrosion currents were -0.02mA to 0.20mA. At the end of the test, the samples

were broken and the bars inspected for rusting. This confirmed the above result with rusting evident on all the bars at 25mm cover in the untreated specimens. In fact, except in the case of the 0.45 water-cement ratio concrete, the bars at 40mm cover had some rust on the top surface; also confirming the potential and corrosion current readings.

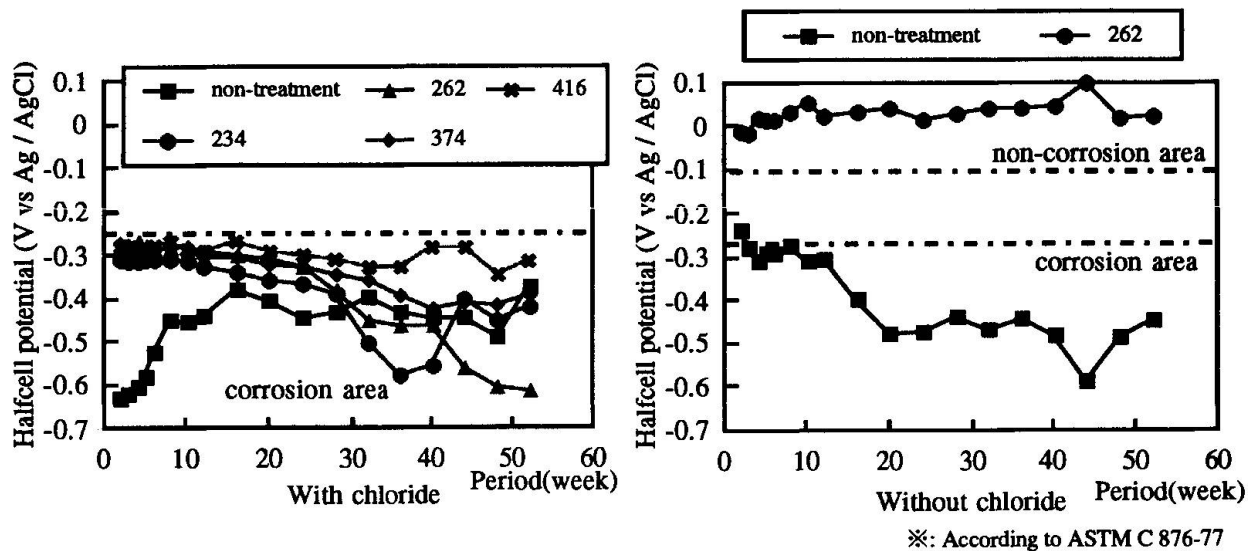
Fig.5 Halfcell potential

Fig.5 shows some results of the halfcell potential obtained from the non-reactive specimens in the condition of partially immersing in chloride solution. While the

halfcell potential of the non-treated specimen without chloride was in the corrosion area, that of the specimen impregnated with 262 was still in the non-corrosion area. This indicates that the silane worked effectively also against corrosion of reinforcement caused by the chloride solution. However, when concrete included much chloride, although the halfcell potential of the impregnated specimens were less negative than that of non-treated specimens in a short term, they gradually became negative with the time passing until some of them were more negative than that of non-treated specimens.
