Zeitschrift: IABSE reports = Rapports AIPC = IVBH Berichte
Band: 73/1/73/2 (1995)

Rubrik: Session B3: Maintenance of structures

Maintenance of Structures
Maintenance des structures
Instandhaltung der Tragwerke

Guidelines for a Handbook on the Service Life of Buildings

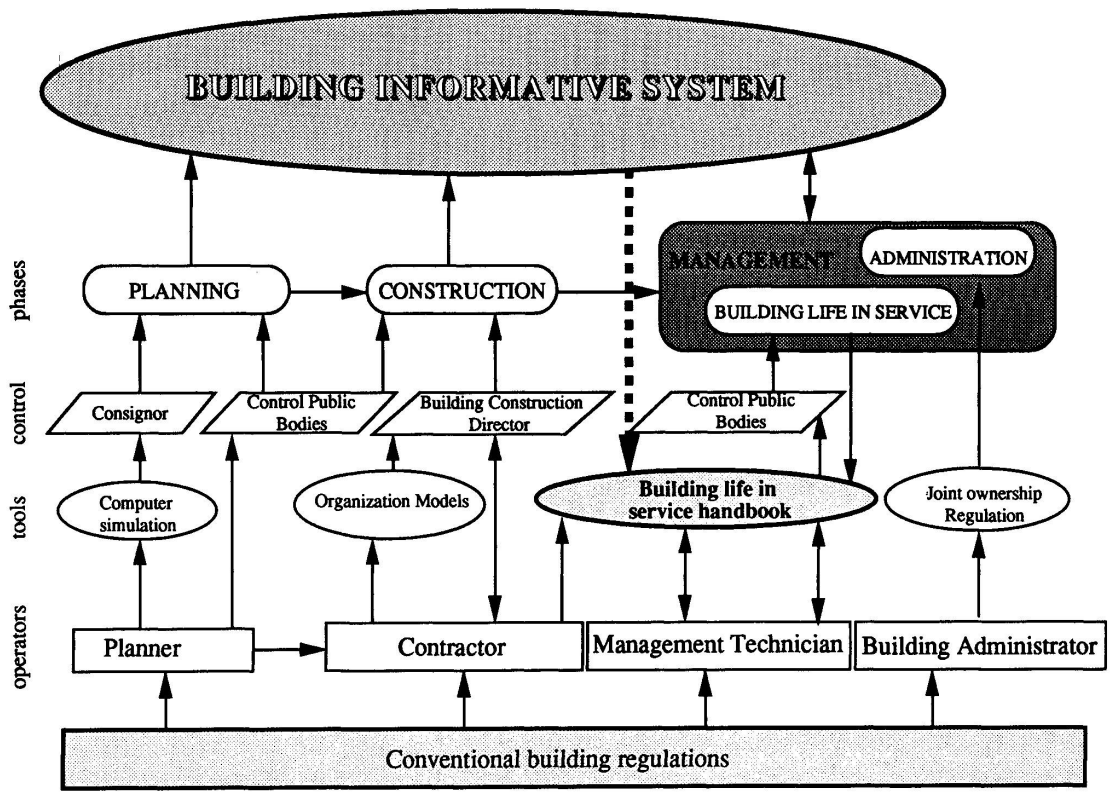
Fig. 1 The Management phase within the Building Process

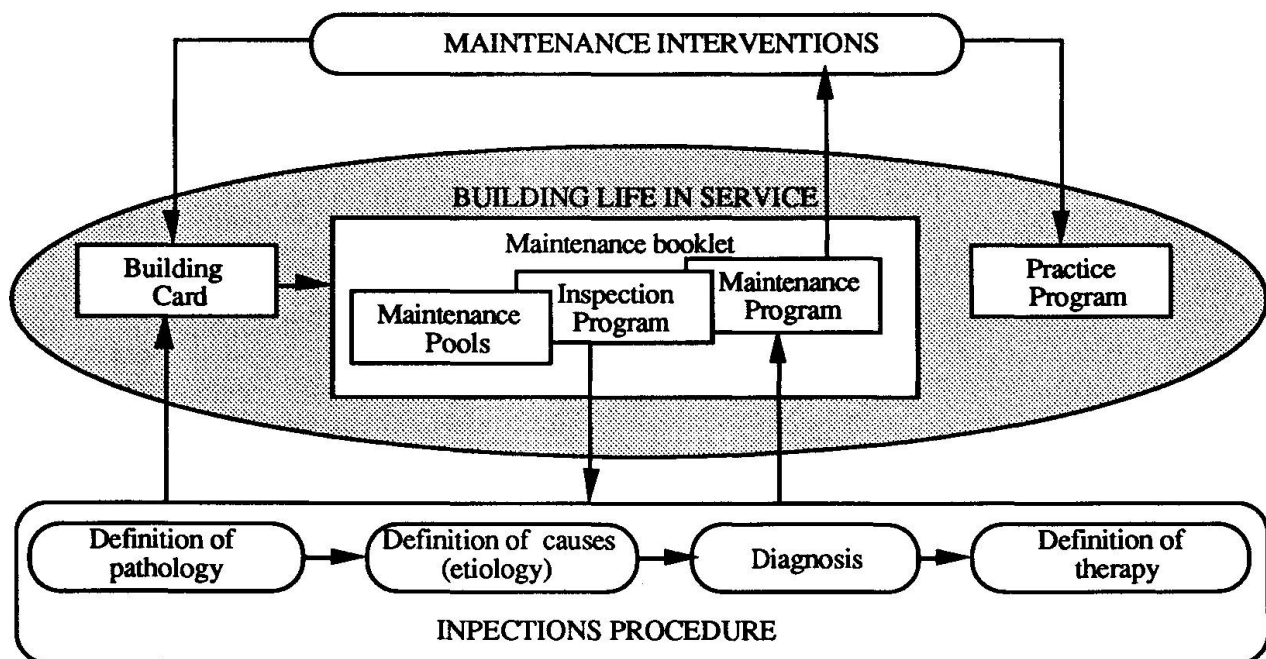
Fig. 2 Relationships between constituent parts of buildings life in service handbook, inspections procedures and execution of maintenance interventions

Such a program should be useful for the final user and the building administrator, in order to avoid requests which are either unexpected and/or contrary to established planning criteria (Fig. 2).

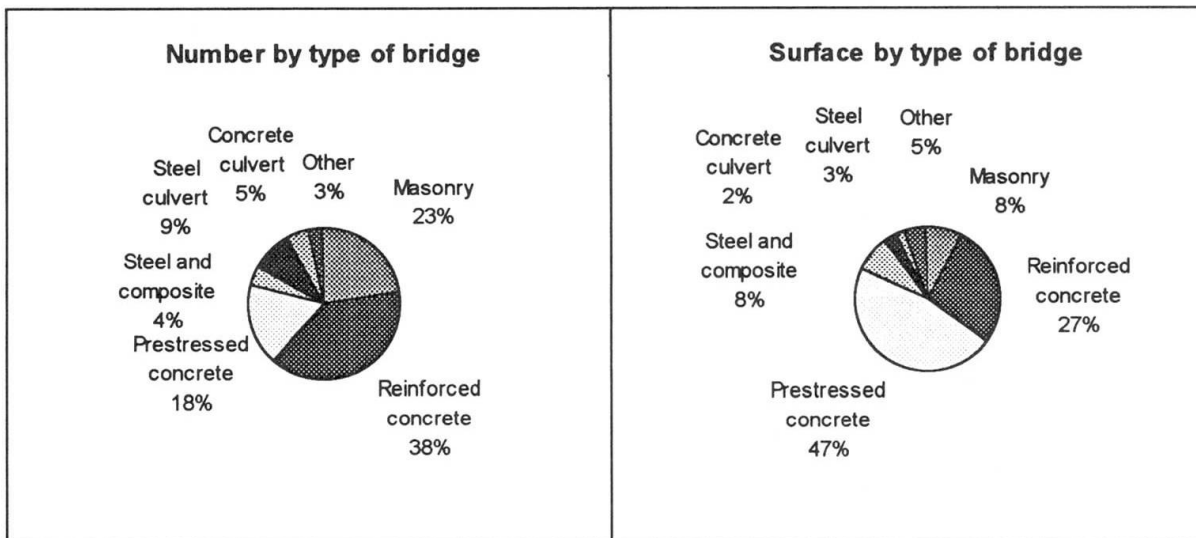
Figure 1 : Inventory of bridges and culverts greater than 2 meters

The diagram Figure 1 illustrate the composition of the patrimony of bridges and culverts of a length superior to 2 meters analysed by type of bridge.

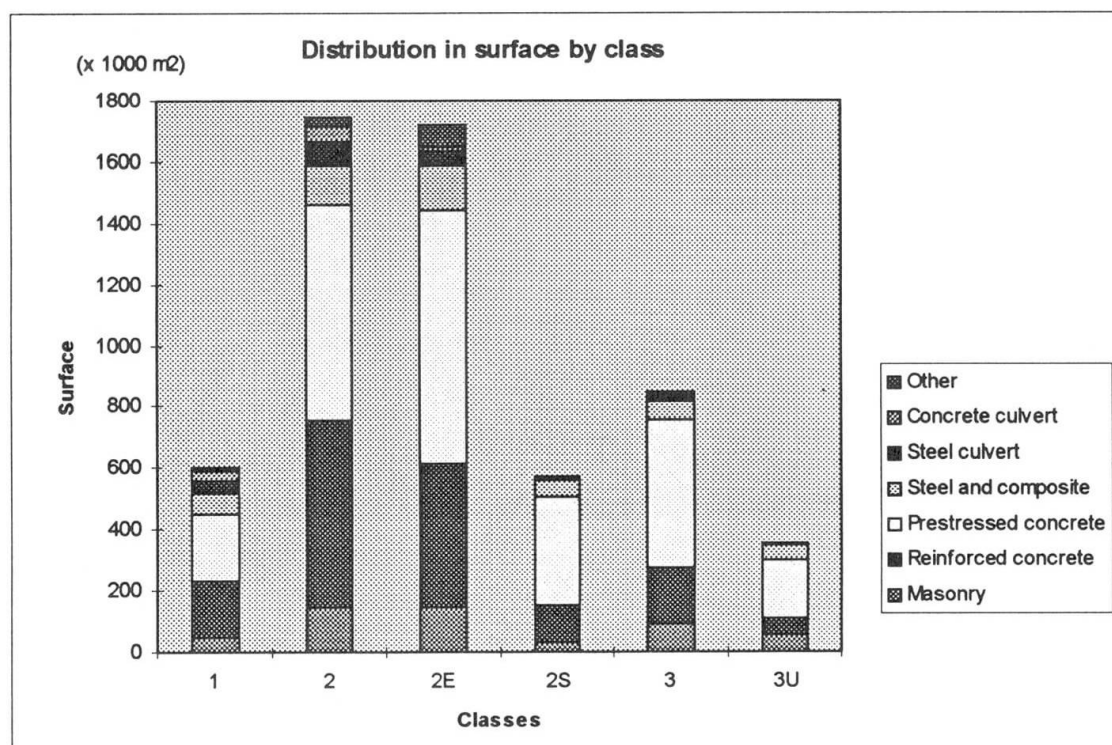
Figure 5 : Distribution by class according to the type of bridge

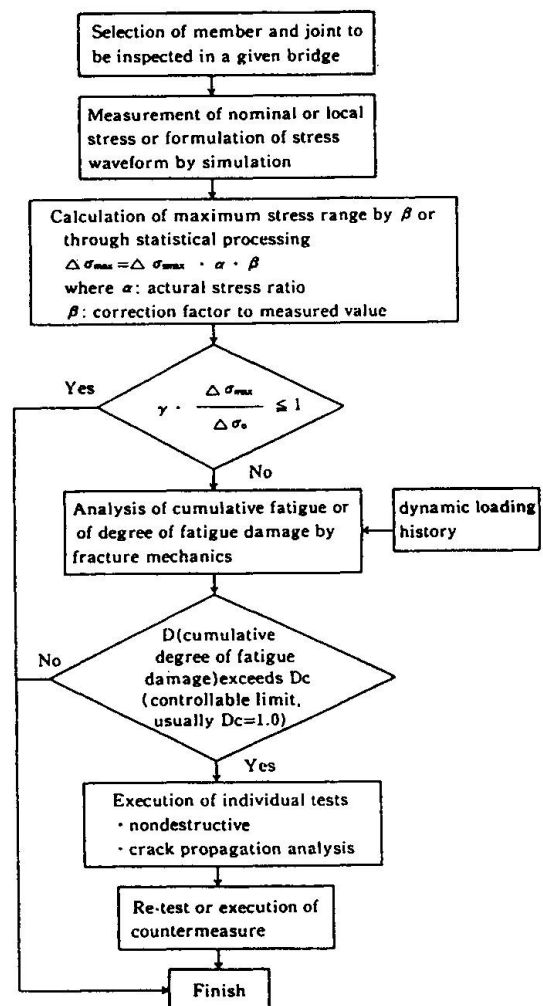
Fig.1 Flow of fatigue damage evaluation

Fig. 1 shows the flow chart of standard evaluation of fatigue damage.

pose a problem at this point in the future. If it is decided that it will be problematic, go to the next step. In the next step, an evaluation is made of cumulative fatigue including the influence of repetition. Load history and stress history are introduced to calculate the degree of cumulative fatigue damage (D) and remaining life. Table 1 shows one guideline for evaluating soundness against the degree of cumulative fatigue damage and remaining life. The degree of cumulative fatigue damage here shows the extent of accumulated fatigue damage. $D \geq 1.0$ shows that a member is considered to have reached its fatigue limit. That is, $D=1.0$ shows that a fatigue crack occurred in a member, and has become long enough to make the member lose its performance or function. However, to be conservative in evaluation, $D=1.0$ can be an indicator of the occurrence of a crack.

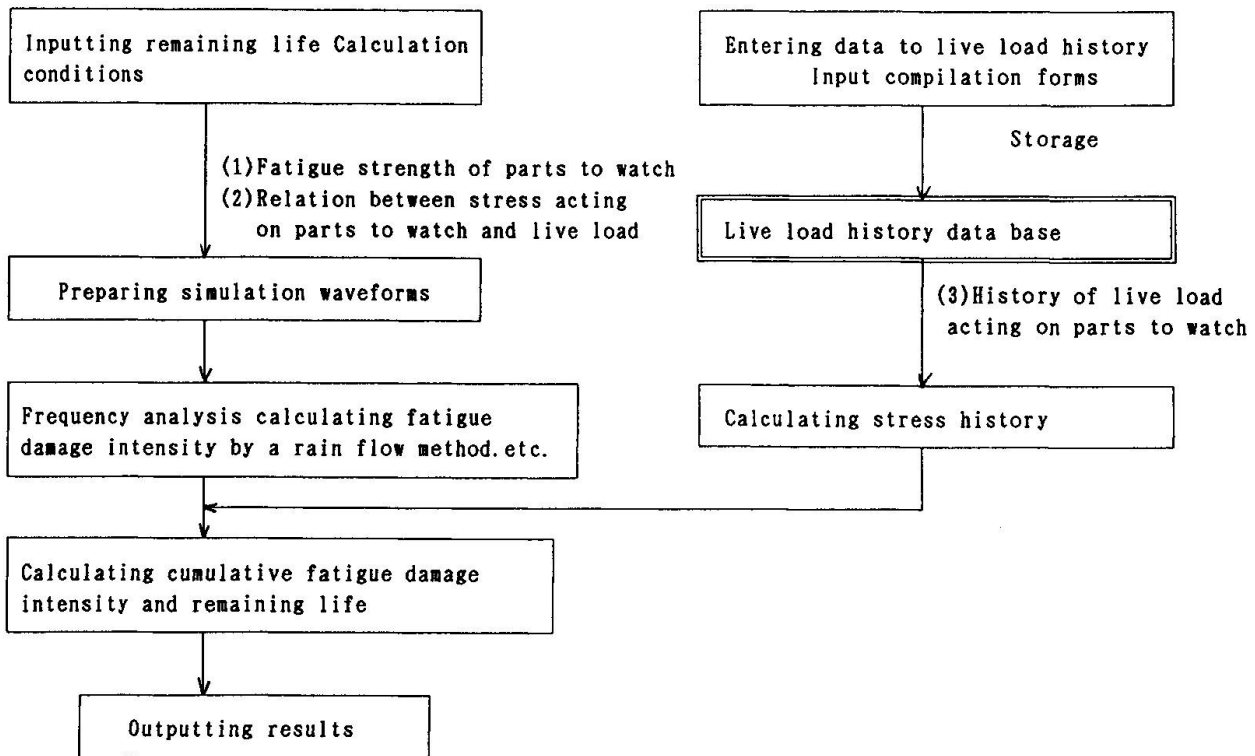
Fig.2 Flow chart of remaining life evaluation and calculation

The theoretical flow of remaining life evaluation is shown in Fig. 2.

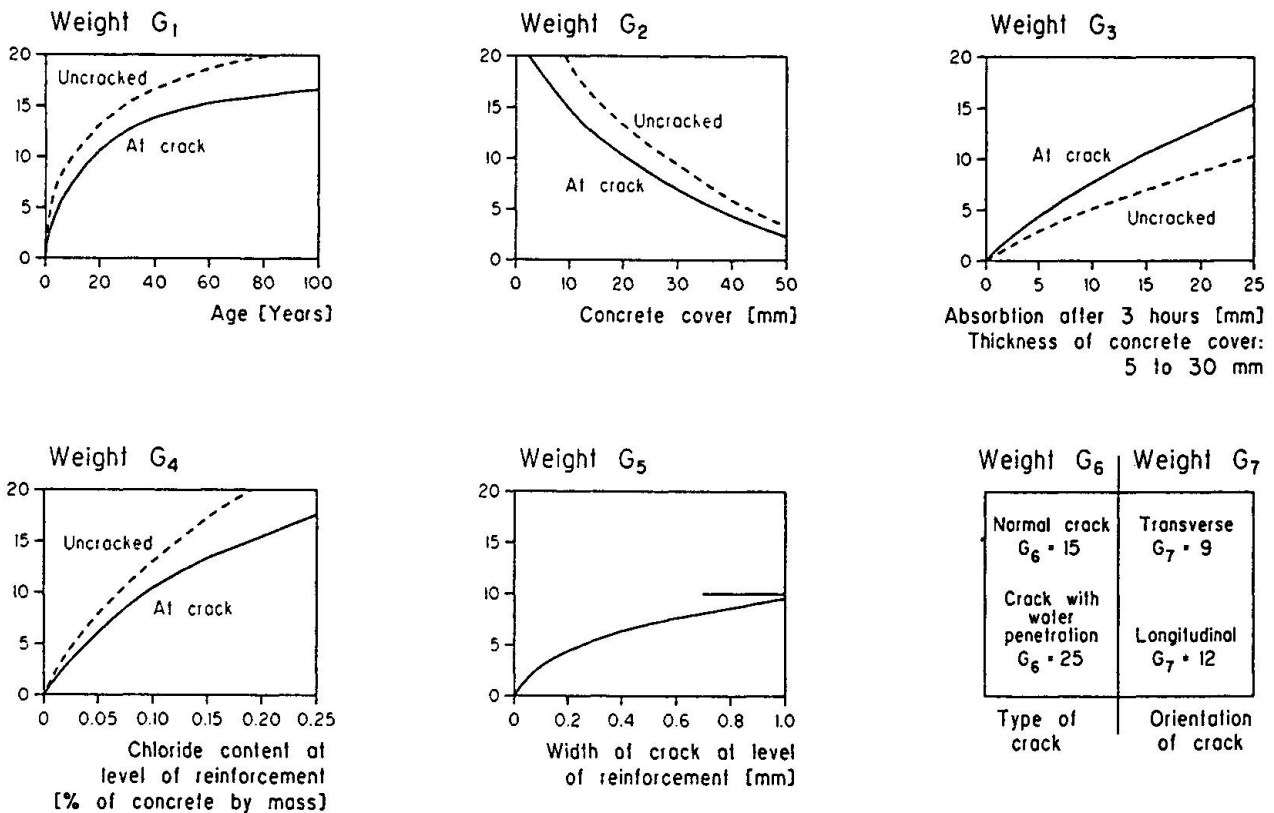
Fig. 1 Weighting functions

Based on these results, threshold values were defined for S in homogeneous regions and at cracks, beyond which corrosion of reinforcement could be deemed to begin. These threshold values are $S=40$ for uncracked homogeneous regions and $S_R=65$ at cracks.

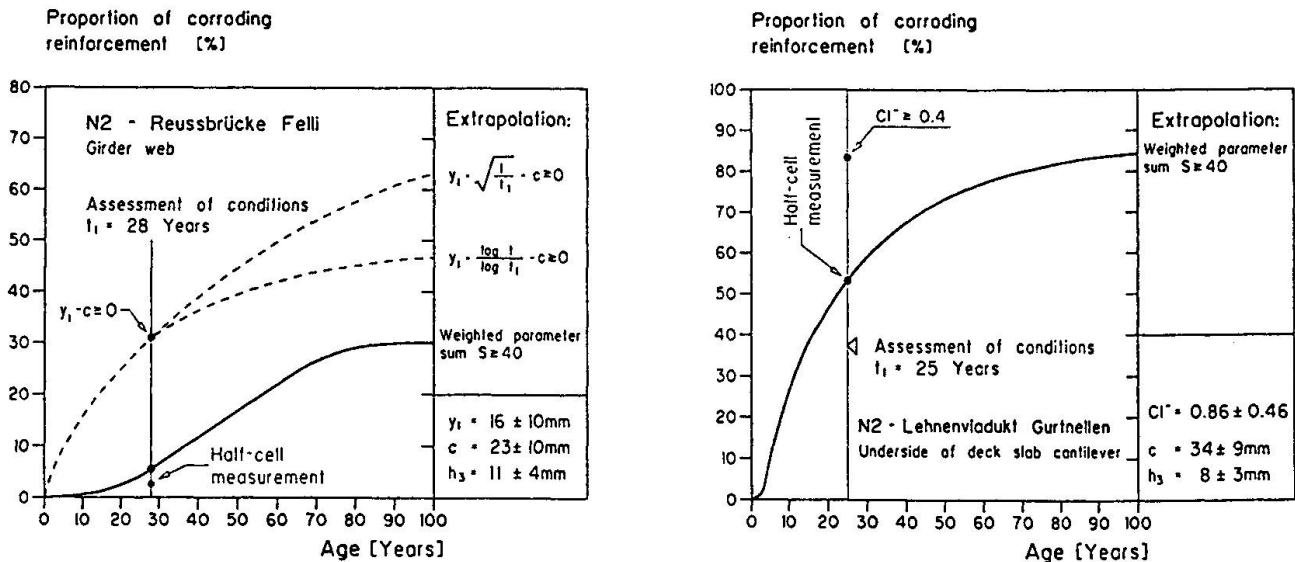
Fig. 2 Forecast of the development of corrosion of reinforcement: (a) Reussbrücke Felli, girder web; (b) Lehnenviadukt Gurtellen, deck slab cantilever (y_1 = depth of carbonation, c = concrete cover, h_3 = water absorption, CI = chloride content at the level of reinforcement (% of cement by mass)). All parameters are normally distributed.)

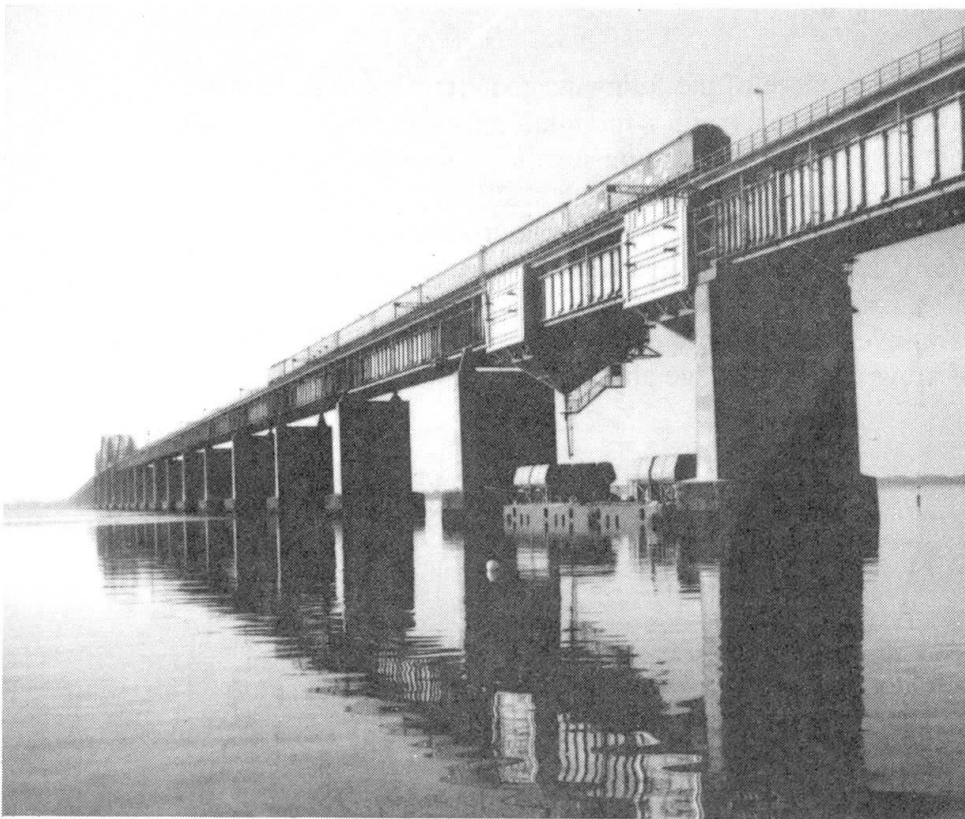
Photo 2 shows the mounting of the mobile platforms under the Storstrøm Bridge.

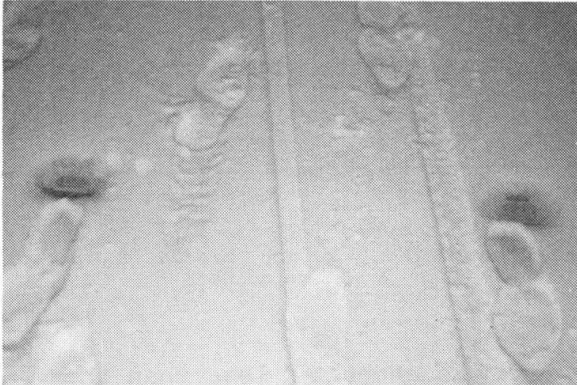
Fig. 9 Moisture Sensors with Snow
