Evaluating and Strengthening Industrial Buildings Damaged by Fires

Andrea BENEDETTI
Associate Professor
University of Ferrara
Ferrara, Italy

The lifespan of an industrial building may be dramatically reduced by fire, even if all safety precautions have been taken. The restoration of a fire-damaged reinforced concrete frame requires, first of all, the evaluation of the damage suffered by the members. In this respect non-destructive testing methods appear suitable for a quantitative definition of the damage; this can lead to the selection of a proper restoration technique. The proposed procedures are illustrated with an example.

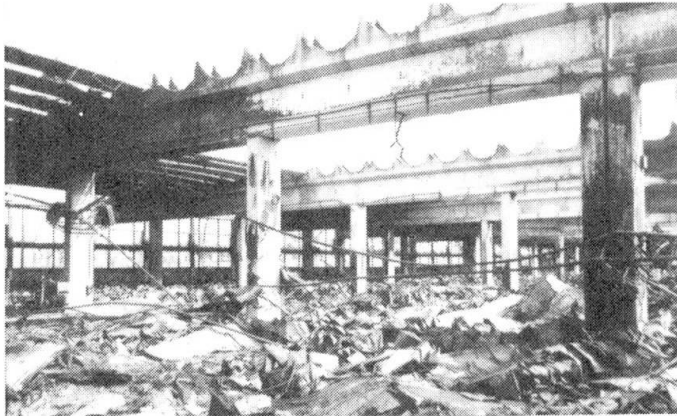
We conclude presenting some interesting features of a restoration work completed few years ago; in fig. 4.1 the appearance of the building after the fire event is outlined. One of the preliminary requests of the company management was to allow for a production restart as soon as possible.

Fig. 4.1.: A. Merloni industrial Site after the great 1993 fire
