The effect of plain bars in R/C beam-column joints under cyclic loading

Zeitschrift: IABSE reports = Rapports AIPC = IVBH Berichte

THE EFFECT OF PLAIN BARS IN R/C BEAM-COLUMN JOINTS UNDER CYCLIC LOADING

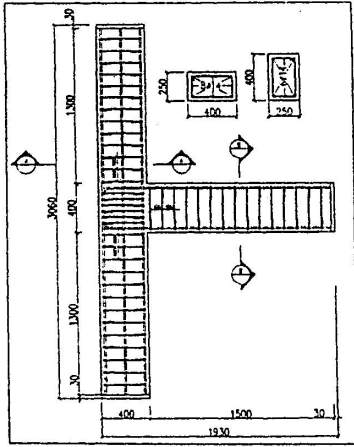
Figure 1. Details of Ductile Specimen

The specimen has the following characteristic details : Column reinforcement : 8 ϕ 14 continuous bars (not spliced), positive beam reinforcement : 3 ϕ 14 continuous bars, negative beam reinforcement : 3 ϕ 14 continuous bars, ties within the joint region : 6 ϕ 10, constant axial load on the column : 160 kN, measured average material strengths were $f'_c = 19.3$ MPa and $f_y = 342$ MPa, number of cycles applied : 27, number of recorded loading steps : 2700.

All the specimens were so detailed that failure would occur in the beam. One of the specimens was detailed in accordance with the ACI "Recommendations" [4] and it will be named as "ductile". The specimen detail is shown in Figure 1. The second specimen was detailed as not conforming seismic detailing procedures on beam-column joints such as no transverse joint reinforcement, larger spacing of beam and column end region ties. The specimen will be named as "non-ductile" regardless of its behavior. The specimen detail is shown in Figure 2. The third one was detailed same as the "non-ductile" one and additionally, a strengthening scheme using adhesively bonded external steel plates was applied on the specimen to investigate behavior of this type of strengthening method under cyclic loading. The specimen will be named as "strengthened". The specimen detail is shown in Figure 3. The word "bare" is used as common for the "ductile" and "non-ductile" specimens.

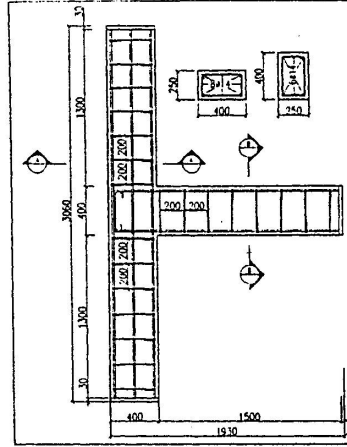
Figure 2. Details of Non-Ductile Specimen

The specimen has the following characteristic details : Column reinforcement : 8 ϕ 14 continuous bars (not spliced), positive beam reinforcement : 3 ϕ 14 continuous bars, negative beam reinforcement : 3 ϕ 14 continuous bars, no ties within the joint region, constant axial load on the column : 160 kN, measured average material strengths were $f'_c = 18.3$ MPa and $f_y = 342$ MPa, number of cycles applied : 25, number of recorded loading steps : 2500.

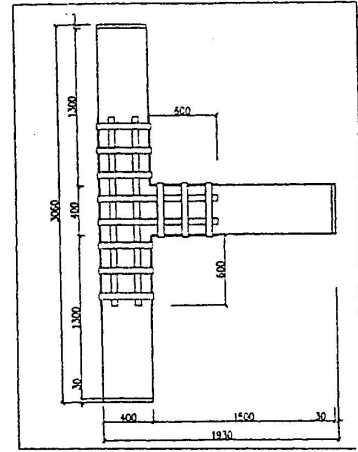
Figure 3. Details of Strengthened Specimen

The specimen has the following characteristic details : Column reinforcement : 8 ϕ 14 continuous bars (not spliced), positive beam reinforcement : 3 ϕ 14 continuous bars, negative beam reinforcement : 3 ϕ 14 continuous bars, no ties within the joint region, external steel plates on the specimen, constant axial load on the column : 160 kN, measured average material strengths were $f'_c = 22.1$ MPa and $f_y = 342$ MPa, number of cycles applied : 22.5, number of recorded loading steps : 2250.

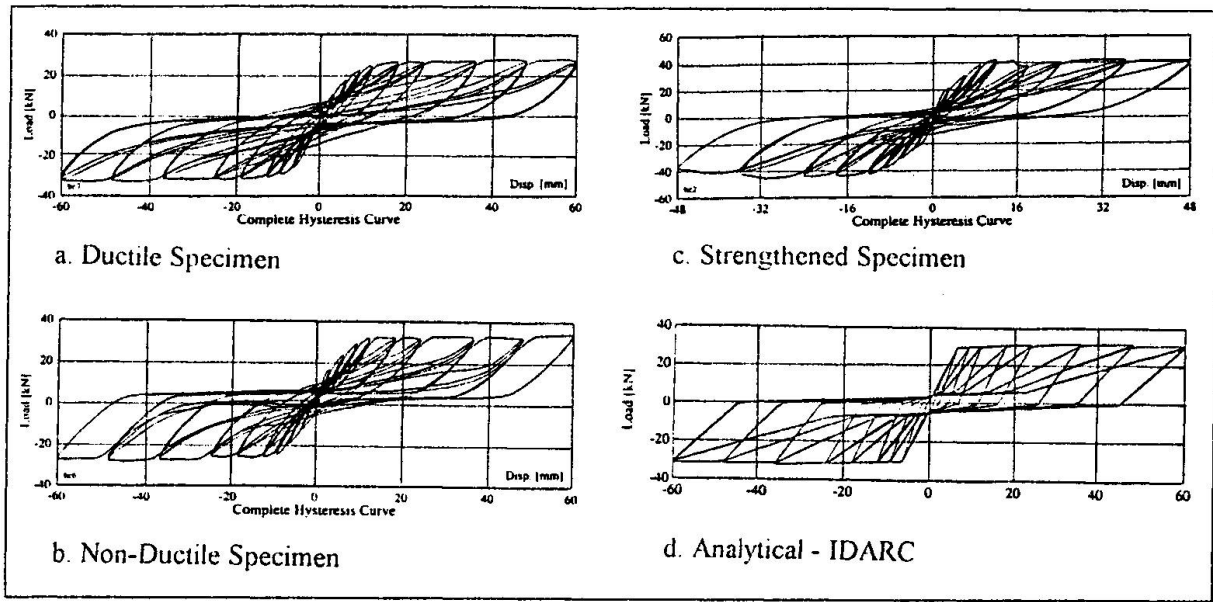
Figure 10. Load-Displacement Curves

The load-displacement curves are shown in Figure 10. The load values reached at extremes of 3 mm, 12 mm, 18 mm, 48 mm and 60 mm cycles are given averaging negative and positive displacement amplitudes as the following. At the first cycle of 3 mm for the "ductile", "non-ductile" and "strengthened" specimens, the measured load values are 12.88 kN, 14.02 kN and 21.68 kN, respectively. At the first cycle of 12 mm, the load values are 27.51 kN, 29.04 kN and 42.75 kN. For the "ductile" and "non-ductile" specimens, the load values are 29.12 kN and 29.04 kN, respectively, for the first cycle of 18 mm. For the "strengthened" specimen, a decrease in load level in tension side of the beam at the first cycle of 18 mm was observed. The measured load value at the third cycle of 12 mm is 38.95 kN while it is 38.36 kN at the first cycle of 18 mm. Instead of an increase in load level due to increase in displacement amplitude, approximately 1.5 percent decrease was measured. This can be attributed to partial separation of the external plates from the concrete surface. Because of this decrease in tension side of the beam at the first +18 mm displacement amplitude the load values for the subsequent cycles are not given for the "strengthened" specimen. At the first 48 mm cycle, the load values are 30.34 kN and 30.42 kN. At the first cycle of 60 mm, the load values are 30.52 kN and 30.75 kN.

As seen from the load displacement curves, all three specimens are almost stabilized the load level after yielding, only slight strength degradation is observed for all specimens tested. The strength degradation is around 4 percent for each repeated cycles of same displacement amplitude. In other words, strength degradation between first and third cycle of same amplitude is around 8 percent.

For the calibration of the load-displacement behavior of the bare specimens a parametric study was performed playing with IDARC Ver. 3.1 hysteretic parameters. The parametric study results are provided in [2]. The analytical load-displacement curve capturing the experimental load-displacement curve is shown in Figure 10.d.

1. As in the current Code, the new draft Turkish Earthquake Code expected to be in use in 1996 does not contain any provisions and recommendations pertaining to the use of deformed bars. As clearly seen from the load-displacement curves that severe pinching occurs in use of plain bars. The draft Code therefore should restrict the use of plain bars as main reinforcement in the 1st and 2nd degree earthquake zones in Turkey.

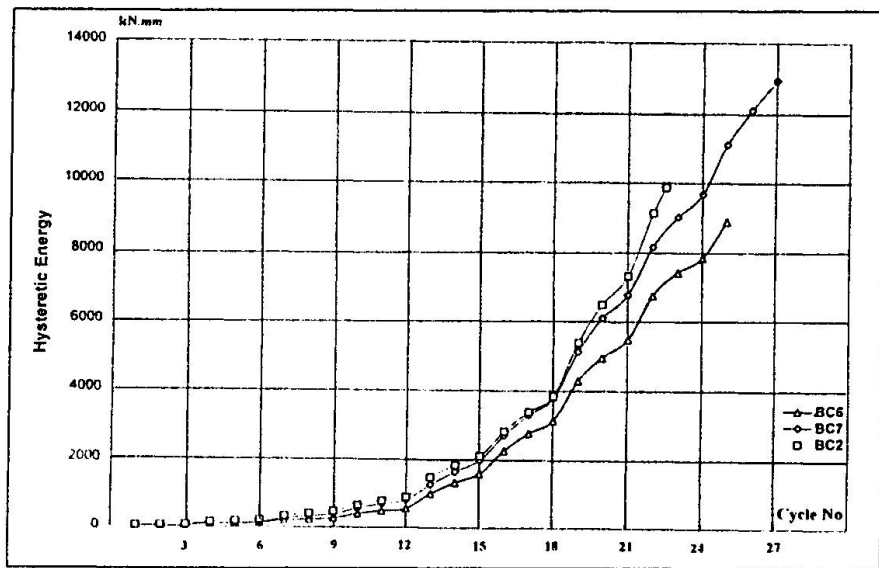
Figure 11. Hysteretic Energy Curves

Hysteretic energy curve for the three experiments is shown in Figure 11. As shown from the figure that the most energy dissipation is occurred for the strengthened specimen. With regard to bare specimens, ductile specimen dissipated more energy than the non-ductile specimen.

Taking the "ductile" specimen hysteretic energy dissipation as the reference (i.e. 100%), energy dissipation values for the other two specimens are given as the following. Hysteretic energy dissipated corresponds to the cumulative dissipated energy for the three repeated cycles of same displacement amplitude. For all three cycles of 3 mm, energy dissipation is 122% and 189% for the "non-ductile" and "strengthened" specimens, respectively. For all 3 mm and 6 mm cycles, the values are 86% and 151%. For the nine cycles up to 12 mm cycle, the values are 68% and 123% for the "non-ductile" and "strengthened" specimens, respectively. For the twelve cycles up to 18 mm cycle, the values are 69% and 111% for the "non-ductile" and "strengthened" specimens, respectively. It can be concluded from the dissipated energy values obtained from the tests in this study that energy dissipation in strengthening by using externally bonded steel plate technique decreases with increase in ductility. In other words, in high ductility demand, the strengthening technique does not provide significant contribution to energy dissipation capacity.
