Session 4: Materials and technology

Zeitschrift: **IABSE reports = Rapports AIPC = IVBH Berichte**

Band (Jahr): **77 (1998)**

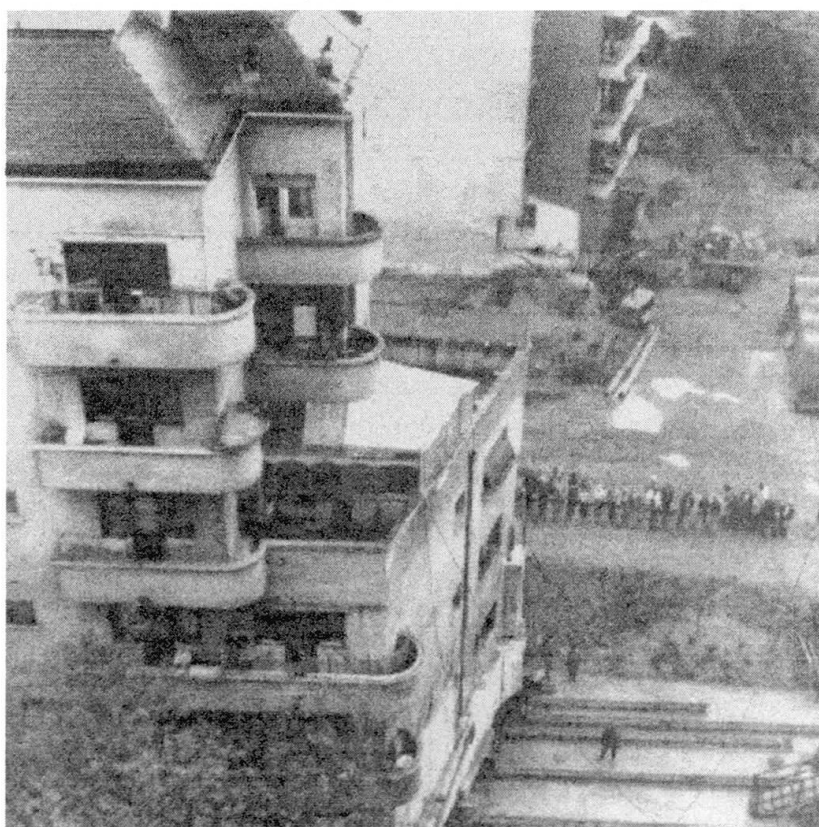
Fig.1 Translation of building from Aurel Vlaicu Street, Bucharest

The replaced constructions were churches, dwelling and social-administrative buildings, hospitals, memorial houses etc. Fig. 1 presents the displacement of a seven story block of flats in Aurel Vlaicu Street, Bucharest, on a built surface of 2245 m² and a structural weight of 5100 tones. The considerably height building was 14.4 m displaced at a speed of 1.9 m/h by means of 52 bogies pulled by two electrical cable hoists.
