Session 6: Repair and rehabilitation methods of historical buildings

Zeitschrift: **IABSE reports = Rapports AIPC = IVBH Berichte**

Band (Jahr): **77 (1998)**

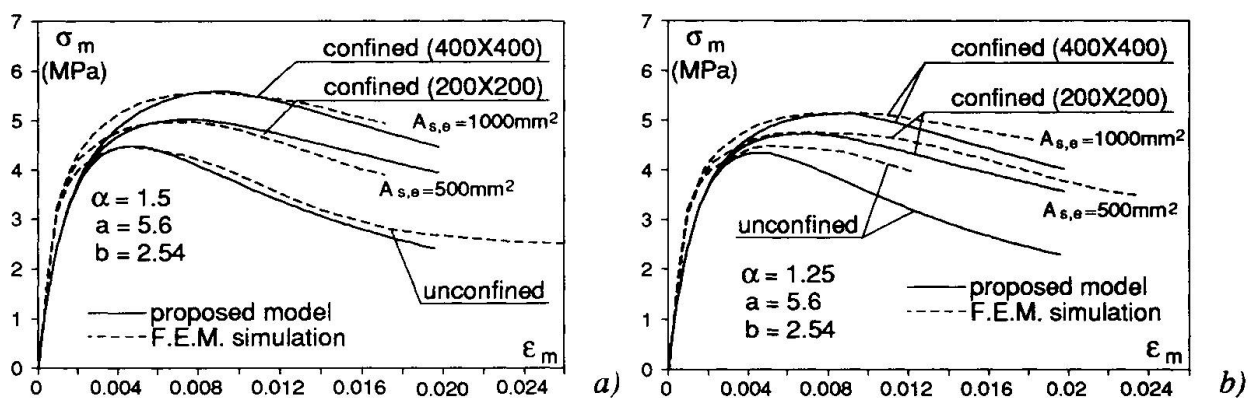
Fig.4 Values of $A_{s,e}$ for $t=500\text{mm}$ (a) and 300mm (b) and corresponding behavioural curves

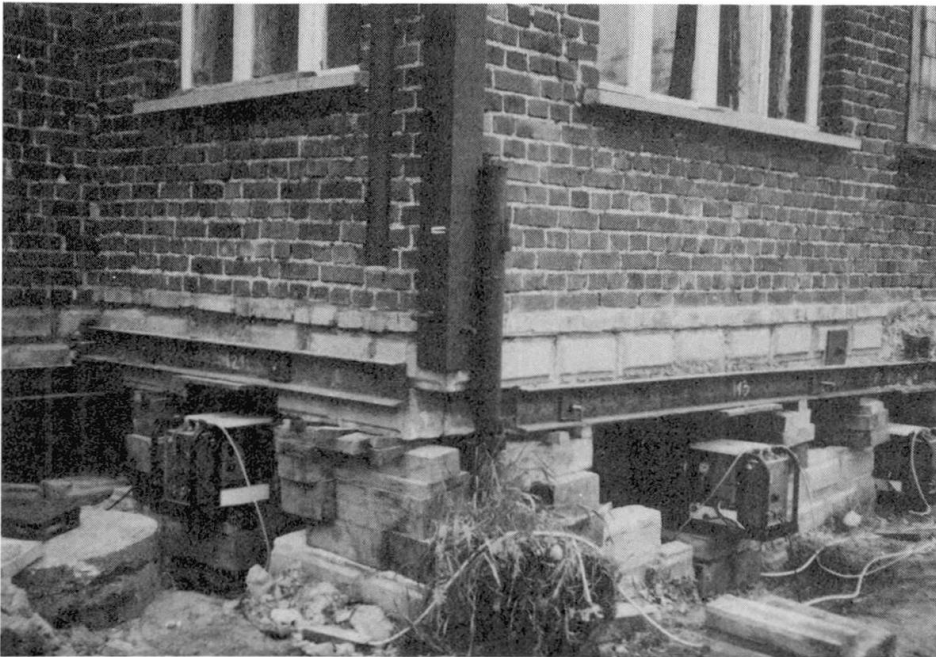
is two channel bars running on both sides of the torn walls. Fig.2 shows built in jacks in cellar storey.

Fig.2 Built in jacks in cellar storey

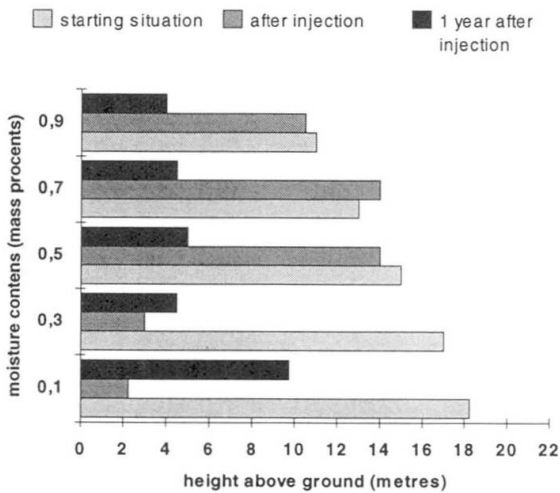
A large number of damaging processes are produced by water entering in the pores and causing several damaging reactions. By a Paraffin treatment the constructions are drying and a moisture barrier is produced. Fig. 2 shows a result of a paraffin injection in a moisture damaged wall.

Fig.2: Moisture distribution inside a wall before and after a paraffin injection

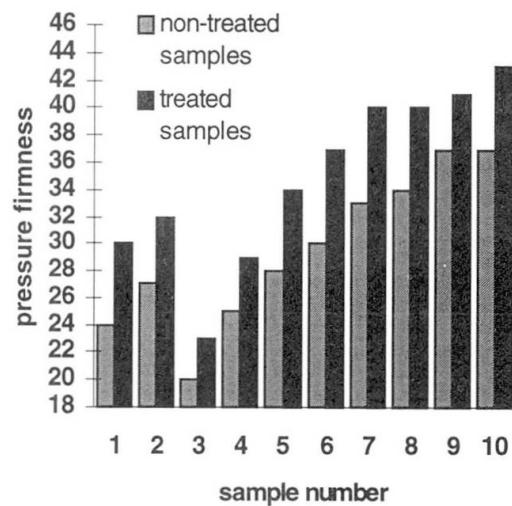
Fig. 3: Increase of compression strength

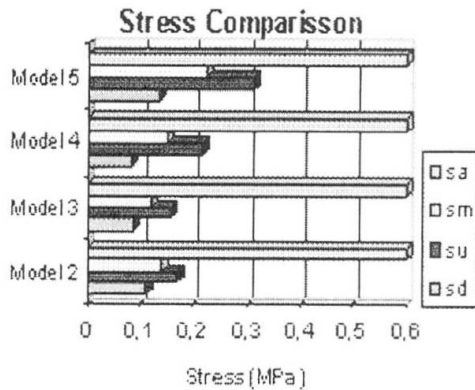
The calculated stresses for Model 1 to 4 were of the same order and occurred at the same section. Between linear elastic and nonlinear models stresses occurred at the same place but their intensity varied for about 30%. Observed general trend was that as the model became more refined, stresses were growing bigger for the same loading. Sensitivity of the response results, within one model type, due to changes in input data in the range of customary values (number and size of FEM, variations in material characteristics) can be neglected.
