Session 6: Repair and rehabilitation methods of historical buildings

Zeitschrift: **IABSE reports = Rapports AIPC = IVBH Berichte**

Band (Jahr): **77 (1998)**

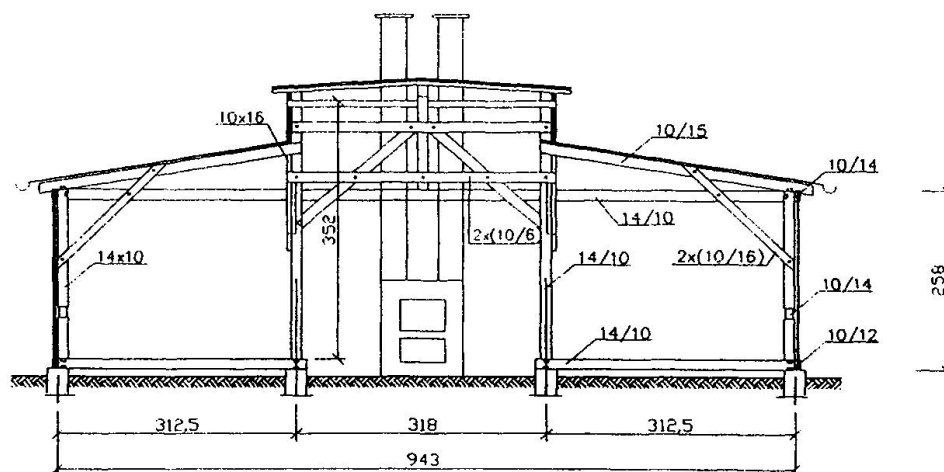
Brzezinka - on 175 ha of Brzezinka Museum 500 structures are situated. All structures were built during the war and had temporary character. Predominant part of all the structures is wooden and brick. Fig.1 shows cross section of a habitable building made by timber and brick.

Fig.1 The cross section of a habitable timber building
