Session 8: Assessment and rehabilitation of existing buildings after accidents

Zeitschrift: **IABSE reports = Rapports AIPC = IVBH Berichte**

Band (Jahr): **77 (1998)**

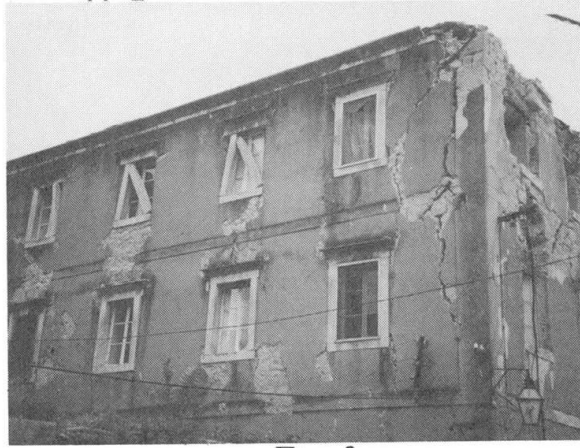
Fig. 3

Structural weakness of the walls: in the façades which were almost parallel to the seismic action (left façade in Fig. 3) cracks under the windows, due to the insufficient stiffness of the floor bands (reduced thickness of the zone under the windows, the lack of horizontal ties), were frequently noted; the façades almost perpendicular to the seismic action were often detached due to the inadequate connections to the lateral walls (left façade in Fig. 3).
