War and earthquake damage in Dubrovnik: preventive and remedial measures

War and Earthquake Damage in Dubrovnik: Preventive and Remedial Measures

Summary

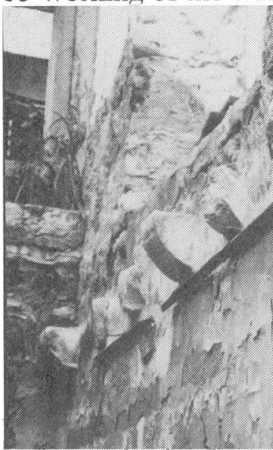
Fig. 1

The main walls of the buildings of Dubrovnik and Ston are usually made of sack masonry, with the timber floors and roofs supported by stone cantilevers inserted in the walls (Fig. 1); this structural solution, because of the lack of connection to the walls, does not help develop the co-operation among the walls themselves, which would allow them to resist the horizontal forces more effectively.

In Dubrovnik the signs of shell impacts are still visible on the fronts of the houses: direct hits struck about 70 % of the 824 buildings of the inner city. Further damage was produced by the fires following to the explosions (Fig. 1): the roofs of 5 buildings were affected by fire and in 9 buildings the roofs and floors were completely destroyed. The damage caused by the earthquake of September 5th 1996 (peak ground acceleration of 0.6 g, epicentre 10 km SE from Ston) can be traced, however, to other causes. These are:

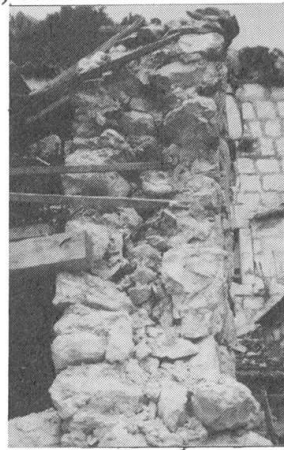
Fig. 2

Intrinsic weakness of the sack masonry (weak bond, decay of the mortar): which explains the detachment of blocks in the external skin and the collapse of entire sections of wall. (Fig. 2).

The materials: the intrinsic weakness of the sack masonry construction requires, both as a preventive and a remedial measure, the injection of the walls, or, in the case of very loose material, which was very common, the use of grout percolated in from the top; cracks, depending on their width, could be filled with grout or repaired with the technique of "unpicking and sewing". (toothing out and bonding)

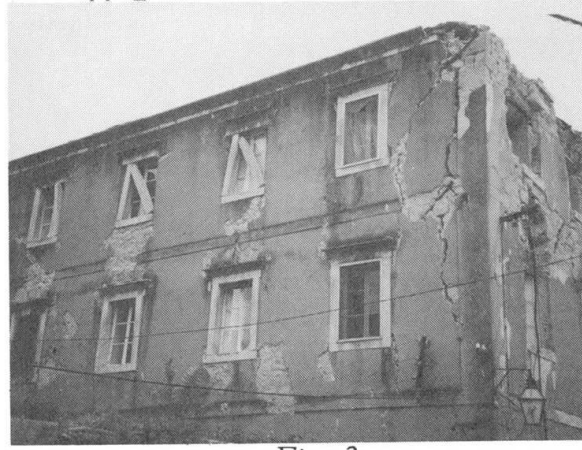
Fig. 3

Structural weakness of the walls: in the façades which were almost parallel to the seismic action (left façade in Fig. 3) cracks under the windows, due to the insufficient stiffness of the floor bands (reduced thickness of the zone under the windows, the lack of horizontal ties), were frequently noted; the façades almost perpendicular to the seismic action were often detached due to the inadequate connections to the lateral walls (left façade in Fig. 3).
