Retrofit of Corroded Splice Plates Using Epoxy Glued Escort Plates

Isao SUGIE
Civil Eng.
Hanshin Expressway Public Corp.
Osaka, Japan

Summary

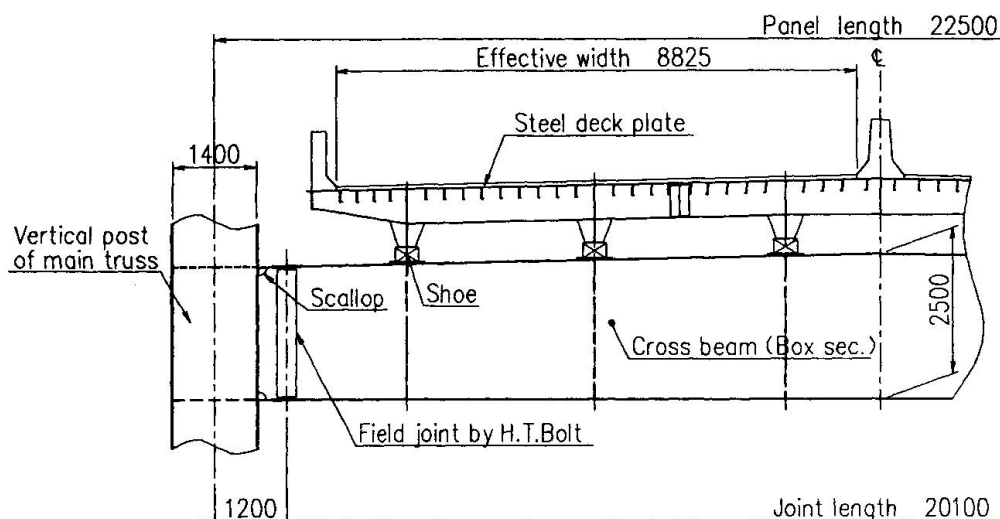
Fig. 2
General view
around corroded
joint

As shown in fig.2, rain water entered from the scallops of the web plate of cross beam welded to the main truss members. There are no drainage holes around them, and the box beams have collected water inside them. As a result, corrosion has been advanced at the lower flange joints of the cross beams. This created two structural problems. One is the reduction of axle force of the high tension bolts. The maximum rate of measured reduction was 30 %, which is bigger than that due to relaxation (approximately 10 to 15%). Another is the reduction of thickness of the splice plates. The most corroded one was 5 mm thinner than the original. Finally, the stress limitation can not be guaranteed at the joints.
