## Retrofit of Corroded Splice Plates Using Epoxy Glued Escort Plates

**Isao SUGIE**  
Civil Eng.  
Hanshin Expressway Public Corp.  
Osaka, Japan

### Summary

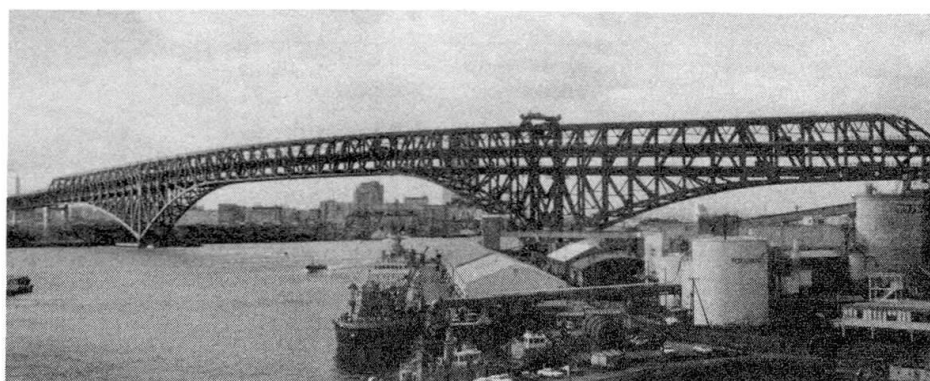
The Port Bridge is the third longest Gerber truss bridge in the world. It was constructed in 1975 and connected the reclaimed lands of Osaka Bay area with a 450 metre centre span as shown in fig.1.

*Fig.1 Overall-view of the Port Bridge*

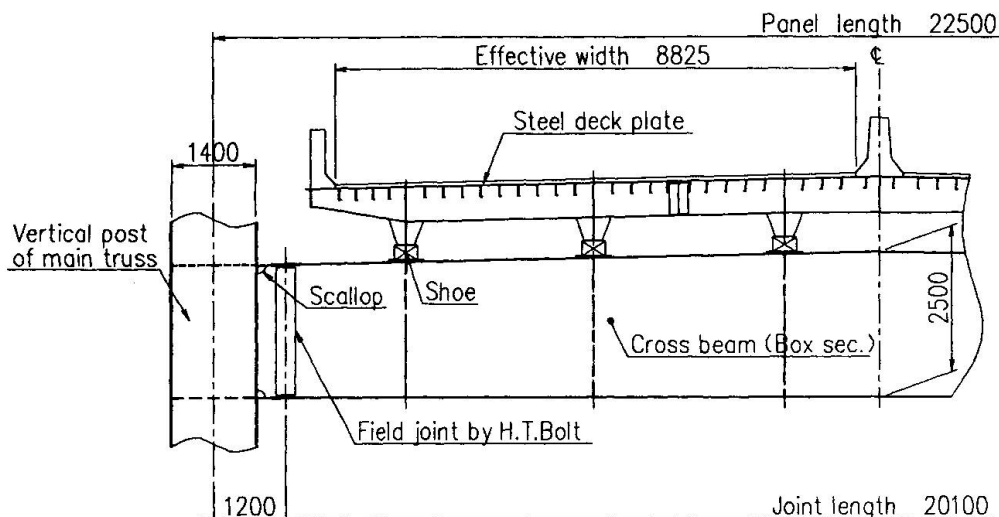
As shown in fig.2, rain water entered from the scallops of the web plate of cross beam welded to the main truss members. There are no drainage holes around them, and the box beams have collected water inside them. As a result, corrosion has been advanced at the lower flange joints of the cross beams. This created two structural problems. One is the reduction of axle force of the high tension bolts. The maximum rate of measured reduction was 30 %, which is bigger than that due to relaxation (approximately 10 to 15%). Another is the reduction of thickness of the splice plates. The most corroded one was 5 mm thinner than the original. Finally, the stress limitation can not be guaranteed at the joints.

Fig. 2  
General view  
around corroded  
joint

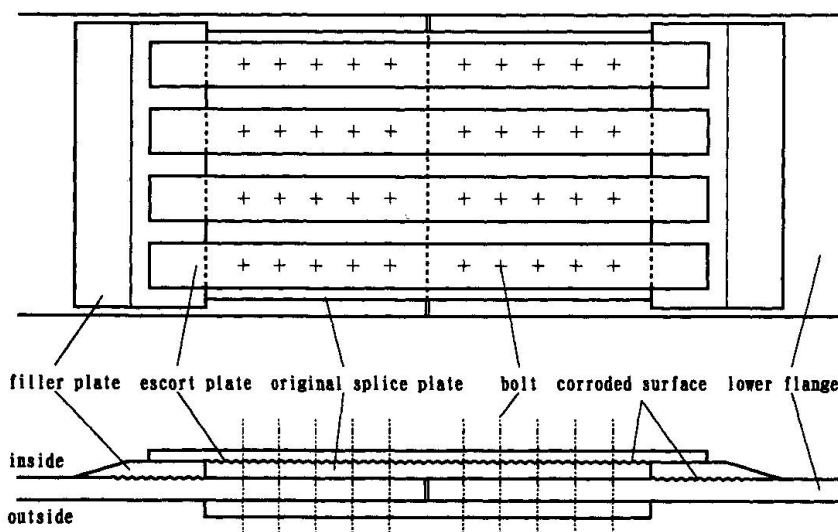
Fig. 3  
Retrofit of  
corroded splice  
plates using  
epoxy glued  
escort plate

Fig.3 shows the retrofit using epoxy glued escort plates. In this method, the original splice plate can remain and only a row of bolts can be removed. These are replaced with new ones at the same time for fitting a long rectangular escort plate. The bolts should be replaced from the centre to the corners of the flange, so that re-distribution of the stress flow can be improved. Filler plates should be also fitted to make up for the lack of thickness of the corroded flange plates. Other methods for retrofit have been considered such as replacement of the whole splice plates or reinforcing them with additional plates fixed by welding. They, however, were rejected for the following reasons.

- (1) The working stresses due to dead loads are too large to remove the whole splice plate and all bolts from the lower flange at the same time.
  - (2) The influence of welding would be great, because high tension steel (HT70, HT80) was used.
- Finally, using epoxy glued escort plates resulted in the most effective and practical method. Laboratory tests have been done to examine the effectiveness of this method. The two bolts model test indicated that there were no remarkable difference between the sound specimen and the corroded ones reinforced by the escort plate. It should be noted that using epoxy resin together with H.T.bolts may be able to reduce the number of bolts at the design stage.
