Cable supported bridge under movement of foundation due to earthquake

Zeitschrift: **IABSE reports = Rapports AIPC = IVBH Berichte**

Band (Jahr): **79 (1998)**

Cable Supported Bridge under Movement of Foundation due to Earthquake

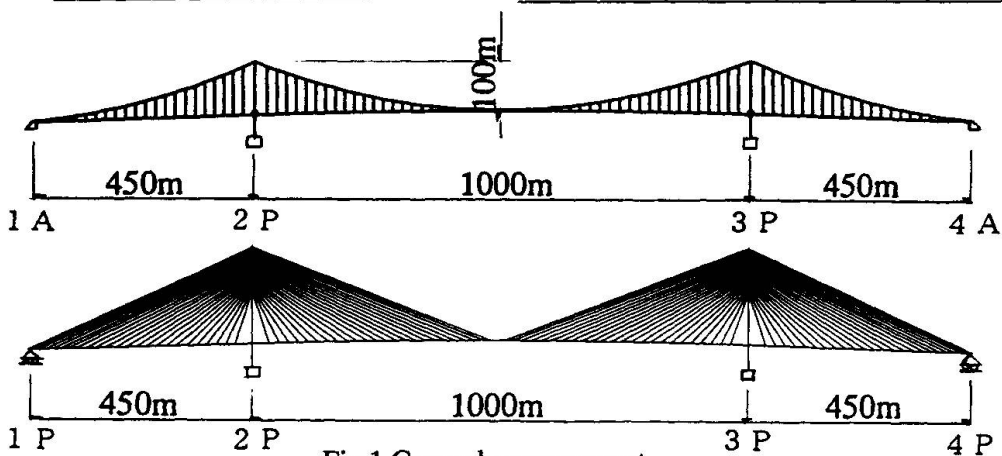
Fig 1 General arrangement

In this circumference, we have computed the behavior of suspension bridge and cable stayed bridge after the completion under the similar scale of movements of the foundations. The bridges for computation are suspension bridge with a main span of 1,000m having un-continuous suspended girder vertically supported by links and transversely supported by wind shoes at the towers and the anchorages, and cable stayed bridge with a main span of 1,000m having continuous suspended girder vertically supported by bearings and links, transversely supported by wind shoes at the towers and the anchorages, and longitudinally supported by spring from the towers. The general arrangements of the bridges are shown in Fig 1. and the characteristics of bridge elements are shown in Table 1.

Table 1. Characteristics of bridge elements

Suspension bridge	
Girder	A=1.378 m ² I _z = 2.43 m ⁴ I _y =162.24 m ⁴
Tower	A=2.362 m ² I _z = 21.97 m ⁴ I _y =12.18 m ⁴
Cable	A=0.195 m ²
Cable stayed bridge	
Girder	A=1.567 m ² I _z =2.58 m ⁴ I _y =172.76 m ⁴
Tower	A=2.362 m ² I _z = 21.97 m ⁴ I _y =12.18 m ⁴
Cable	A=0.009~0.015 m ²

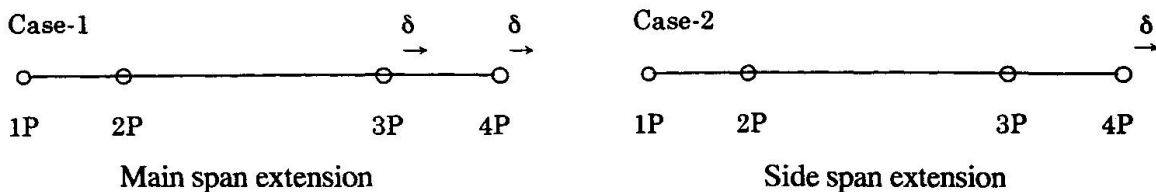
Fig 2. Longitudinal movement

We assumed two cases. One is a tower foundation and an anchorage (or a pier) in the same side move longitudinally outward by the same distance (main span extension), which simulates that fault located in the main span slides, and the other is only an anchorage (or a pier) moves longitudinally outward (side span extension), which simulates that fault located in the side span slides, as shown in Fig 2.

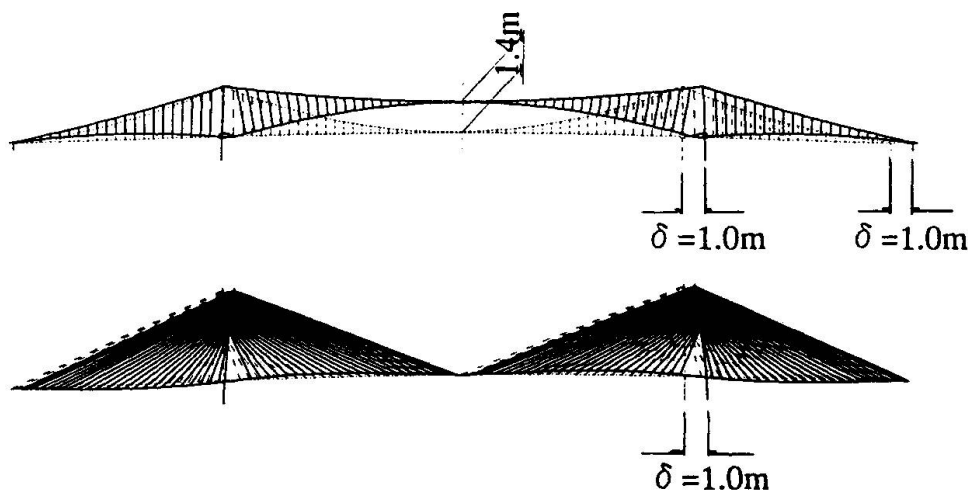
Fig 3. Bridge deformation

Fig 3. shows the deformation of two bridges for the main span extension of 1.0m, and Fig 4. & 5 show the extra stresses occur in the tower and in the cable of the two bridges by the main span extension ranging from 0.5m to 1.0m . Suspension bridge is able to absorb a extension of main span easily by a change of cable sag (1.4m for extension of 1.0m), which doesn't make tower top displacement much (0.09m each) to balance cable forces of main span and side span at tower top and increase a stress of main cable (13Mpa). By this behavior, suspension bridge is not much overstressed by main span extension. While, cable stayed bridge absorbs a extension of main span by displacement of tower tops (0.52m each for extension 1.0m) inward pulled straight by stay cables. By this behavior, cable stayed bridge is much stressed by main span extension, and the extra stress occurs at the tower base comes up to 17% of its allowable stress by a extension of 1.0m.
