Structural design of large-span single layer latticed dome

Zeitschrift: **IABSE reports = Rapports AIPC = IVBH Berichte**

Structural Design of Large-Span Single Layer Latticed Dome

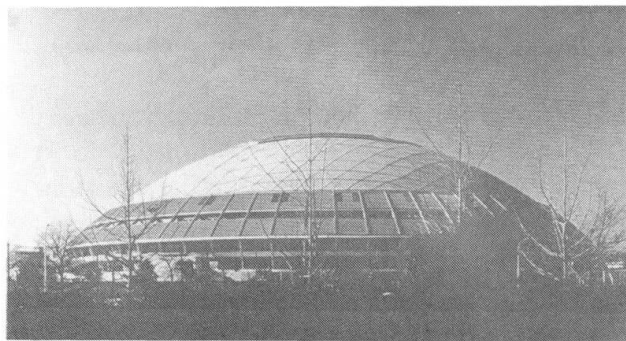
Photo 1-1 Panoramic view of Nagoya Dome

The building dealt with in this report is "Nagoya Dome" constructed in Nagoya City, Japan. This building is a multi-purpose stadium with steel roof, mainly used for baseball games. The construction of the building was commenced in August, 1994 and completed in March, 1997. (Photo 1-1)

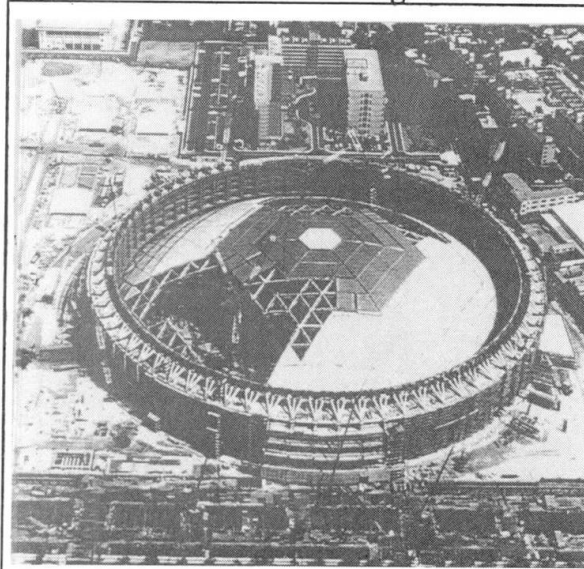
Photo. 3-1 Over view of construction state

The imperfections accompanying the construction are shown by the differences between the member stresses / contact deformations calculated in the above method and the results obtained in the method (perfect system analysis) where all the loads were applied together to the perfect system model usually used for the structural analysis. Photo 3-1 shows the construction in progress, and Fig. 3-1 shows the sketch of the analytical models.
