CASE STUDIES AND LESSONS LEARNED FROM RECENT SCOUR-RELATED BRIDGE FAILURES IN THE UNITED STATES

Peter F. LAGASSE

Senior Vice President
Ayres Associates, Inc.
Fort Collins, CO USA

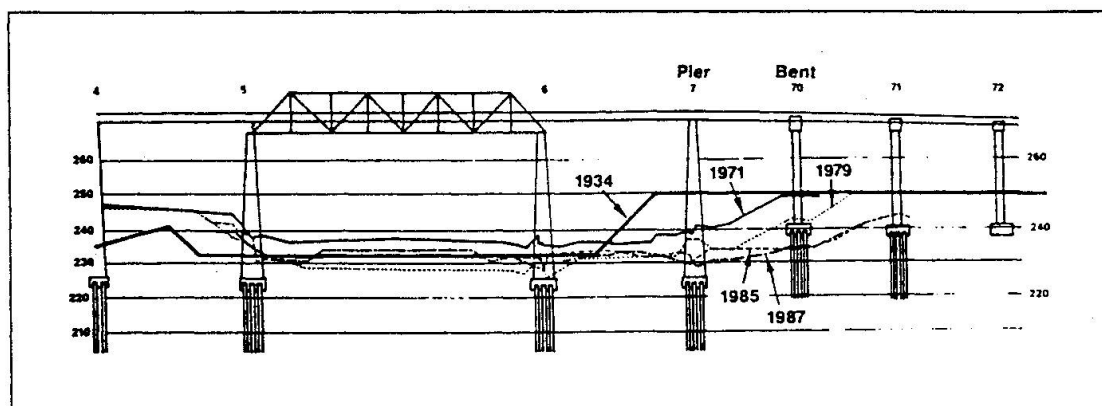
The bridge substructure consisted of main channel piers and floodplain bents supported on piles about 6.1 m long (Figure 2). There was about a 4-meter difference in elevation between the pile cap for the main channel piers and the pile cap of the shallower floodplain bents. A post-failure investigation revealed the following rates of channel migration into the north bank of the river at the bridge: 1931 to 1975 - 0.24 m/yr; 1975 to 1989 - 1.37 m/yr; and 1981 to 1989 - 0.58 m/yr [4].

Figure 2. Channel cross section change at the Hatchie River bridge, Tennessee.

The NTSB determined that the probable cause of the collapse of the northbound U.S. Route 51 bridge spans was the northward migration of the main river channel, which the Tennessee Department of Transportation failed to evaluate and correct. As with the Schoharie Creek failure, the lack of structural redundancy in the design of the bridge spans contributed to the severity of the accident [4].
