Session 6: Construction. Part 2

Zeitschrift: **IABSE reports = Rapports AIPC = IVBH Berichte**

Band (Jahr): **80 (1999)**

Session - 6
Construction (Part - 2)

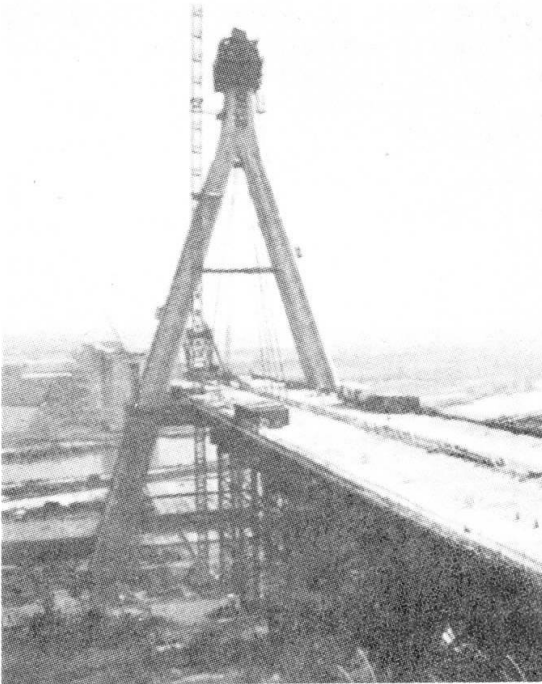
Fig.3 Kao Ping Hsi Pylon

In the course of the preliminary design, two variations were considered for the pylon foundation; one foundation with slurry walls and the other with piles of \varnothing 1.50 m. Under the observance of the dispersing forces, as well as the scouring, an efficient comparison of both variations was executed, whereby it was shown that a slurry wall foundation is the more favorable solution from the economic point of view. Additionally, this system results in a substantially greater security of the foundation elements.

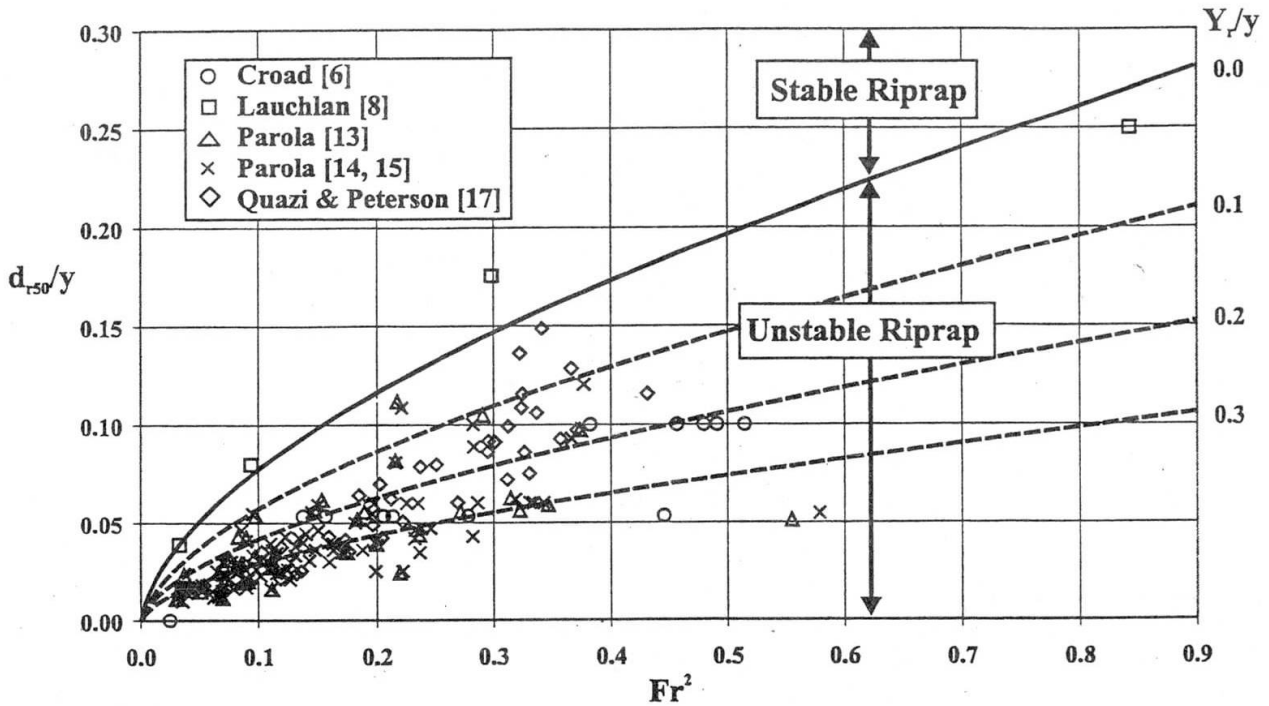
Figure 2 Design Curves for Riprap Size by Lauchlan [8]

Riprap was selected based on the Lauchlan [8] equation (2) with $Y_r = 0$. For $V = 3.6$ m/s and $y = 5.96$ m, $d_{r50p} = 724$ mm, equivalent to a model size of 36.2 mm. Two sizes of riprap were used in the model, having median sizes, $d_{r50m} = 35$ mm and 28 mm, and grading satisfying the criteria of equation (3). Note that subscripts 'p' and 'm' refer to prototype and model, respectively. The riprap was placed according to the recommendations in Figure 3 (end radii = 1.5b, width = 3b), with the top surface flush with the undisturbed bed. Tests were conducted with the pier both aligned with the flow and also skewed at angle $\theta = 10^\circ$ to the flow. Two thickness arrangements were tested. One arrangement featured $t_r = 2d_{r50}$ throughout the layer. For the other arrangement, the thickness of the riprap layer was increased to $3d_{r50}$ for the section of riprap upstream of the pier where it was observed that the worst scour occurred.
