# Session 1: Durability & robustness

Zeitschrift: **IABSE reports = Rapports AIPC = IVBH Berichte**

Band (Jahr): **83 (1999)**

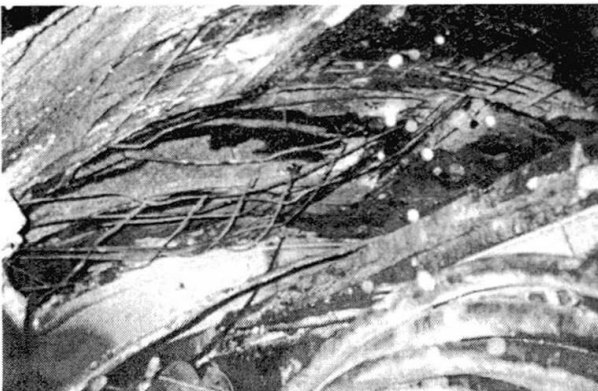
*Great Belt Tunnel after a fire during construction.*

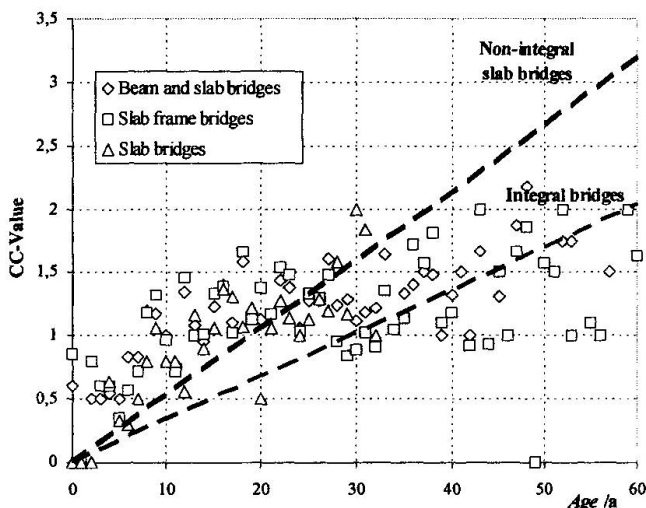
Fig. 3 Development of damage measured as the equivalent overall condition class for the three compared bridge types. The bridges of integral type slab frame bridges and beam and slab bridges compared with the non-integral type slab bridge. The evaluation shows that the integral type has a slower increase of damage than the non-integral type.

Information from elderly inspections has been collected, and put into a database called BEA (Bridge Element Analysis), Racutanu (1998). The information in the database shows how the structural members have served in time. Fig. 3 shows an example of the development of total condition class (CC) where condition class 3 means that the bridge must be repaired immediately
