Soil Erosion Forms in the Simen Mountains-Ethiopia (with map 1:25 000)

By Hans Hurni*

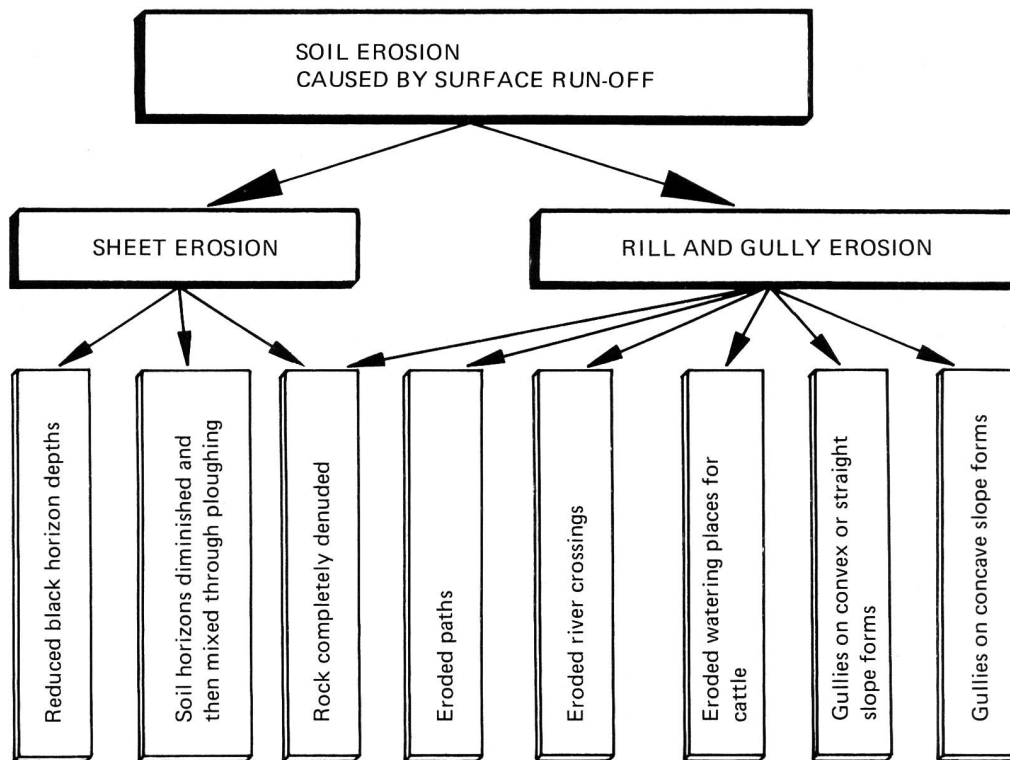
Figure 3: Soil Erosion Forms

caused by surface run-off are sheet erosion, rill erosion and gully erosion (BENNET 1955: 59–70). Wind erosion forms are negligible in Simen. The three groups of water erosion had to be modified slightly for Simen in order to be as realistic as possible. Figure 3 shows the correlation of the different soil erosion groups as they were used to present soil erosion damage on the map.

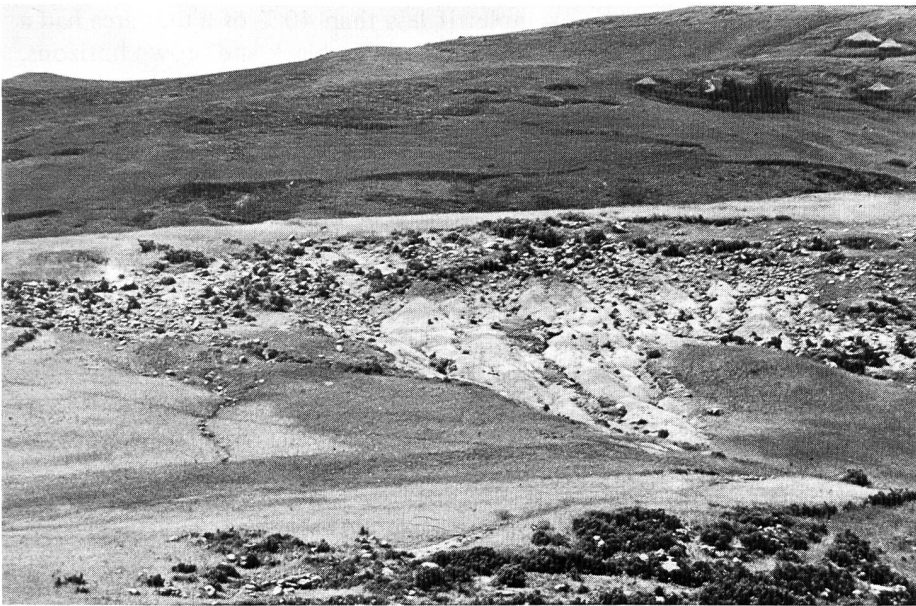
Typical Eastern-exposed slope in the Jinbar valley.

The soil is extremely damaged by soil erosion. In many places the rock is completely denuded. Gullies are numerous. Yields are minimal.

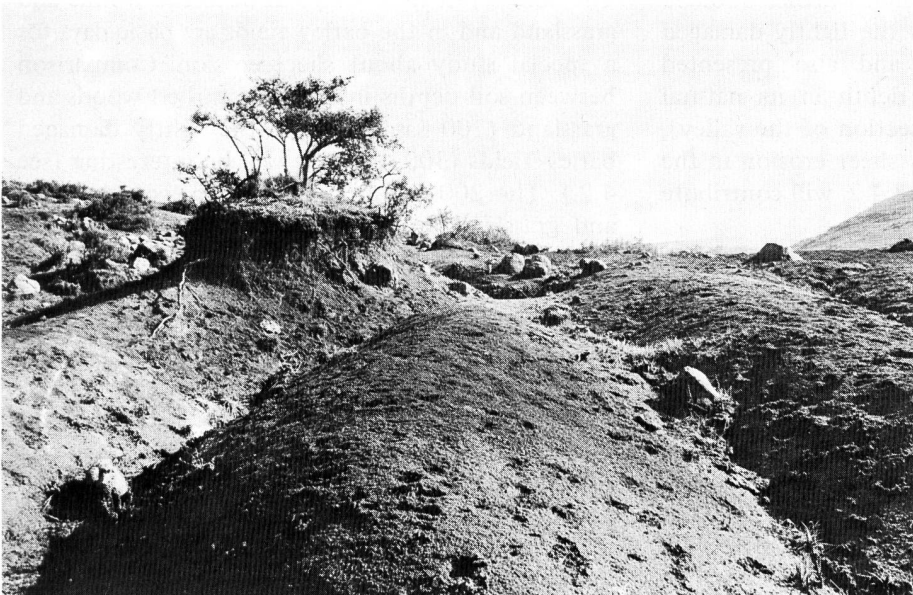
Bushes retain some earth in extremely eroded areas. On both sides of the bush, gullies are washed into the weathered basaltic rock.

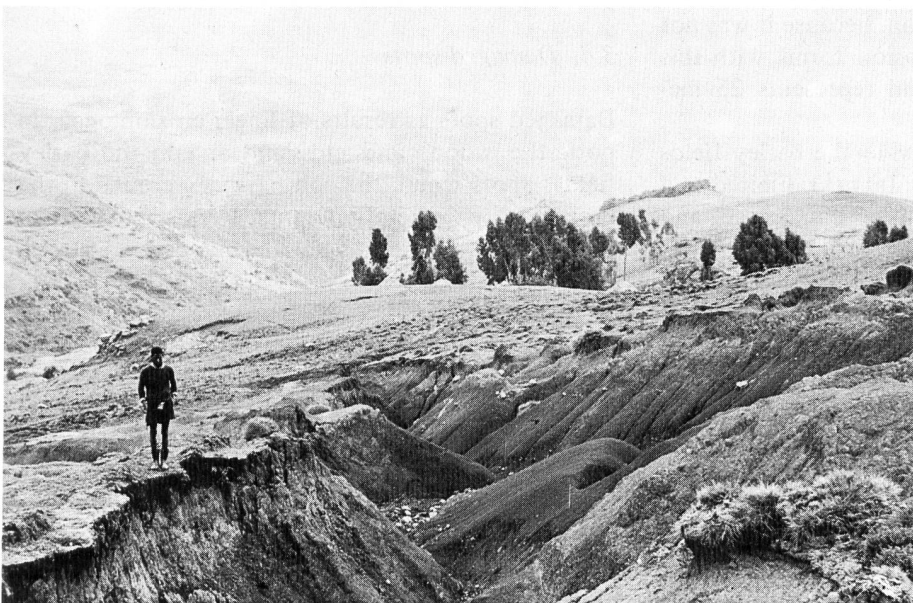
Immense gully on one of the barley fields of the Jinbar valley.
