# Replacement of Natural Stone on the Royal Palace in Stockholm

## A Technical and Ethical Dilemma

Andreas Heymowski

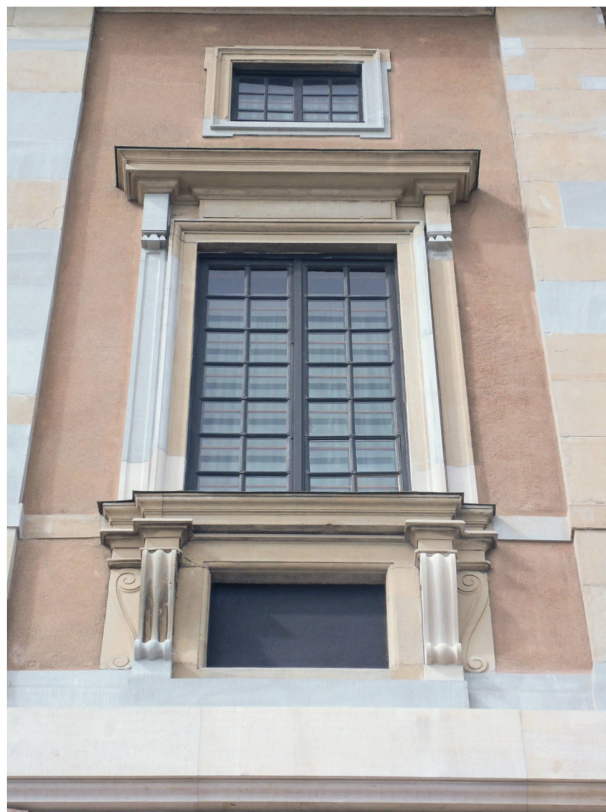
3 *The façade after stone replacement. Old Gotland stones are a dark yellowish grey, new Gotland or Roschacher stones are a blueish grey and new Obernkirchener stones are a light yellowish grey. Whether the colour differences are acceptable or not is a matter of ideology and taste (Photo A. Heymowski).*

I will not tire you with tales of the complicated processes of finding craftsmen, of purchasing and of hewing the new stone. We have learnt a lot about the stone market, stone hewing, stone mounting, etc. Many times we have been on the brink of despair when stone hasn't been delivered at all, or delivered much too late, or in the wrong colour or with incorrect hewing (fig. 3).

But eventually most things have turned out in a satisfactory way. I would say 80-85 % of the work is quite good and, luckily, most of the flaws are not visible from the ground. Still, as you can see, the new stone is detectable, the yellow Obernkirchener and the blueish grey Rorschacher (and in some places new Gotland). In Sweden we have a tradition to patinate new stone, so as to make it blend with the old one. We made a test, giving the new stone a very thin coat of paint. Here you cannot say which is new and which is old. But we've decided to wait and see what happens to the new stone, hoping that with time it will blend in without us having to patinate it.
