Autor(en): **Weber, Bill**

Zeitschrift: **Swiss express : the Swiss Railways Society journal**

# FROM RUIN TO RACK

**After a Complicated Road Journey Restoration begins on Europe's Largest Narrow Gauge Steam Rack Locomotive**

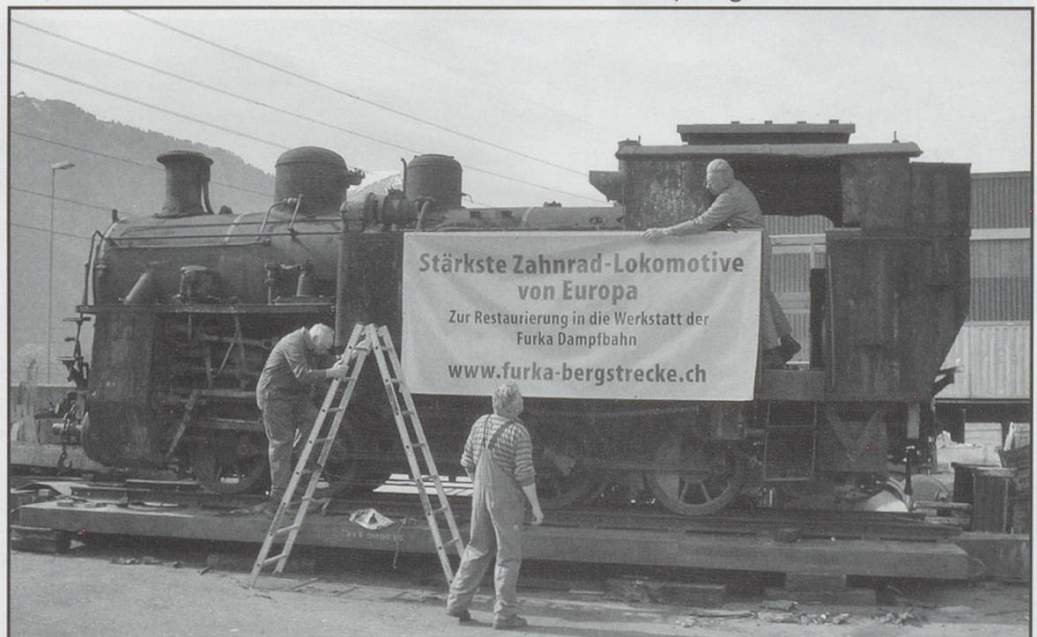
**LEFT:** The crane lifts the locomotive onto the trailer at Altdorf

large crane and a specially configured HGV and trailer owned by Wipfli AG, Flüelen arrived. The crane was set up and lifting chains were attached to the lifting "I" beams. The trailer had a section of metre-gauge track installed for the locomotive. The crane then proceeded to lift the 35-ton locomotive and place it on the transport trailer. The lifting beams were then removed, stored and the locomotive was secured with chains. During the move from Altdorf to Flüelen it was noticed that the tracks supporting the locomotive were showing signs of bending and a detour was made to the transport company's office and an additional support beam was placed under the rear of the locomotive.
