# Landslip disrupts the Brienz Rothorn Bahn

Mike Ellis

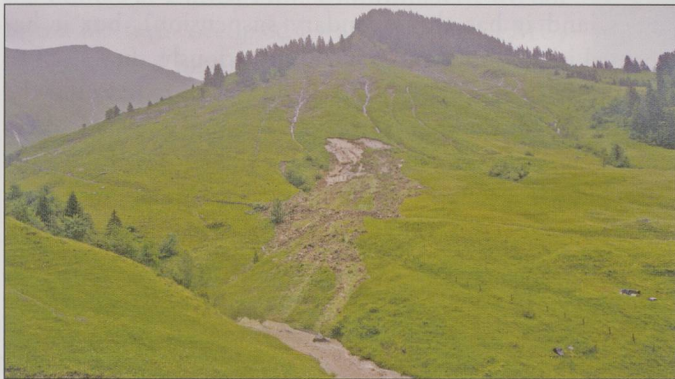
A clear view of just what has happened. The track, is some 3-4m out of alignment, completely free of the trackbed and now buried under a thick layer of clay, trees and boulders.

On the 24th July severe summer storms and extended rainfall resulted in a major mudslide taking place on the Brienz Rothorn Bahn (BRB) just below the 4km marker on the section immediately above Planalp. The ensuing damage included 70m of track work swept away from the track bed and a layer of debris 2m thick deposited onto, and around, the route. This, together with completely blocked storm drains and an interrupted service, has had quite a detrimental impact on the railway's short summer season. The clearance work naturally took priority over other duties and BRB staff from all disciplines were drafted-in to work on re-establishing the infrastructure to enable services to resume to Rothorn Kulm. Whilst a reduced steam service was maintained for visitors between Brienz and Planalp, works trains, along with imported heavy equipment, were in use to remove the debris and enable an assessment of necessary repair work to be undertaken. The preliminary clearance operation took about a week before service could be resumed to the railway's isolated mountain hotel at 2255m above sea level. With improved weather after the incident the trains resumed timetable running again and were well patronized. The accompanying photos give a good idea of just what confronted the civil engineering team and indicate what had to be done to regain normality on this popular railway in the heart of the Bernese

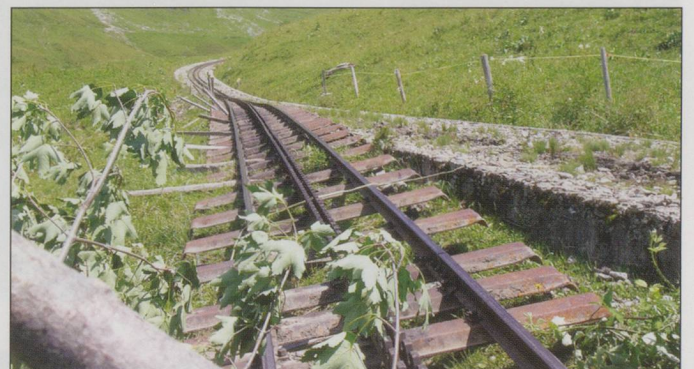
*BELOW:* Amazingly the fishplate bolts have held and this despite the considerable stress upon them. The damage has therefore been unwittingly extended either side of the actual slip area.
