# BRIENZ ROTHORN BAHN

A Swiss Heritage Railway goes searching for old skills

Michael Ellis

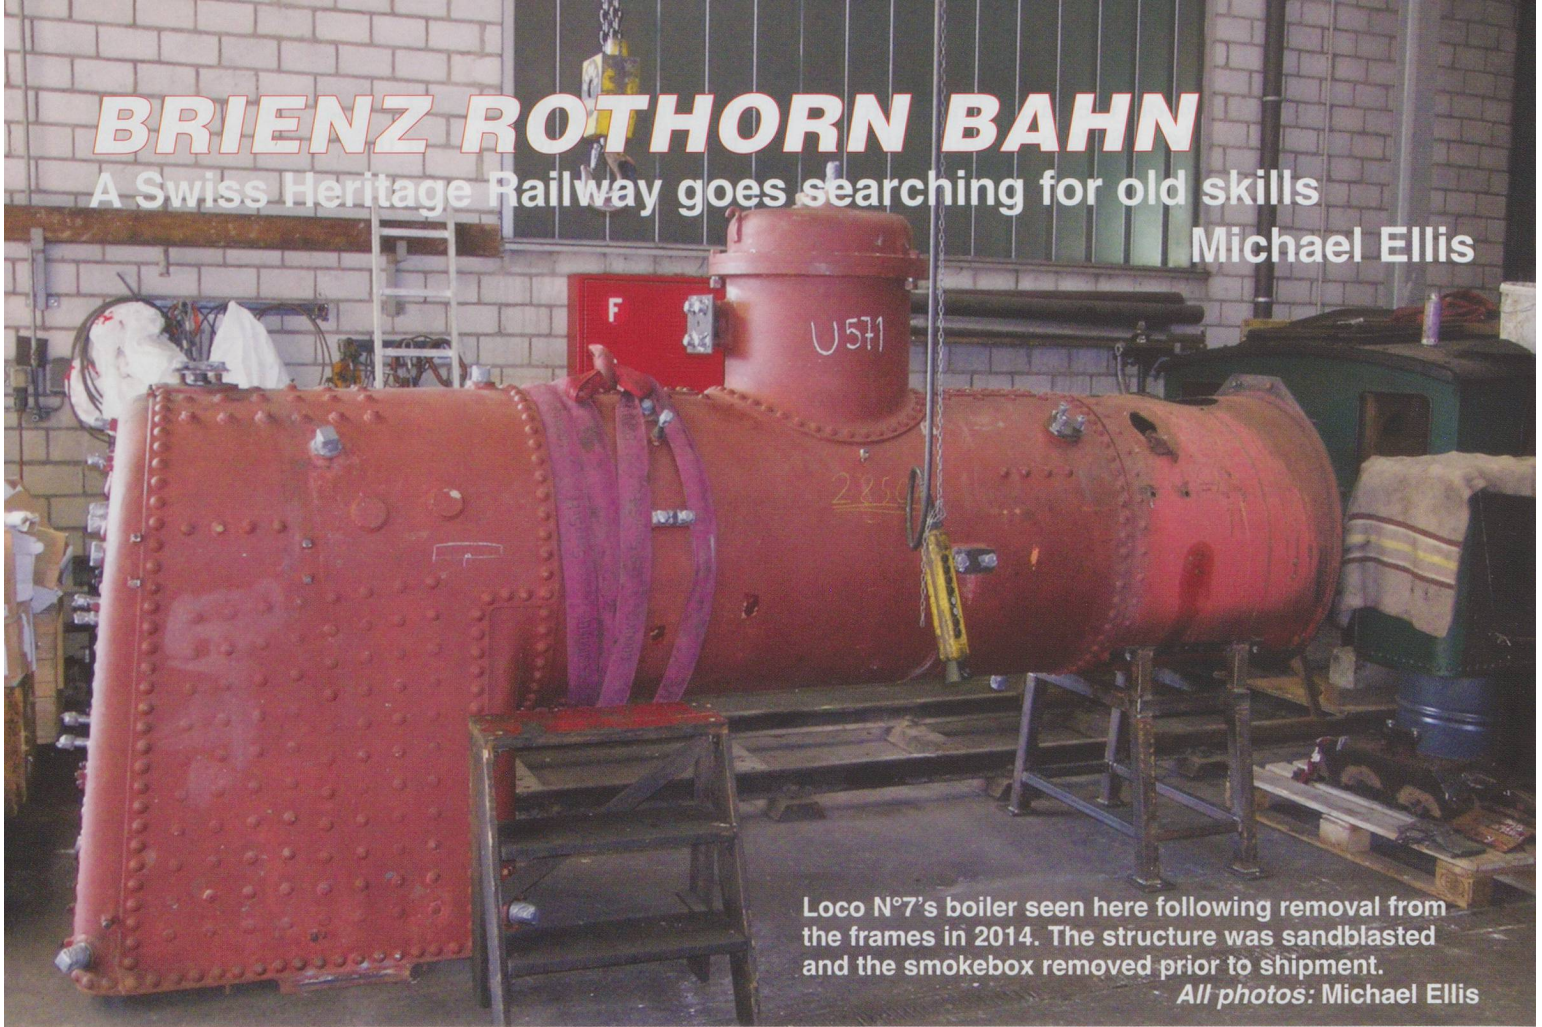
Loco N°7's boiler seen here following removal from the frames in 2014. The structure was sandblasted and the smokebox removed prior to shipment.

The BRB's loco H2/3 No.7 has been out of traffic for a long time; a major overhaul was due some 10-years ago and boiler problems were known to exist. The BRB are able to handle most overhauls themselves, but major boiler work is one item well outside our abilities. Searches throughout Switzerland, once a world leader in such engineering, reveals that today not one single company exists that will undertake this type of work. A company in Germany would supply an all-new welded boiler but would not work on an 85 year old component. As a heritage railway with interest to maintain its assets as near to original as possible, a new design boiler was not a solution that Daniel Schlosser, our Technical Operations Manager, wanted to consider. There were therefore no options open when the predicament came to my hearing in 2013. Being a 'Brit' with interest and knowledge of the UK railway heritage scene, I naturally suggested we enquire within the UK to ascertain whether or not any
