**Zeitschrift:** Swiss express : the Swiss Railways Society journal

**Artikel:** A 'Railway' bridge with a difference

# A 'Railway' Bridge with a difference

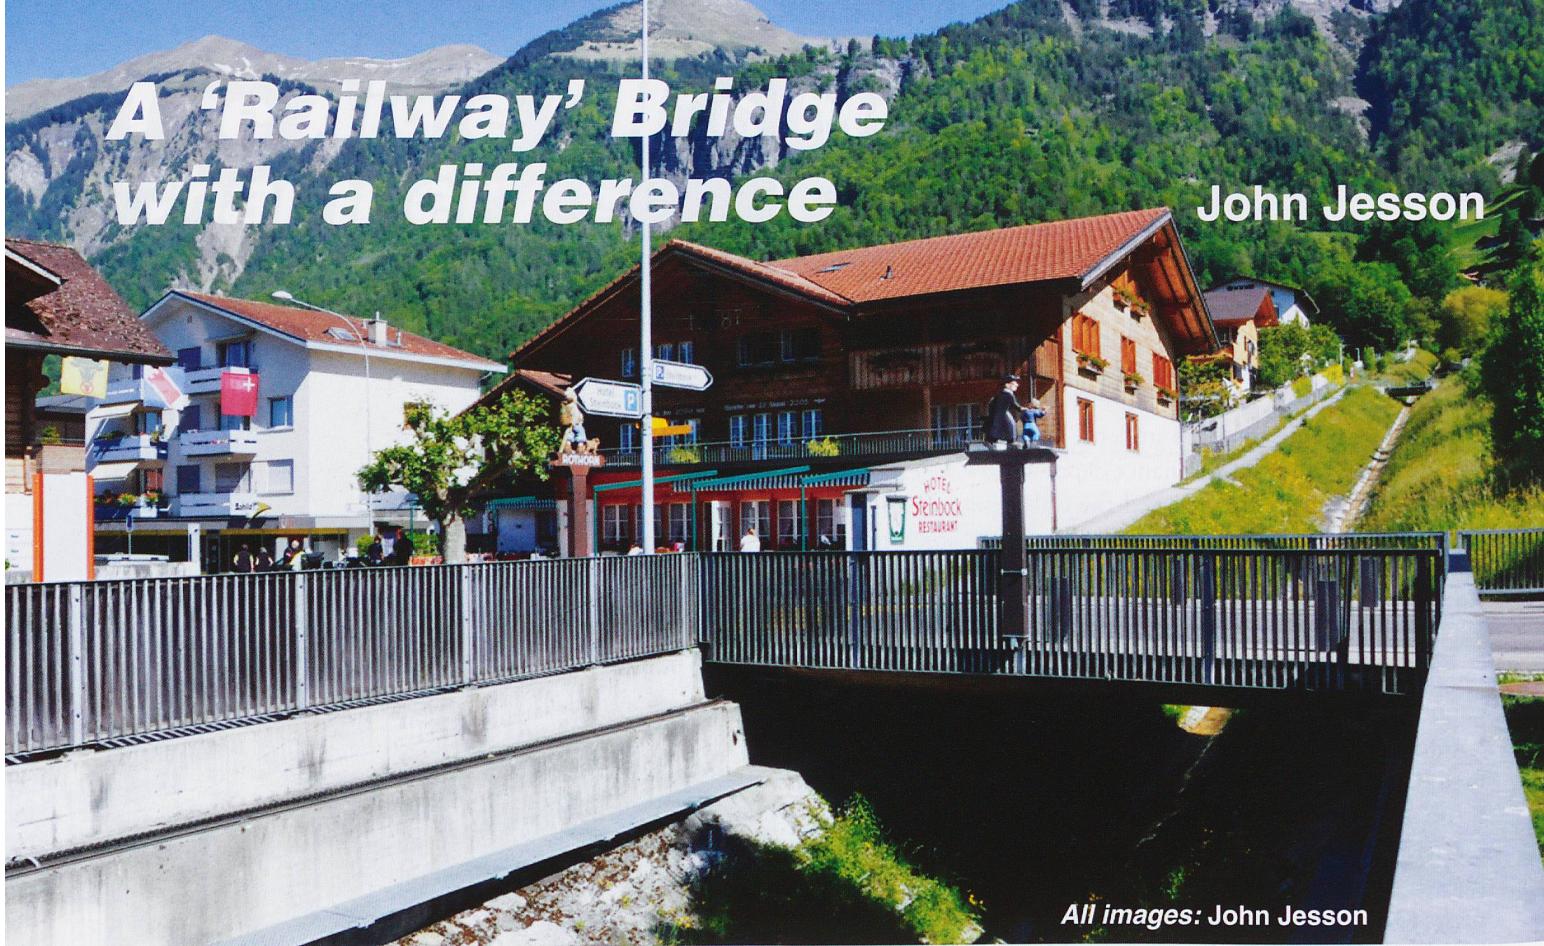
From the lake side of the bridge, showing one of the rails and the steepness of the drop of the Trachtbach.

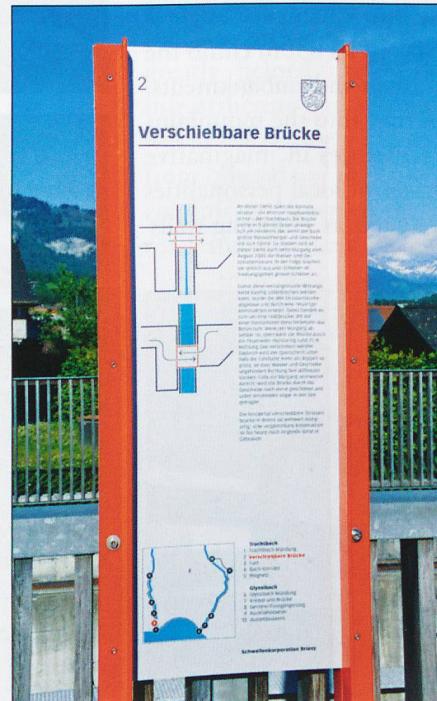
An dieser Stelle quert die Kantonsstrasse – die Brienz Hauptverkehrsachse – den Trachtbach. Die Brücke stellte in früheren Zeiten unweigerlich ein Hindernis dar, wenn der Bach grosse Wassermengen und Geschiebe mit sich führte. So stauten sich an dieser Stelle auch beim Murgang vom August 2005 die Wasser- und Geschiebemassen. In der Folge brachen sie seitlich aus und richteten im Siedlungsgebiet grosse Schäden an.

Damit diese verhängnisvolle Wirkungskette künftig unterbrochen werden kann, wurde die alte Straßenbrücke abgebaut und durch eine neuartige Konstruktion ersetzt. Dabei handelt es sich um eine Holzbrücke, die auf einer horizontalen Verschiebbausbahn aus Beton ruht. Wenn ein Murgang abschbar ist, dann kann die Brücke durch die Feuerwehr rechtsrund rund 25 m Richtung See verschoben werden. Dadurch wird der Querschnitt unterhalb der Fahrbahn mehr als doppelt so gross, so dass Wasser und Geschiebe ungehindert Richtung See abfließen können. Falls ein Murgang unerwartet eintritt, wird die Brücke durch das Geschiebe nach vorne geschoben und unter Umständen sogar in den See getragen.

Die horizontale verschiebbare Straßenbrücke in Brienz ist weltweit einzigartig; eine vergleichbare Konstruktion ist bis heute noch nirgends sonst in Gebrauch.

LEFT: The panel alongside the bridge, describing its operation.  
FAR LEFT: The main text in German.

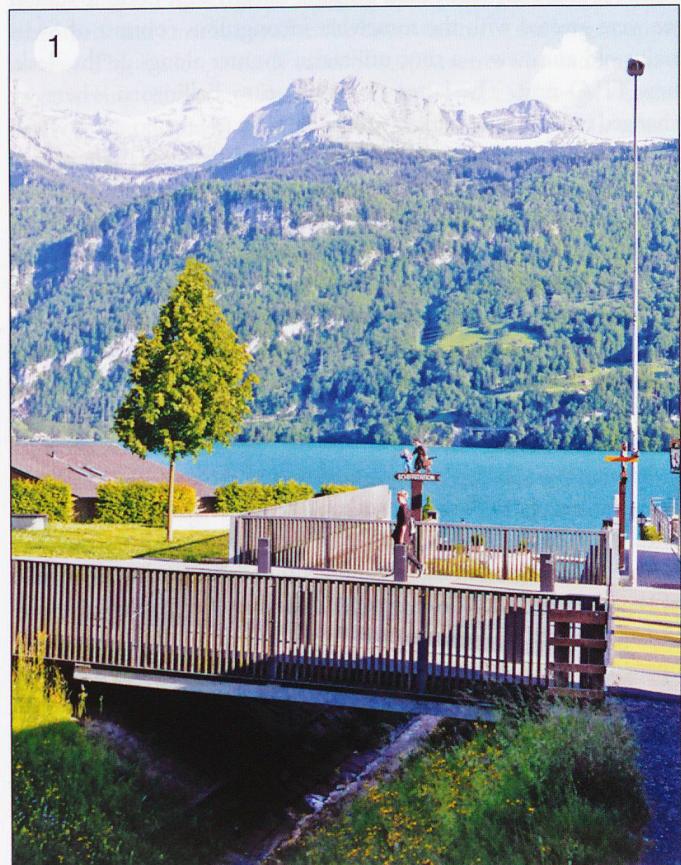
1

1. A general view of the bridge with the lake in the background.

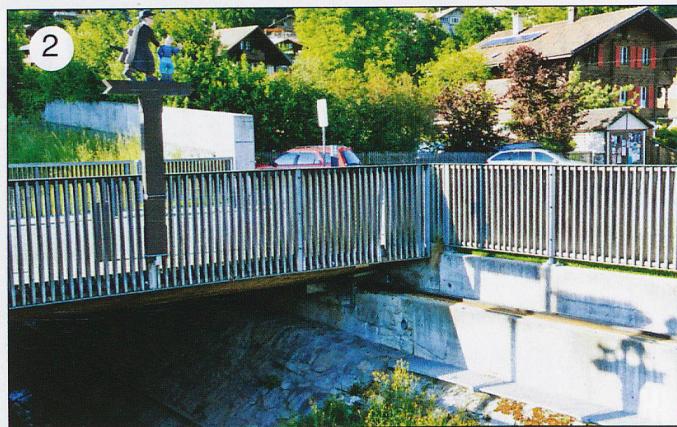
2

2. One corner of the bridge.

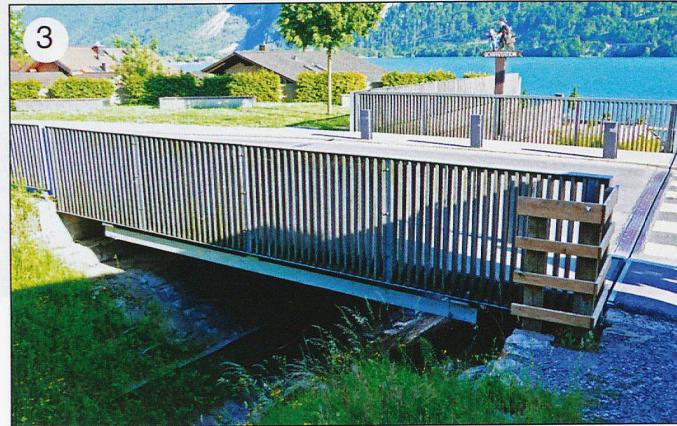
3

3. The bridge from the upstream side, showing the restricted clearance, as well as the decorative sign and the obstructing tree.

work in the severely damaged areas much more difficult. The chosen solution to guard against any future inundation is the new bridge, which can be moved 'downstream' towards the lake, thus allowing a much larger aperture (more than double) for the water and debris to flow through and into the lake. As it runs on steel wheels on steel rails, that surely makes it a "railway". Movement of the bridge is by electric power and the bridge moves 25 metres. There is open space on each side of the new bridge position with removable guardrails, so that diverted road traffic can still run through. However, on one side the open space is grassed, with a tree in what, would become, the middle of the carriageway!

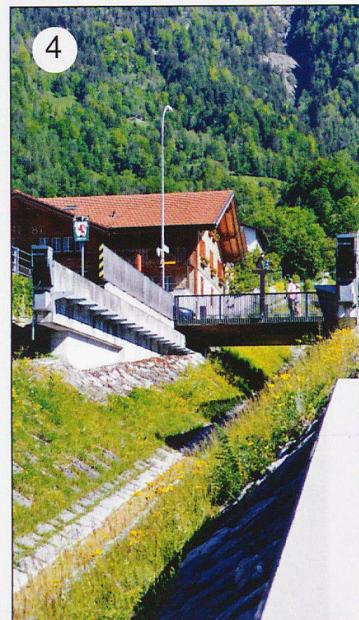
4

4. This gives a better idea of just how steep the waterway is, and how much extra space for water and debris is achieved by moving the bridge. The controls for the bridge are also in the picture.
