Artikel: TIG arc remelting as a repair method for steel railway bridges (Japan)
Autor: Masuda, Y. / Sakamoto, K.
DOI: https://doi.org/10.5169/seals-20935

5. TIG Arc Remelting as a Repair Method for Steel Railway Bridges (Japan)

Owner: *Central Japan Railway Co.*
Engineer: *Central Japan Railway Co. Railway Technical Research Institute*
Date of Construction: *1964*
Date of Repair: *1987*

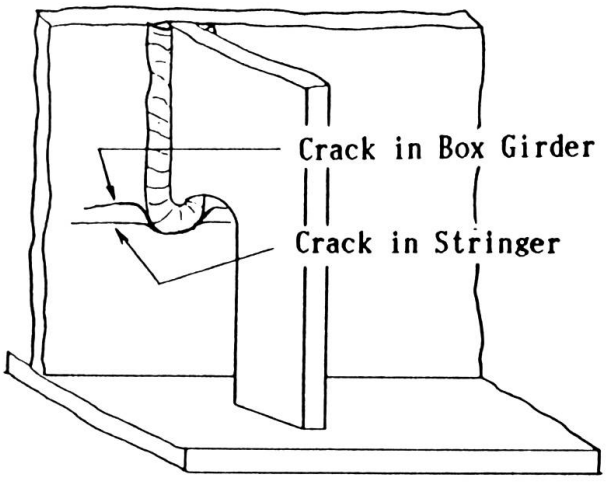
Fig. 2 Schematic of Crack Propagation

All these cracks were initiated at the stiffener end and the schematic of crack propagation was shown in Fig. 2.

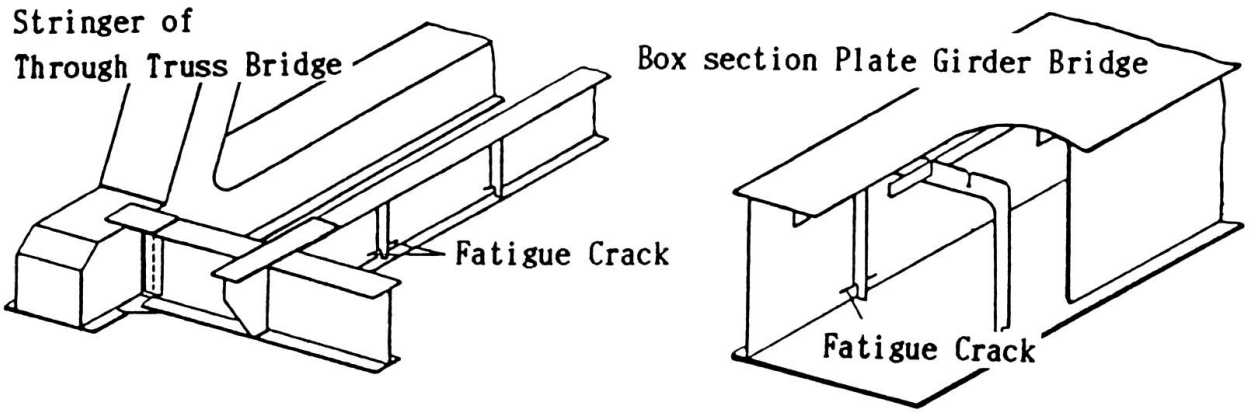
Fig. 1 Fatigue Crack at Stiffener End

Fatigue cracks have been detected at the toe of fillet welded joints of stiffener ends in the web plates of stringer beams of truss bridges and box section plate girders (see Fig. 1). The first fatigue crack was found in 1975. The rates of the number of bridges having cracks detected to that of the same type of bridges are seven percent for truss bridges and five percent for box girders.

In the repair work, toes of fillet welded joints were inspected first with the magnetic particle testing. If no crack was indicated or the crack size was indicated as less than 10 mm, TIG arc remelting was simply performed. When the crack size was more than 10 mm, the cracks were firstly removed by arc air gouging and re-welded, then the toes of the re-welded joints were remelted by TIG arc. If the crack size was very large, additional steel plates were attached after re-welding.

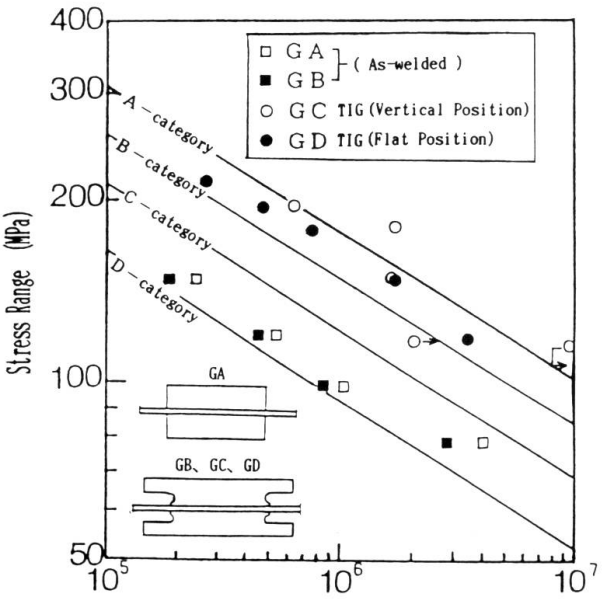
Fig. 4 Results of Fatigue Test

Fatigue tests were performed to confirm the effect of this treatment on improvement of fatigue strength. The fatigue strength of a joint subject to TIG arc remelting was much higher than that of an as-welded joint as shown in Fig. 4.
