Fatigue strength of welded butt joints of multiple plate flanges of beams

K.P. BOLSHAKOV
cand. of techn. science
All-Union Res. Inst. of Transp. Constr.
Moscow, USSR

I.M. SHAFERMAN
Engineer
All-Union Res. Inst. of Transp. Constr.
Moscow, USSR

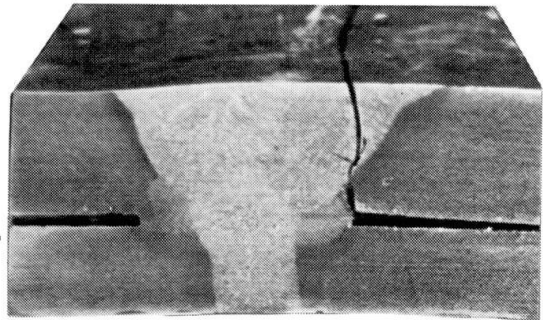
At our Institute attention has been paied for the first time to
reliability of such joints during fatigue test of I-beams with
double plate flanges. Beam flanges were welded with single - V
(butt) joint according to the technology [1-3] . Tests were sup-
posed to be conducted under variable load of 2 million cycles,
however fatigue fracture of joints was found to initiate before
specified time. In all cases fatigue crack occurred at the point
of joint intersection with gap between plates (fig. 1).

fig.1. Fatigue fracture of
double plate beam flange
joint

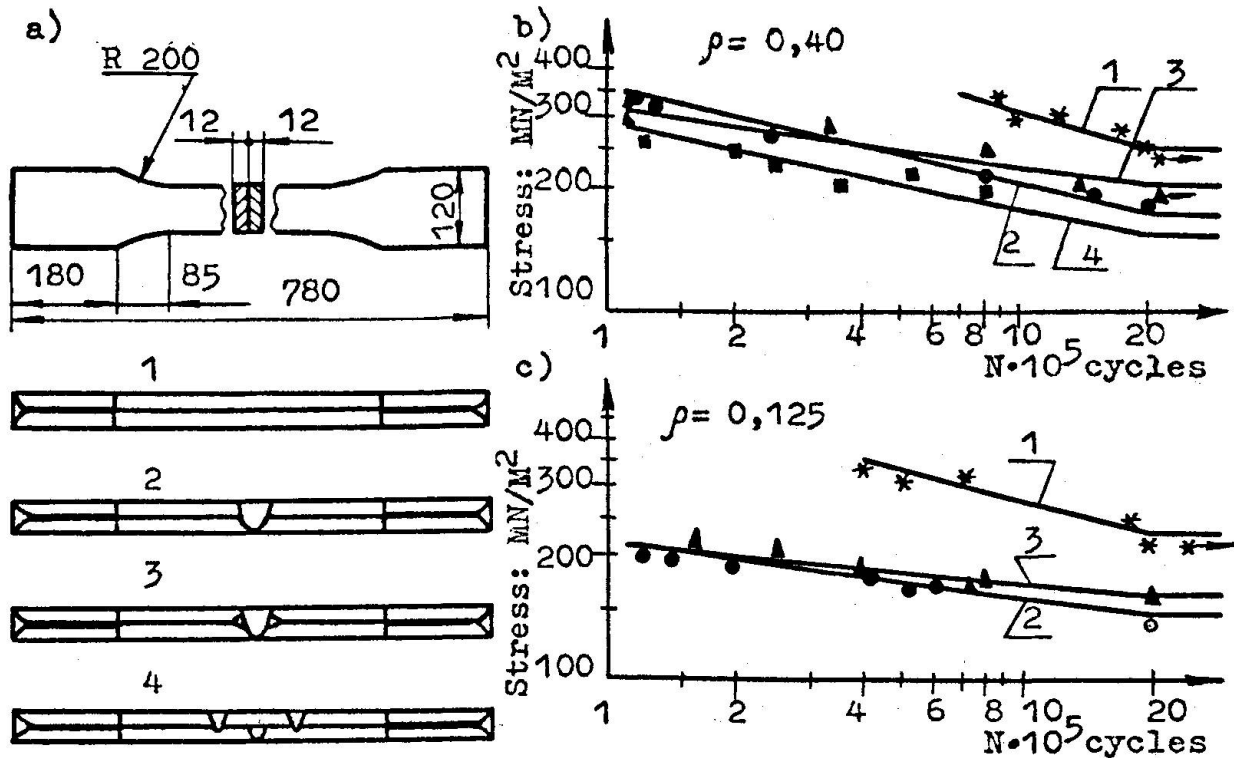
Tests have demonstrated that regardless of the technology applied
all specimens fracture (in beams as well - fig. 1) occurred at
the point of joint intersection with gap between plates. Fatigue
strength limit in series 2 and 4 (fig. 2,d) appeared to be the
lowest and approximately the same at ρ = 0,40; fatigue strength
limit in series 3 is slightly higher comparing with series 2 and
4, but lower in comparison with base metal (series 1). Tests con-
ducted at ρ = 0,125 support the conclusions relative to series 2

fig. 2. The curves of specimens fatigue strength (O – data from ref [2])

reference [2] for double V butt joint is shown here too. Fatigue strength limit of such joint obtained from "weak regime" tests (ρ= 0,18) appeared to be similar to fatigue strength limit at ρ= 0,125 in series 2. Therefore recommendations [2] haven't provided significant advantages.

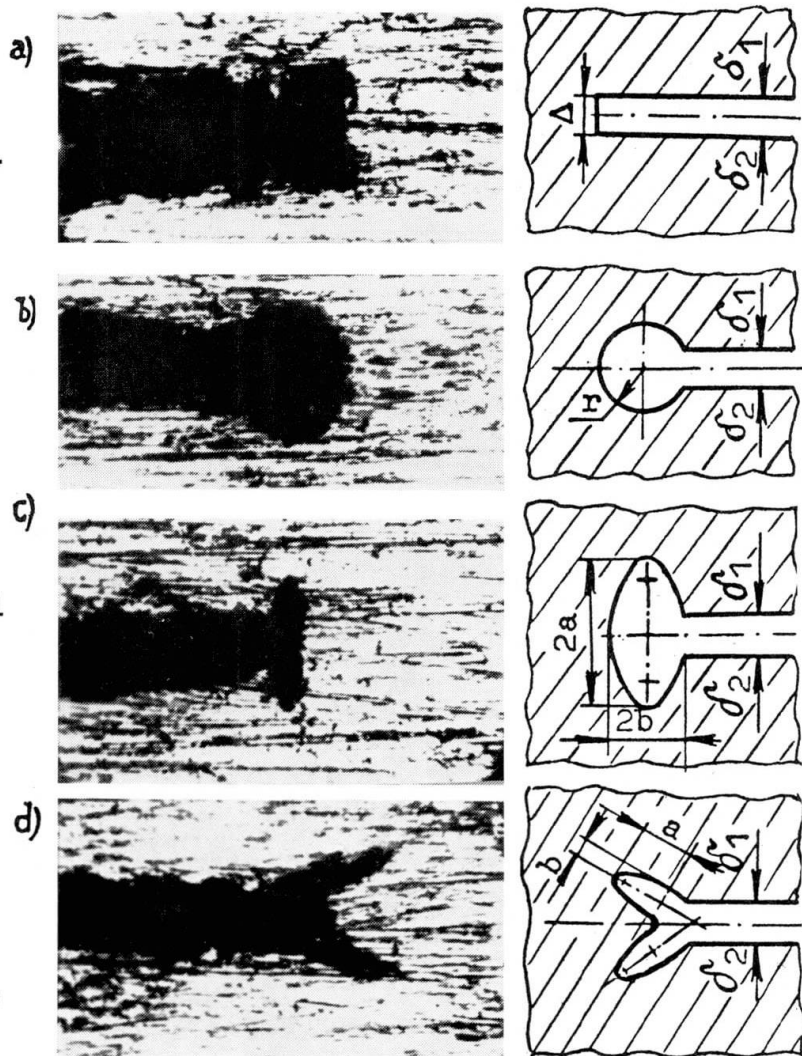
To find out the conditions of stress concentration occurrence the contours of points of joint intersection with gap between plates were investigated by means of microscope. It has been determined that in most cases the contours are close to rectangular (fig.3a). However in a number of cases distortions (defects) were observed such as spherical expansion with radius r at $\Delta < r << d_1, d_2$ (fig. 3b); sharp cross expansion of a specific size - 2a $>$ 2b,
  b $\cong$ $\Delta < 2a << d_1, d_2$ and section form similar to elliptical (fig. 3c); branching from intersection point, section shape being close to elliptical with similar sizes ratio (fig. 3d). The mentioned defects have been induced by slag inclusions along the line of joint - gap intersection.

fig. 3. Zones of joint intersection with the gap

of ellipse large axis to extention
direction [6] Maximum meaning of K_t
will be at the ends of large axis
when $\alpha = \pi/2$ and corresponds to
defects shown in fig. 3b. Such de-
fects existing, coefficient of con-
centration [8] might be very high
(fig. 4c). In all considered cases,
where defects resulted from slag
inclusions(fig.3,b,c,d.), the gap
should not affect concentration le-
vel as it is situated in the zone
of least stresses.

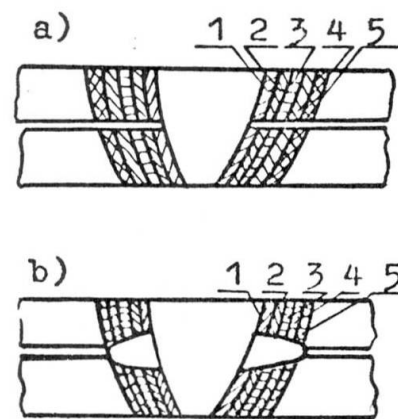
Higher fatigue strenght of series
3 (fig. 2) may be explained as
follows. Joint circumjacent zone
includes five sections of thermic
influence zone (fig. 6). The sec-
tions hardness decreases as it is
moved away from joint axis at
HRB = 86 (in the first section) up
to HRB = 68 (in the fifth section)
These zones plasticity varies
inversely with hardness. In series
2 concentrator is located in the
zone of high hardness,but less
elasticity (fig. 6a). In series 3 -
in the zone of less hardness,but higher elasticity (fig. 6b).
These factors determine the difference in connections behaviour
under fatigue loading.

fig. 6. Concentrators location in joint circumjacent zone

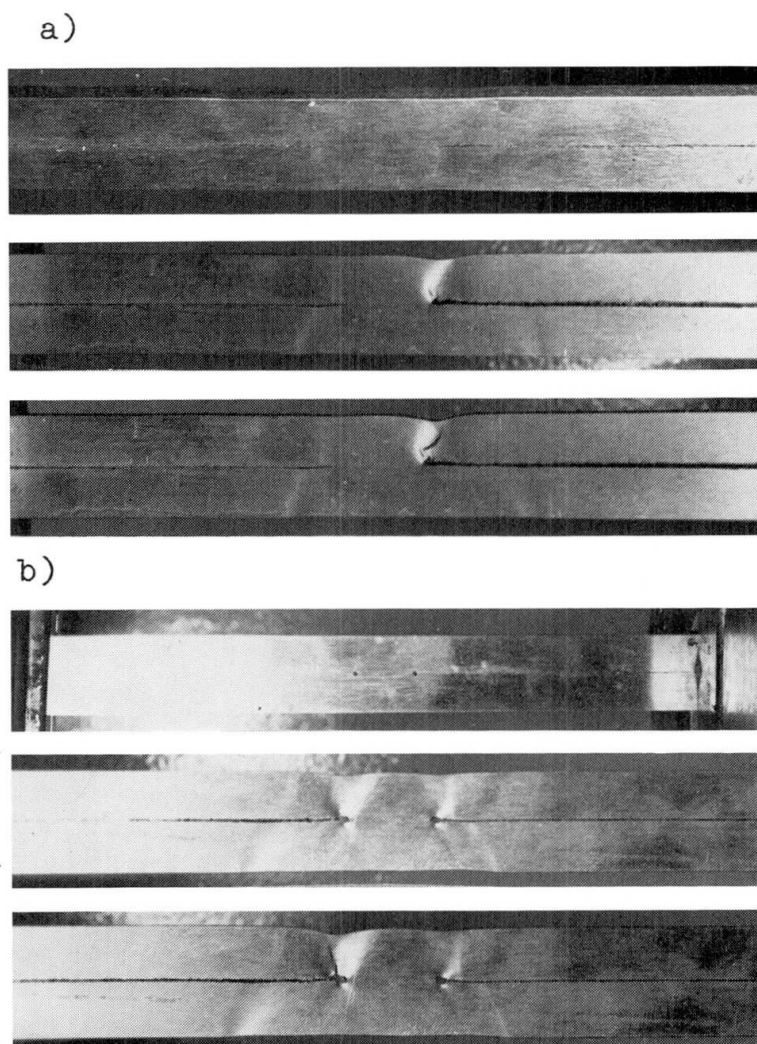
To determine the fracture mechanism of welded butt joint of multiple plate pack tests have been carried out on static tension of specimens possessing higher efficient coefficient of concentration B and specimens with artificial defects — apertures of 1,5 mm diameter simulating defect shown in fig. 3b. In both cases fracture initiated from the point of joint intersection with the gap (fig.7).

fig. 7. Static tension fracture
