Repair and Strengthening of Reinforced Concrete Buildings

Tsuneo OKADA
Professor
Univ. of Tokyo
Tokyo, Japan

SUMMARY

In 1978, a severe earthquake shook the Peninsula Izu located 120 km southwest of Tokyo, Japan. Several R/C school buildings were damaged. This paper presents the damage, the method of repair and strengthening, and the seismic capacity of the pre- and post-strengthened buildings.

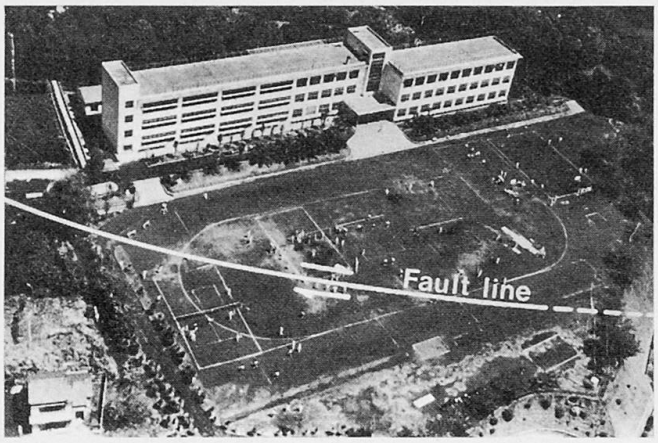
A short discription about earthquake damage is shown in Table 1. Among them, the damage of Inatori junior high school building was most severe, while the frames could maintain structural performance after the earthquake. As shown in Fig.3, a major fault line was found across the ground. A number of cracks were found in columns, beams, walls and slabs. The damage was most significant in the slabs at the center core. The crack pattern showed that the east wing and the west wing moved in the opposite direction(Fig.4).
Atagawa junior high school building was one of the damaged buildings. A number of cracks were seen in columns, beams and walls. Both ends of the building were sunk several centimeters. By the excavation of ground, it was found that the footing beams at the west end were failed in shear. Seismic performance of other school buildings were quite well, while hair cracks in the structures, and damage to the non-structural elements were found.

Fig. 3 Bird's eye view of Inatori Junior High School

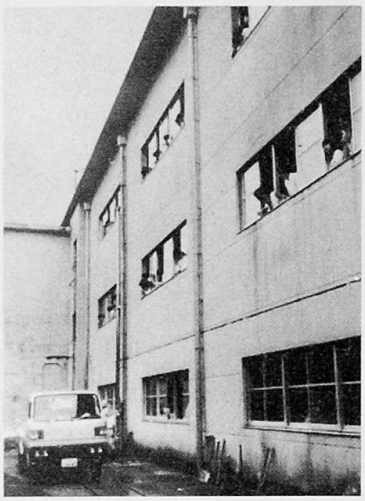
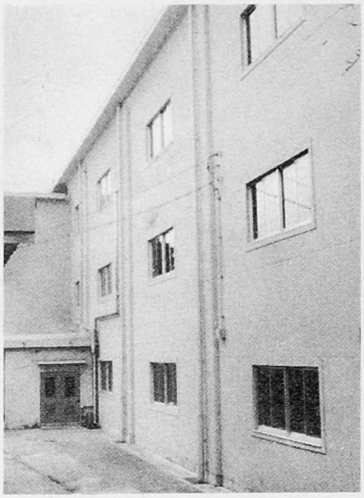
Fig. 5 Shear walls of Inatori Junior High School

Considering these analyses and the grade of damage, the following permanent therapy was adopted for two junior high school buildings : 1) Inatori Junior High School — The east wing was also demolished and replaced to new building in 1983. The west wing was strengthened by adding reinforced concrete shear walls in the existing frames(Fig.4,5). By this therapy, the Is-index of the west wing is estimated more than 1.0. 2) Atagawa Junior High School — This building was also strengthened in 1983 as shown in Fig.6,7,8. Reinforced concrete walls were added in the existing frames. Reinforced concrete cores were newly constructed at the both ends of the building and jointed to the existing part. The penthouse was taken off to reduce the building weight.

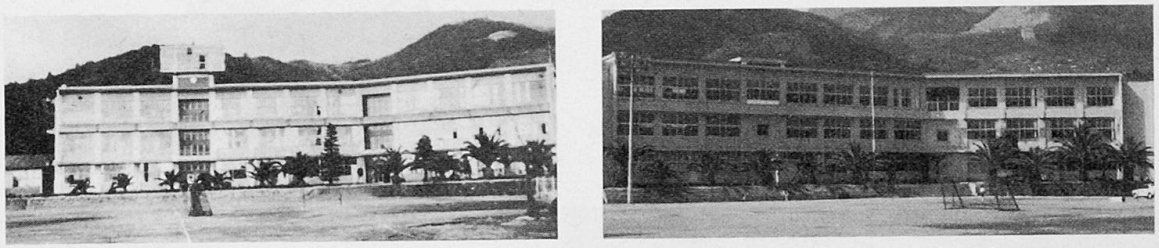
Fig. 6 Overall views of Atagawa Junior High School

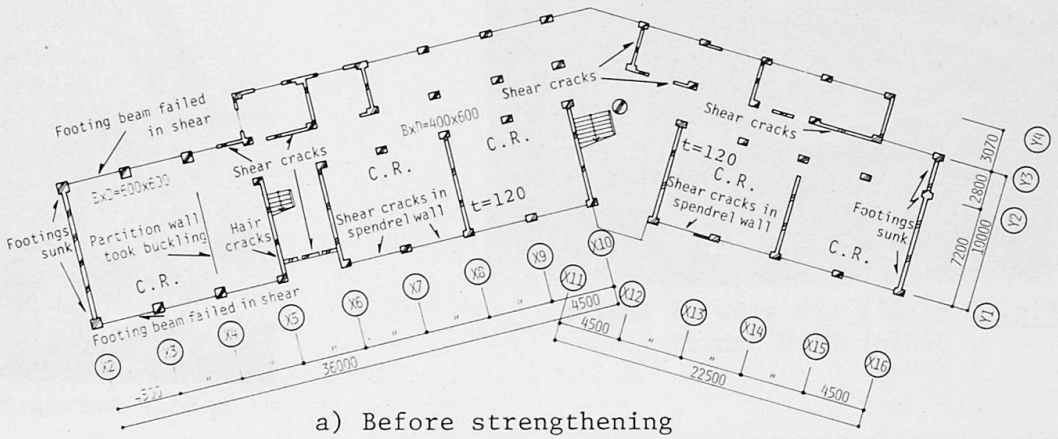
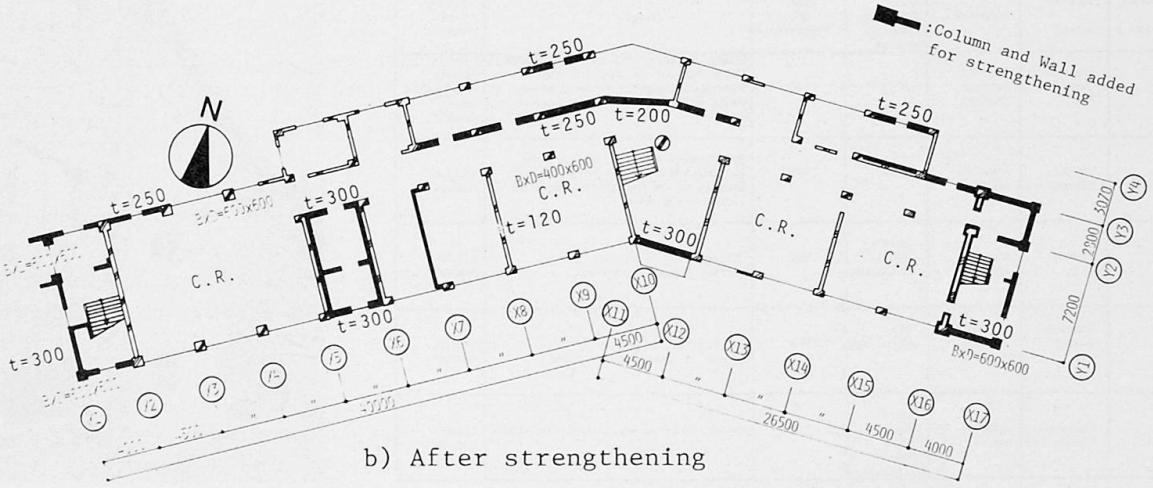
Fig. 7 Plan of Atagawa Junior High School

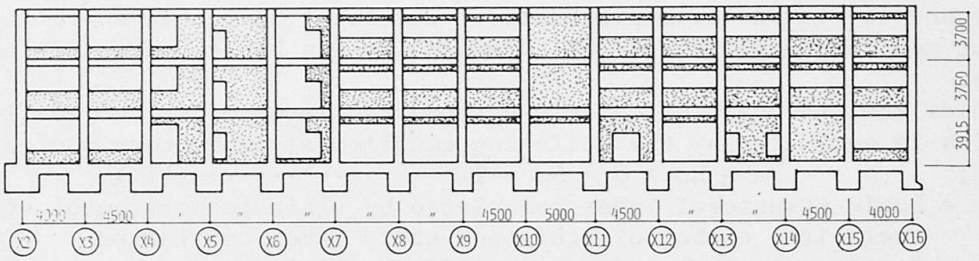
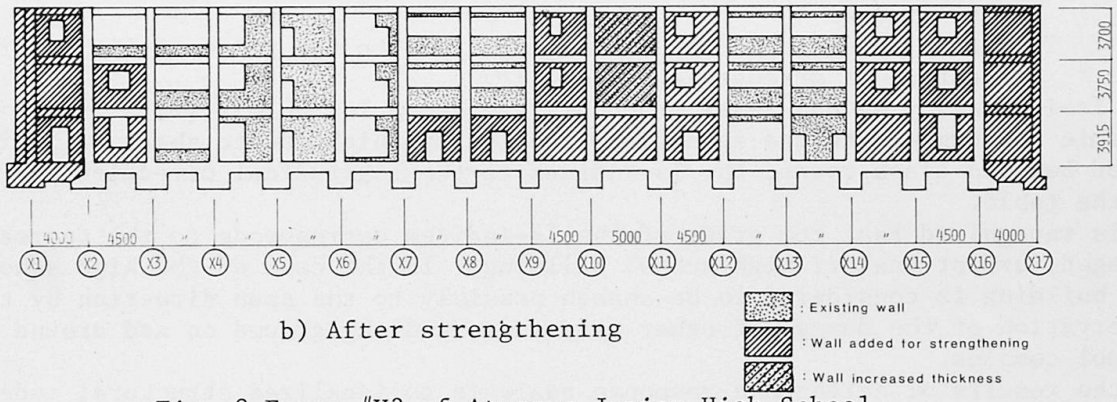
Fig. 8 Frame #Y3 of Atagawa Junior High School

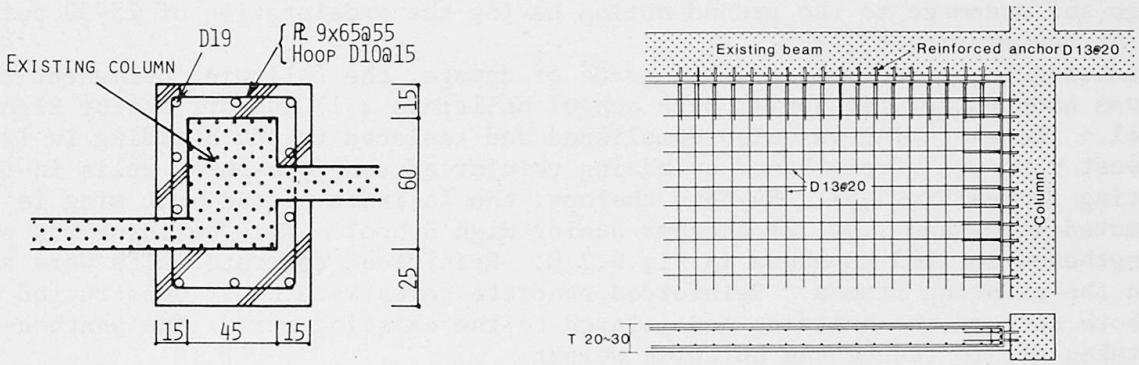
Fig. 9 Detail of joints

Detail of joints are shown in Fig.9, which are typical practices in Japan. By this therapy, the Is-index after strengthening is estimated more than 1.0.

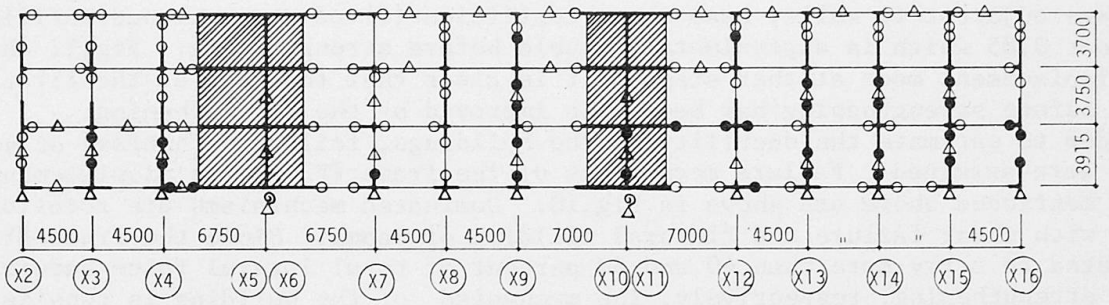
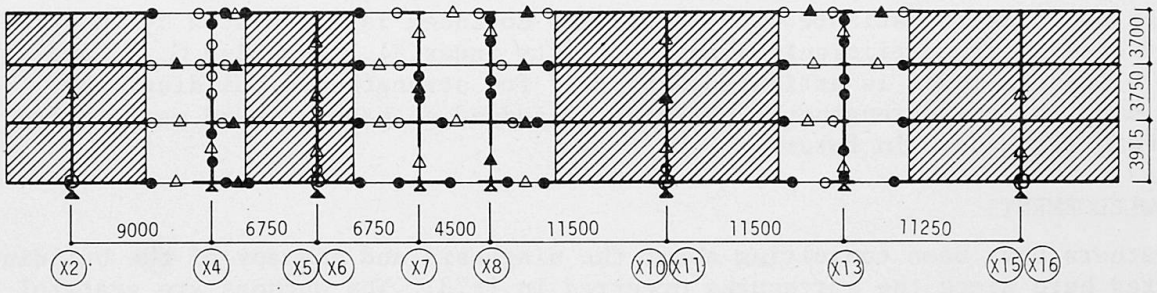
As shown in Fig.10, each member was idealized into beam model having rigid zones at both ends. In order to represent the non-linearity of member, one-component model consisting of series combination of flexural spring and shear spring was used. A degrading tri-linear type of hysteretic rule was used for flexural spring and an origin-oriented type for shear spring. At the bottom of the wall, bi-linear elastic spring was attached representing the rotation of footing. A bent of the frame lines was not considered.

Fig. 10 Failure mechanism of Atagawa Junior High School (δ_1=2 cm, R_1=1/200)

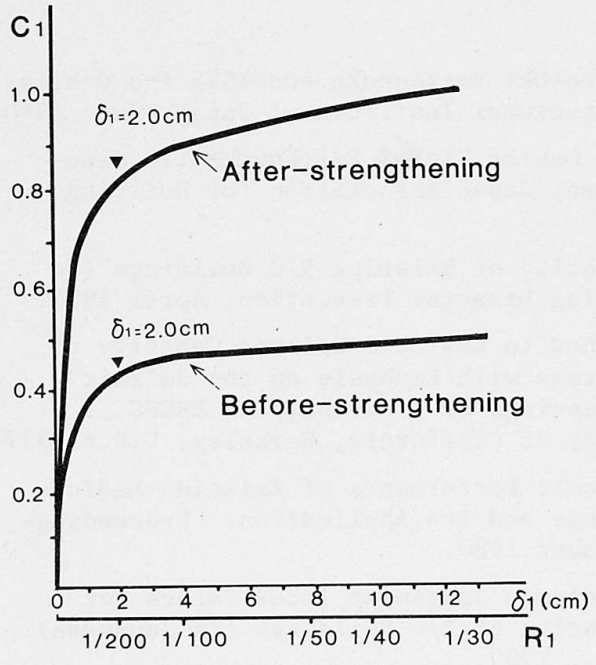
Base shear coefficent-story drift relationship at the first story is shown in Fig.11. At the stage of the displacement of 2cm, where shear failure occurs

Fig. 11 Base shear coefficient - story drift relationship of Atagawa Junior High School (1st story)

in beams adjacent to walls, base shear coefficient(C) of strengthened building is about 0.85 which is approximately double before strengthening. Fig.12 shows the displacement mode at that stage. It is clear that the sway at the first story before strengthening has been also improved by the strengthening.
In order to estimate the ductility of the buildings, failure mechanisms of structures were examined. Failure mechanisms of the frame #Y3 at the displacement stage mentioned above are shown in Fig.10. Dominated mechanisms are rotation of walls with shear failure and flexural yielding of beams. Since the frame #Y3 is estimated to carry more than 40 and 60 percent of total lateral force before and after strengthening, respectively, the mechanism of the building is considered as same as the frame #Y3.
According to the third level procedure of the Guideline, a ductility index(F) of such building is estimated 1.0 to 1.5 and Eo-index is calculated by the product of base shear coefficient(C) and ductility index(F). Assuming G, S_D and T are 1.0, the Is-index is estimated 0.85-1.27 for strengthened building. By these studies, the strengthened building is judged to have a sound performance to severe earthquake in future.

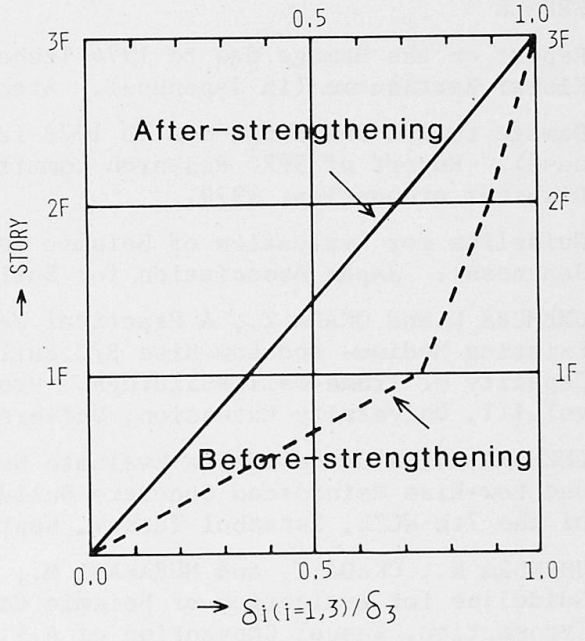
Fig. 12 Mode of displacement(δ_1=2 cm) of Atagawa Junior High School
