Zeitschrift: **IABSE reports = Rapports AIPC = IVBH Berichte**

Band (Jahr): **46 (1983)**

Strengthening of a Prestressed Concrete Shell Structure

Hassan HOSNY
Dr., Assoc. Prof.
Mansoura Univ.
Mansoura, Egypt

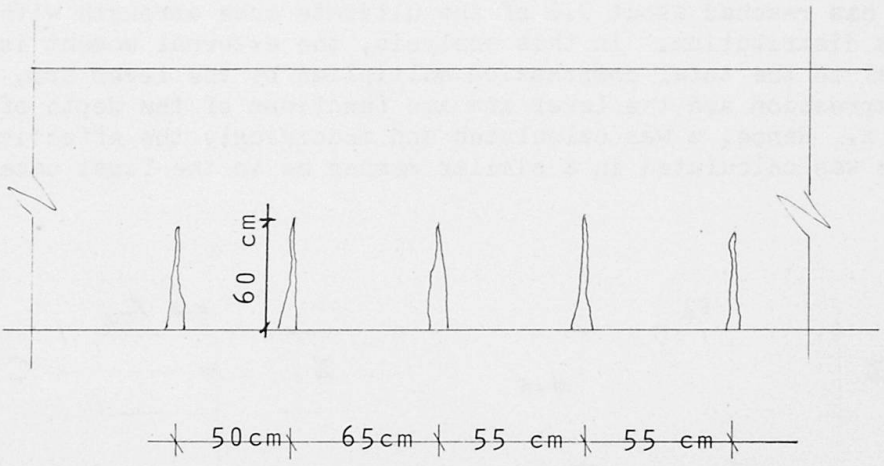
Fig. 2 Cracks At Mid Span Of Beams

- In the webs of the prestressed beams - especially for those of the intermediate beams- several cracks spaced about 50cm between each other were noticed at mid-span. These cracks were extending vertically about 60cm from the bottom surface of the beams with crack widths varying from 0.5 to 3mm on both sides and on the bottom surface of the beams as shown in fig.2.
- In some localized areas of the shells, longitudinal and transversal cracks on the inside face and sometimes on the outside face were noticed. In these areas one can assume that the concrete is linked together along the cracks - which act as hinges- only by the reinforcing bars.

The main reasons for the damages were the miss use and bad maintenance. A steel water tank of two cubic meters capacity was located on top of one of the shells. Plenty of pipe networks were also located on top of the shells. These pipes were not well connected and leakage of water and chemicals was noticed. The gutters over the valley beams, between adjacent shells, were found to be almost filled with mud which prevented proper drainage of water to take place. This mud and water added an extra load on the beams which was not taken in to account in the original design.

Due to the above mentioned reasons, the beams were cracked and the prestressing cables started to corrode. Accordingly, the effective prestressing forces were reduced considerably, followed by rupture of prestressing cables and sudden collapse.

- In the second method, the beams were to be strengthened by the use of external prestressing cables. These cables were to be anchord - outside the building - in precast concrete end blocks. Fig. 6 & 7 show the end blocks used for the intermediate beams and that used at the expansion joints. It should be noted that for the end blocks at expansion joints neoprene sheets were installed between the columns and the blocks in order to allow for expansion movements. Fig. 8,9&10 show the repair for the exterior beams, for the intermediate beams and for the beams at the expansion joints respectively. The advantage of this method over the first method is that it saves time, it is easy to perform, it does not add any more weight to the beams and it needs no shuttering, i.e. the repair can be carried out without the need of stopping the production of the factory. However, it needs especial prestressing equipments to be available.

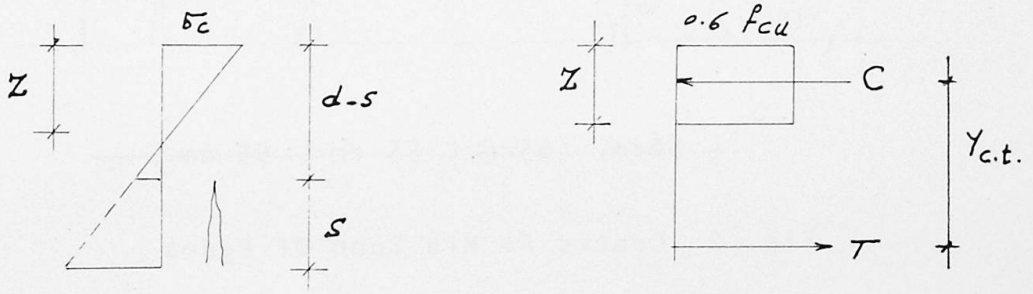
Fig. 3 Assumptions Of Stress Distribution

- In the first case, fig. 3a, the stress distribution was assumed to be linear. In this case it was assumed that the tensile stress at the level of the top end of the crack is equal to the tensile strength of the concrete which can be evaluated. The actual external moment applied on the section was calculated, i.e. it was known. Thus from first principals, the total compression was calculated which is equal to the total tension. The effective prestressing force was accordingly estimated.
- In the second case, fig. 3b, it was assumed that the compressive stress in

the concrete has reached about 0.6 of the ultimate cube strength with a non-linear stress distribution. In this analysis, the external moment is known which is equal to the total compression multiplied by the lever arm, $Y_{c.t.}$. Both the total compression and the lever arm are functions of the depth of the nutral axis, z. Hence, z was calculated and accordingly the effective prestressing force was calculated in a similar manner as in the first case.

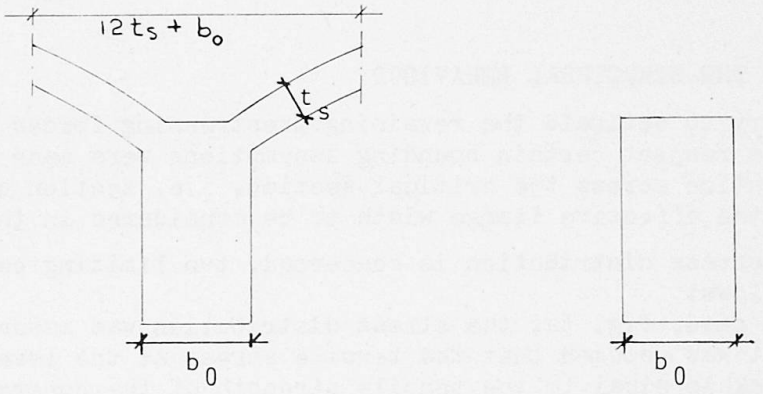
Fig. 4 Assumption Of Effective Flange Width Acting

As far as the effective flange width is concerned, two cases were considered for each stress distribution case as follows:
- The beam was considered to be as a rectangular section without any flanges acting as shown in fig.4a. This case gave the heighest value of loss of prestressing.
- The beam was considered to have an effective flange width equal to the web bredth plus twelve times the shell thickness as shown in fig. 4b.

It should be noted that the problem under consideration is not that straight forward and some engineering judjment had to be made. From the crack pattern in the valley beams together with the above mentioned calculations, it was estimated that a maximum loss of about 40% in the original prestressing force has taken place.
