Transient Vibration in Light Frame Floors

Anthony NASH
Consult.
Charles M. Salter Assoc. Inc.
San Francisco, CA, USA

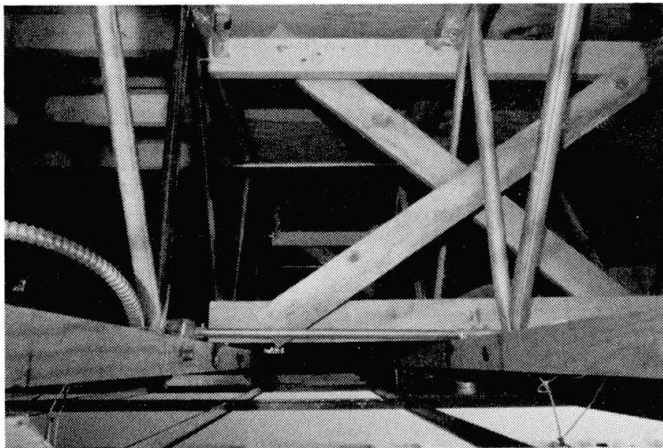
FIGURE 3: VIEW OF
FLOOR FRAMING

ide of a typical floor system. The open web trusses are seen receding into the plane of the paper. The photograph also illustrates some cross-bracing that had been installed in an earlier attempt to alleviate complaints by the occupants. Heeldrop measurements conducted on this floor placed it in the "strongly perceptible" region of the rating scheme.

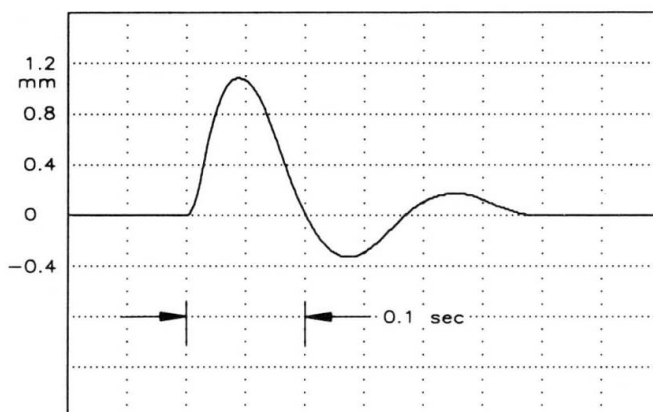
FIGURE 4: FLOOR
DISPLACEMENT

Figure 4 is a typical [inverted] displacement-time history measured at the midspan of such a floor. The displacement transient is a rapidly decaying sinusoid having a peak amplitude of 1.1 mm and a free vibration frequency of 5.7 hertz. The product of peak amplitude and frequency is 6.3 [mm-hertz]. Several observers agreed that the response was indeed "strongly perceptible."

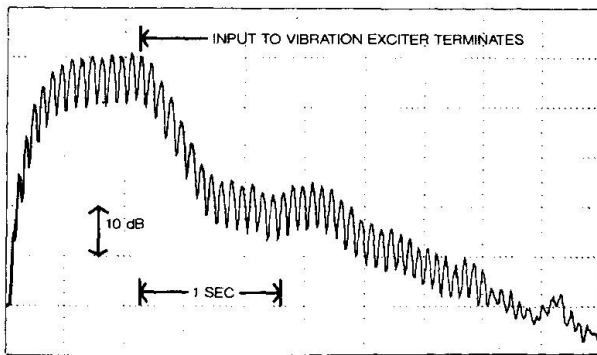
FIGURE 5: DECAY OF FLOOR
VIBRATION (7.5 HZ)

al position of the exciter. Figure 5 is one example of a free vibration decay after the exciter was stopped. The decay over the first 30 decibels was so rapid that the response near the source was dominated by ringing of the electronic filter used to process the accelerometer signal. This characteristic suggested that either the floor system had extremely high damping or that the mechanical energy propagated away from the source.

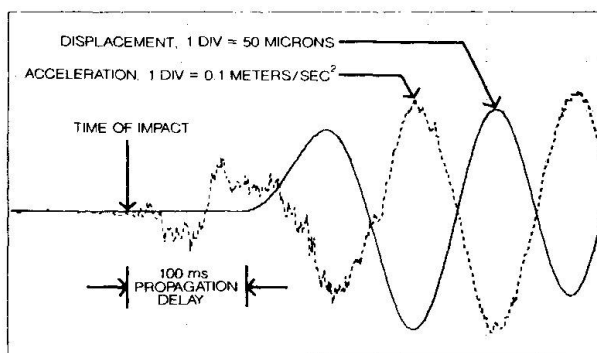
FIGURE 6: VIBRATION
10 METERS FROM HEELDROP

Further tests using the heeldrop method tended to confirm the propagation hypothesis. Figure 6 illustrates the acceleration and displacement measured at a joist midspan 10 meters away from the impact point (which was also at a joist midspan). In this figure, the floor received a heeldrop impact at t = 0 and the response commenced t = 100

milliseconds later (propagation speed = 100 meters/second.) The reduction in peak floor displacement from the impact point to the distant measurement location was approximately 20 decibels.

- Improving the vibration characteristics of light frame floors will require either significantly attenuating propagating wavefronts or increasing the bending stiffness of the floor diaphragm so its propagation speed is nearly infinite. An infinite propagation speed means that all joists will resist local impact forces at the same time in inverse proportion to their distance from the impact point.
