Artikel: The development of asphalt surfacings for steel bridge decking

The Development of Asphalt Surfacing for Steel Bridge Decking

Road Research Laboratory, Department of Scientific and Industrial Research,
United Kingdom

At the request of the Joint Consulting Engineers for the proposed new bridges over the rivers Forth and Severn, the British Ministry of Transport and Civil Aviation asked the Road Research Laboratory to make tests to help to decide on the choice of a surfacing that would be sufficiently impervious to protect the steel decking from rust and corrosion, and that would be durable, non-skid and of a thickness not exceeding 2 in. It was desirable to test the possible surfacings on the full-scale and steel panels 9 ft. long by 7 ft. wide of a construction similar to that of the then proposed decking were placed in the carriageway of the Colnbrook By-pass on Trunk Road A. 4. This road carries more than 40,000 tons of traffic per day and some of the test panels were subjected to this traffic for periods of up to six years.

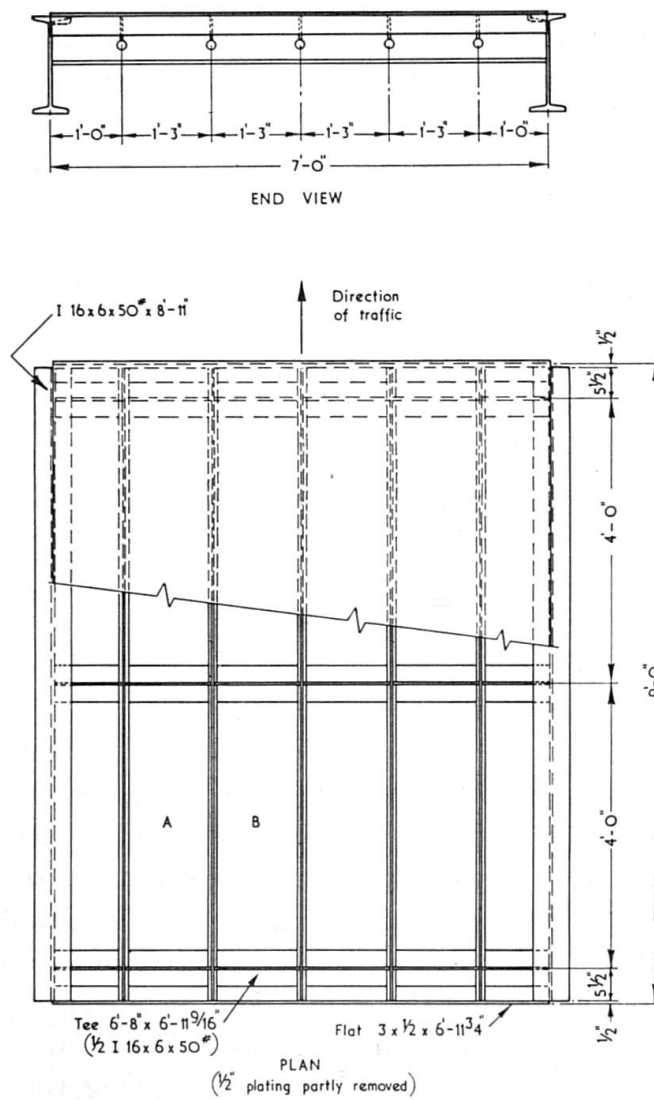
Fig. 1. Deck Panels for First Surfacing Test.

Loading tests were made on these panels on two occasions — 2nd February and 1st March, 1950 — to determine whether the surfacings would crack due to the deflection of the decking under the maximum design wheel load of $12\frac{1}{2}$ tons. The load was applied in turn at positions A and B (see fig. 1) on each panel. The load was applied to the plate by a hydraulic jack through a section of 14-in. wide solid rubber tyre mounted on a wooden block, and released rapidly by unscrewing the valve. The tests were repeated twice each day and the temperature of the mastic at the time of test varied between 1 and $4\frac{1}{2}$ °C. The mastic surface did not crack during these tests. Since the stiffness of the decking on the proposed bridge is greater than that of the

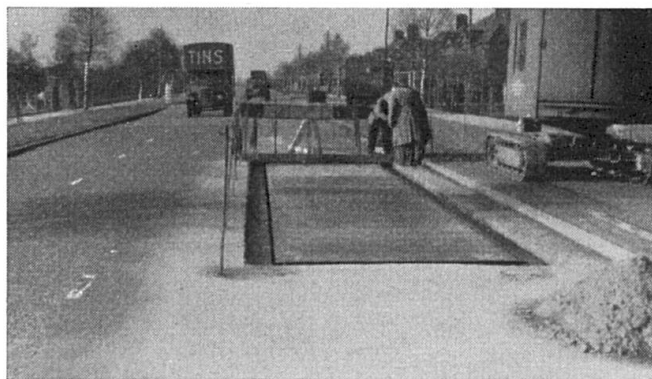
Fig. 2. Panels in Position Prior to Surfacing.

For the full-scale tests, four panels, each 9 ft. long by 7 ft. wide, were laid in the road (see fig. 2). Three of the panels had smooth deck plates while the fourth had a chequered plate which was included because it was feared that the surfacing might "push" on a smooth plate. The four plates were sand-blasted and painted as described, and then placed in the carriageway with their ends supported on concrete beams. The levels of the panels were stepped to permit thicknesses of surfacing of 1 in., $1\frac{1}{2}$ in. and 2 in. to be laid on the three smooth plates and a $1\frac{1}{2}$ -in. surfacing on the chequered plate. Fig. 2 shows the panels in position before surfacing. Steel plates 12 in. wide covered the gaps between the sides of the panels and the road. The panels were sited on the braking side of a bus-stop and thus received maximum traffic forces. A proprietary brand of mastic asphalt was selected as suitable; this was supplied and laid by the Limmer and Trinidad Lake Asphalt Company Limited. The material complied in general with B.S. 1447, Table 1, Col. 3, but the penetration of the 50/50 mixture of Trinidad Lake asphalt and asphaltic bitumen was in the neighbourhood of 10. The penetration of the soluble portion of this binder was about 20. 40 per cent of granite chippings were added, as indicated in B.S. 1447. $\frac{1}{2}$ inch coated granite chippings were rolled into the surface of the mastic to provide a non-skid surface.

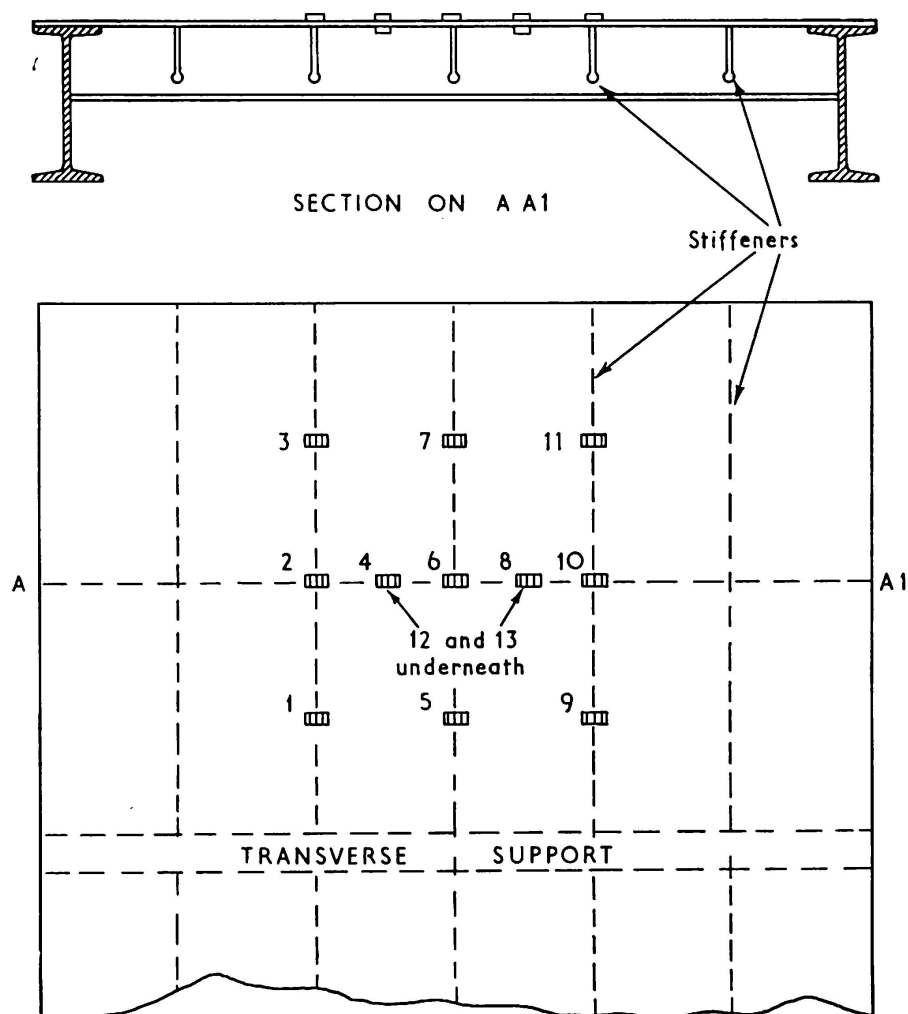
Fig. 11. Portion of Deck Plate Showing the Positions of Strain Gauges.

Gauges 1 to 11 were used on the upper surface of the steel and gauges 12 and 13 were attached to its under side. The strain gauges were of the foil type and were cemented to the steel by an epoxide resin. A thermocouple was also attached to each steel plate to measure the temperature of the asphalt surfacing.

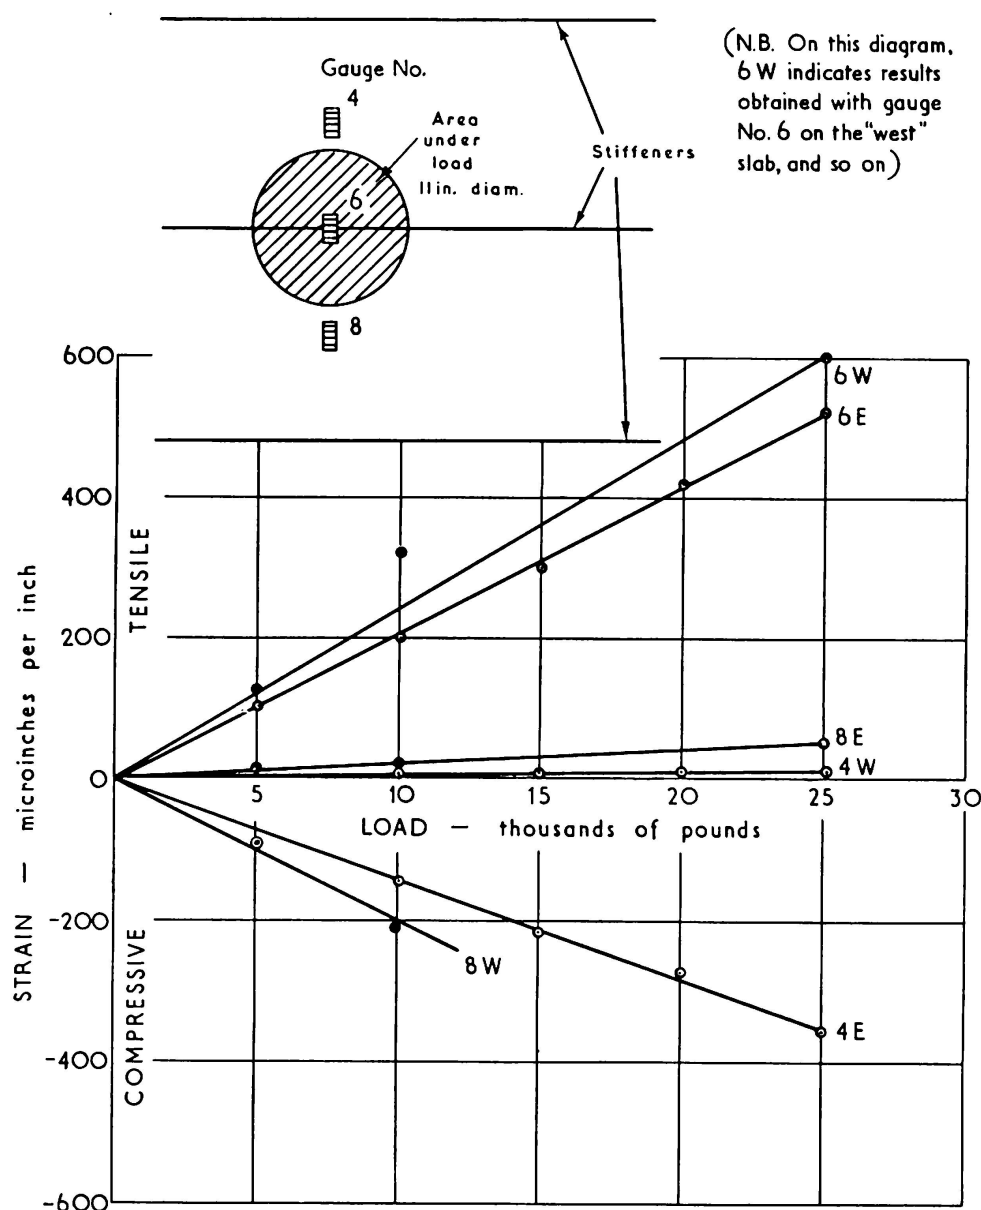
Fig. 12. Results of Static Tests on the Bare Steel Plate With Centre of Load Over Gauge No. 6.

were made are shown in figs. 12 and 13, one test being made directly over the central stiffener and the other midway between two stiffeners. Figs. 12 and 13 show the measured strains plotted against applied load. Linear relationships occurred between strain and load in all cases, hence these diagrams could be used to determine the strain in the steel at a load equal to that applied by each wheel when tests were made later with a moving vehicle. The largest tensile strains in the transverse direction occurred at gauge No. 6 on both panels, this gauge being that placed across the stiffener. As figs. 12 and 13 show, the rigidity of the panels (marked "East" and "West") was approximately equal, particularly having regard to the variations that might occur in producing the complicated welded structures.

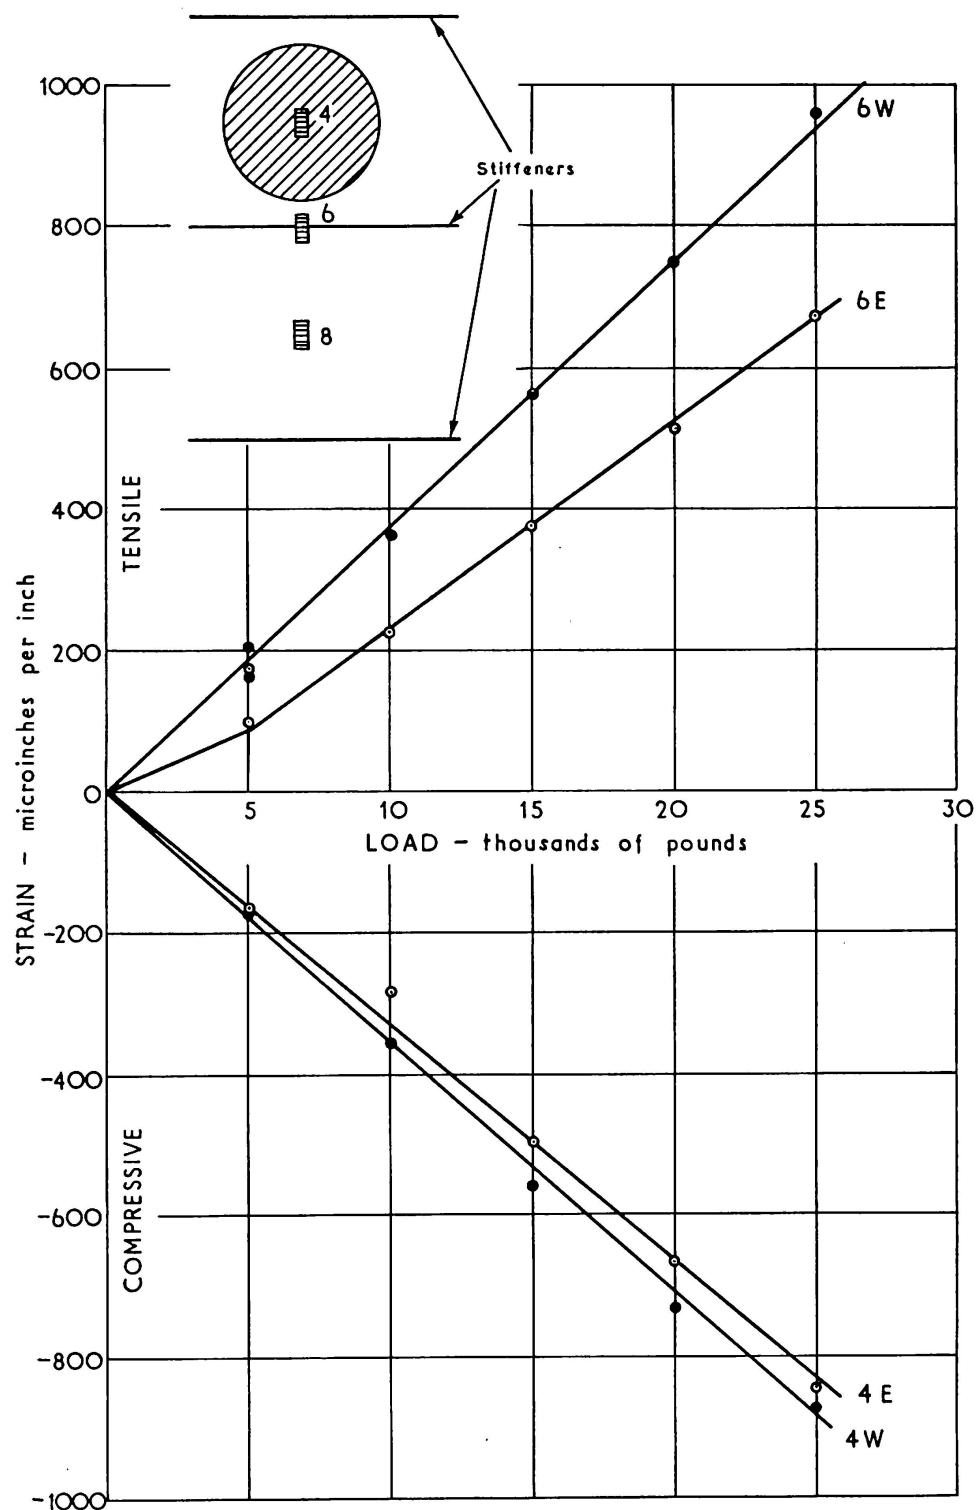
Fig. 13. Results of Static Tests on the Bare Steel Plate With Centre of Load Over Gauge No. 4.

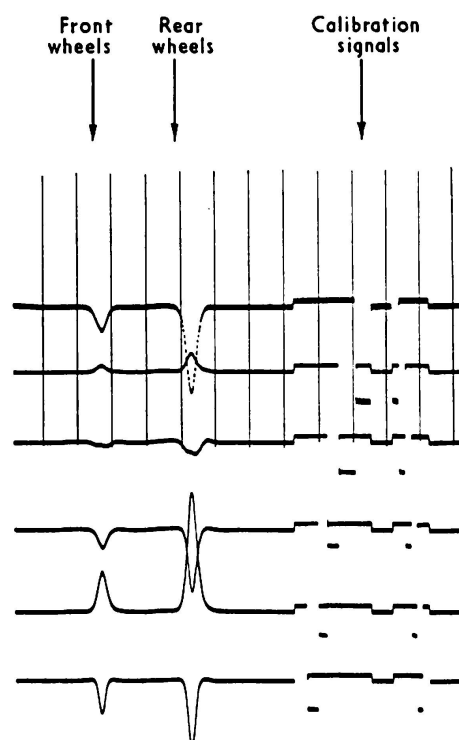
Fig. 14. Dynamic Strain Record. Vehicle Travelling at Creep Speed (About 3 mile/h).

The waveform of the recorded strain did not vary with vehicle speed, but the duration of the strain was, of course, inversely proportional to the speed. A typical set of records is shown in fig. 14.
