Zeitschrift:	IABSE congress report = Rapport du congrès AIPC = IVBH Kongressbericht
Band:	6 (1960)
Artikel:	Laboratory testing of full-size aluminium bridge
Autor:	Michalos, James / Kubo, Gerald G. / Birnstiel, Charles
DOI:	https://doi.org/10.5169/seals-7016

Laboratory Testing of Full-size Aluminum Bridge

JAMES MICHALOSGERALD G. KUBOCHARLES BIRNSTIELPh. D., Prof. and ChairmanPh. D., Associate ProfessorM.C.E., InstructorDepartment of Civil Engineering, New York University, New York, N. Y., U.S.A.

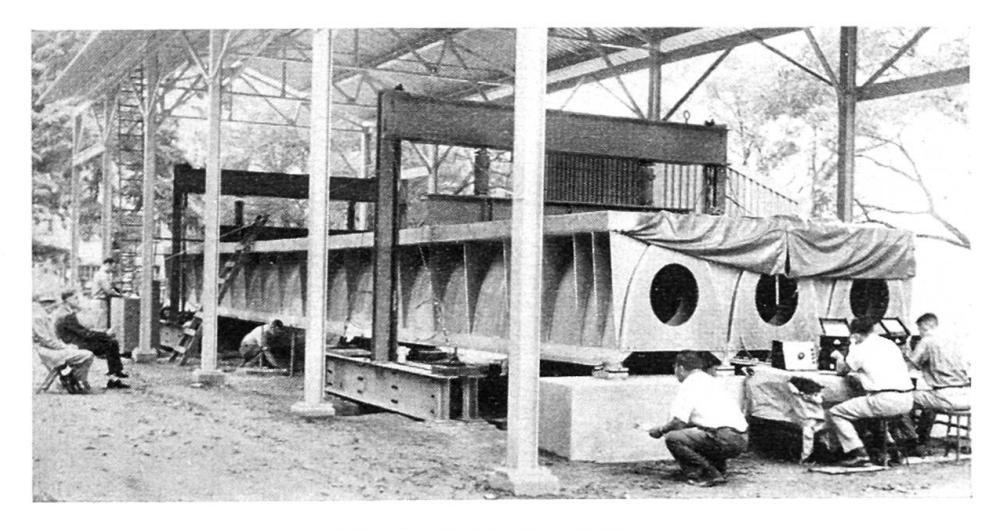
Fig. 1. Static Load Test.

The live loads were applied, as shown in Fig. 1, by means of hydraulic rams symmetrically positioned on transverse distribution beams. Thus the force was distributed essentially as a line load across the width of the deck. The loads were placed 12 ft. 2 in. from each end bearing so as to produce vertical shear and bending moment values which would be proportional to the design shear and design moment respectively. As used herein, design shear and design moment are the maximum values produced in a one-lane, simply-supported bridge by a 20-ton truck, together with impact effect, as defined by the current AASHO specifications.
