Short communications

Zeitschrift: **IABSE reports of the working commissions = Rapports des commissions de travail AIPC = IVBH Berichte der Arbeitskommissionen**

BEHAVIOUR OF AN ASEISMIC STRUCTURE
DURING CAUCETE EARTHQUAKE
OF NOVEMBER 23, 1977

DAMAGE TO BRIDGES DURING THE NORTH CAUCASUS EARTHQUAKES

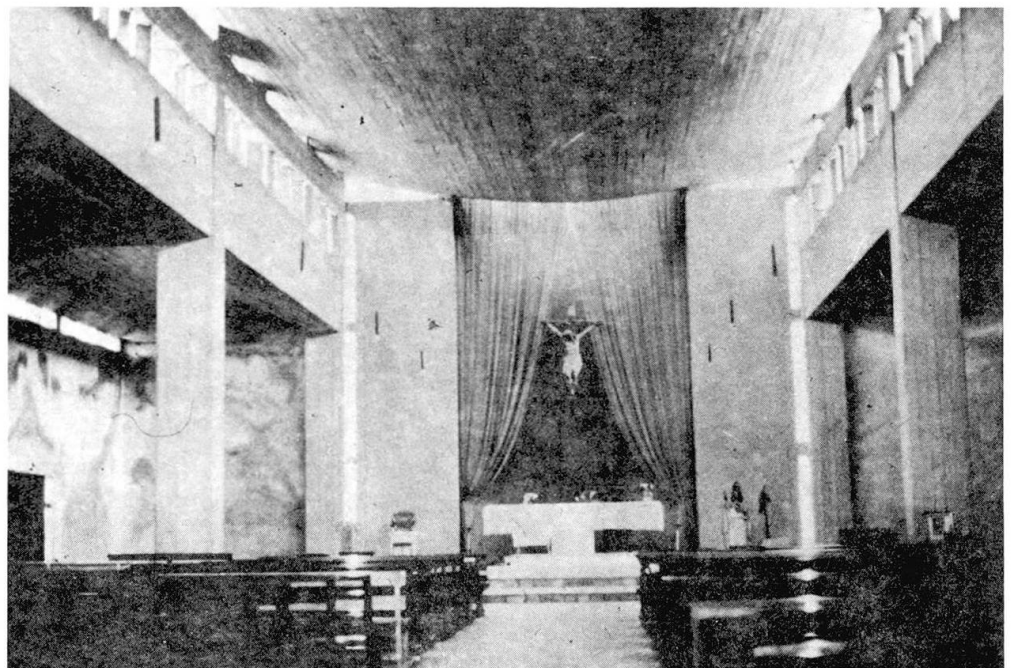
Fig. 2 - Central Nave

Building examination after the earthquake reveals no damage in the reinforced concrete elements. The front brick walls show limited cracks, while there are no apparent cracks in lateral walls, but inner plaster spalled in wide areas. Some glass breakage in windows occurred (approx. 10 %), and light damages in masonry can be seen at both sides of apse, where roof shell touches the wall.

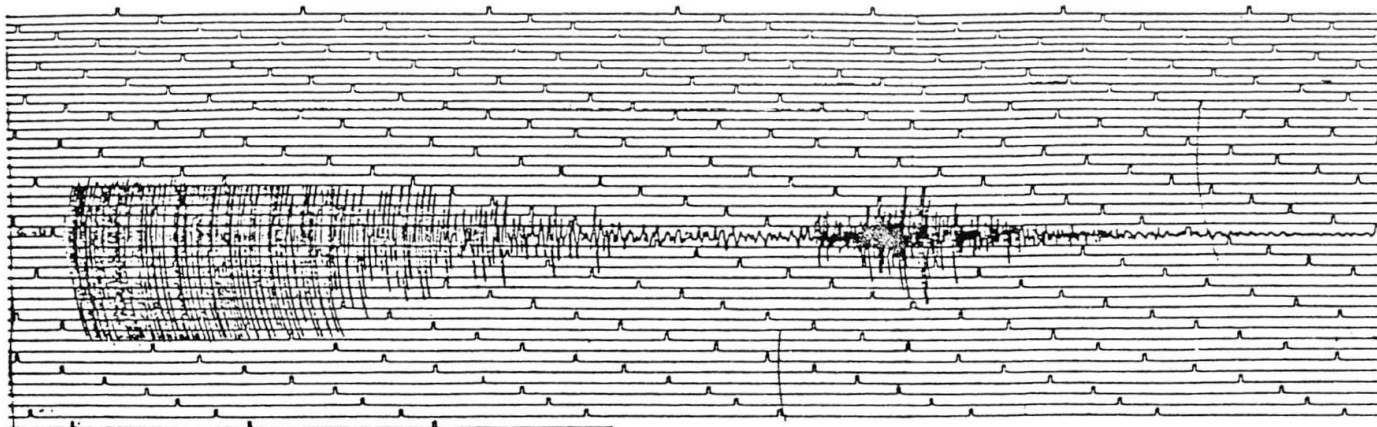
The main shock was preceded by a small shock a few minutes before. Its record is incomplete because the seismograph at Catania University went off the scale (fig. 3) as did the one at Messina University.

As appears clear from fig. 3 the main shock was very quickly followed by an induced sussultory earthquake.

Fig. 3: The Patti earthquake recorded at the University of Catania.
