Artikel: Rehabilitation of two existing tunnels in West Malaysia: a case study
Autor: Singh, Parnam
DOI: <https://doi.org/10.5169/seals-59073>

Rehabilitation of Two Existing Tunnels In West Malaysia: A Case Study

Parnam Singh
Manager
L&M Structures Sdn
Bhd, West Malaysia

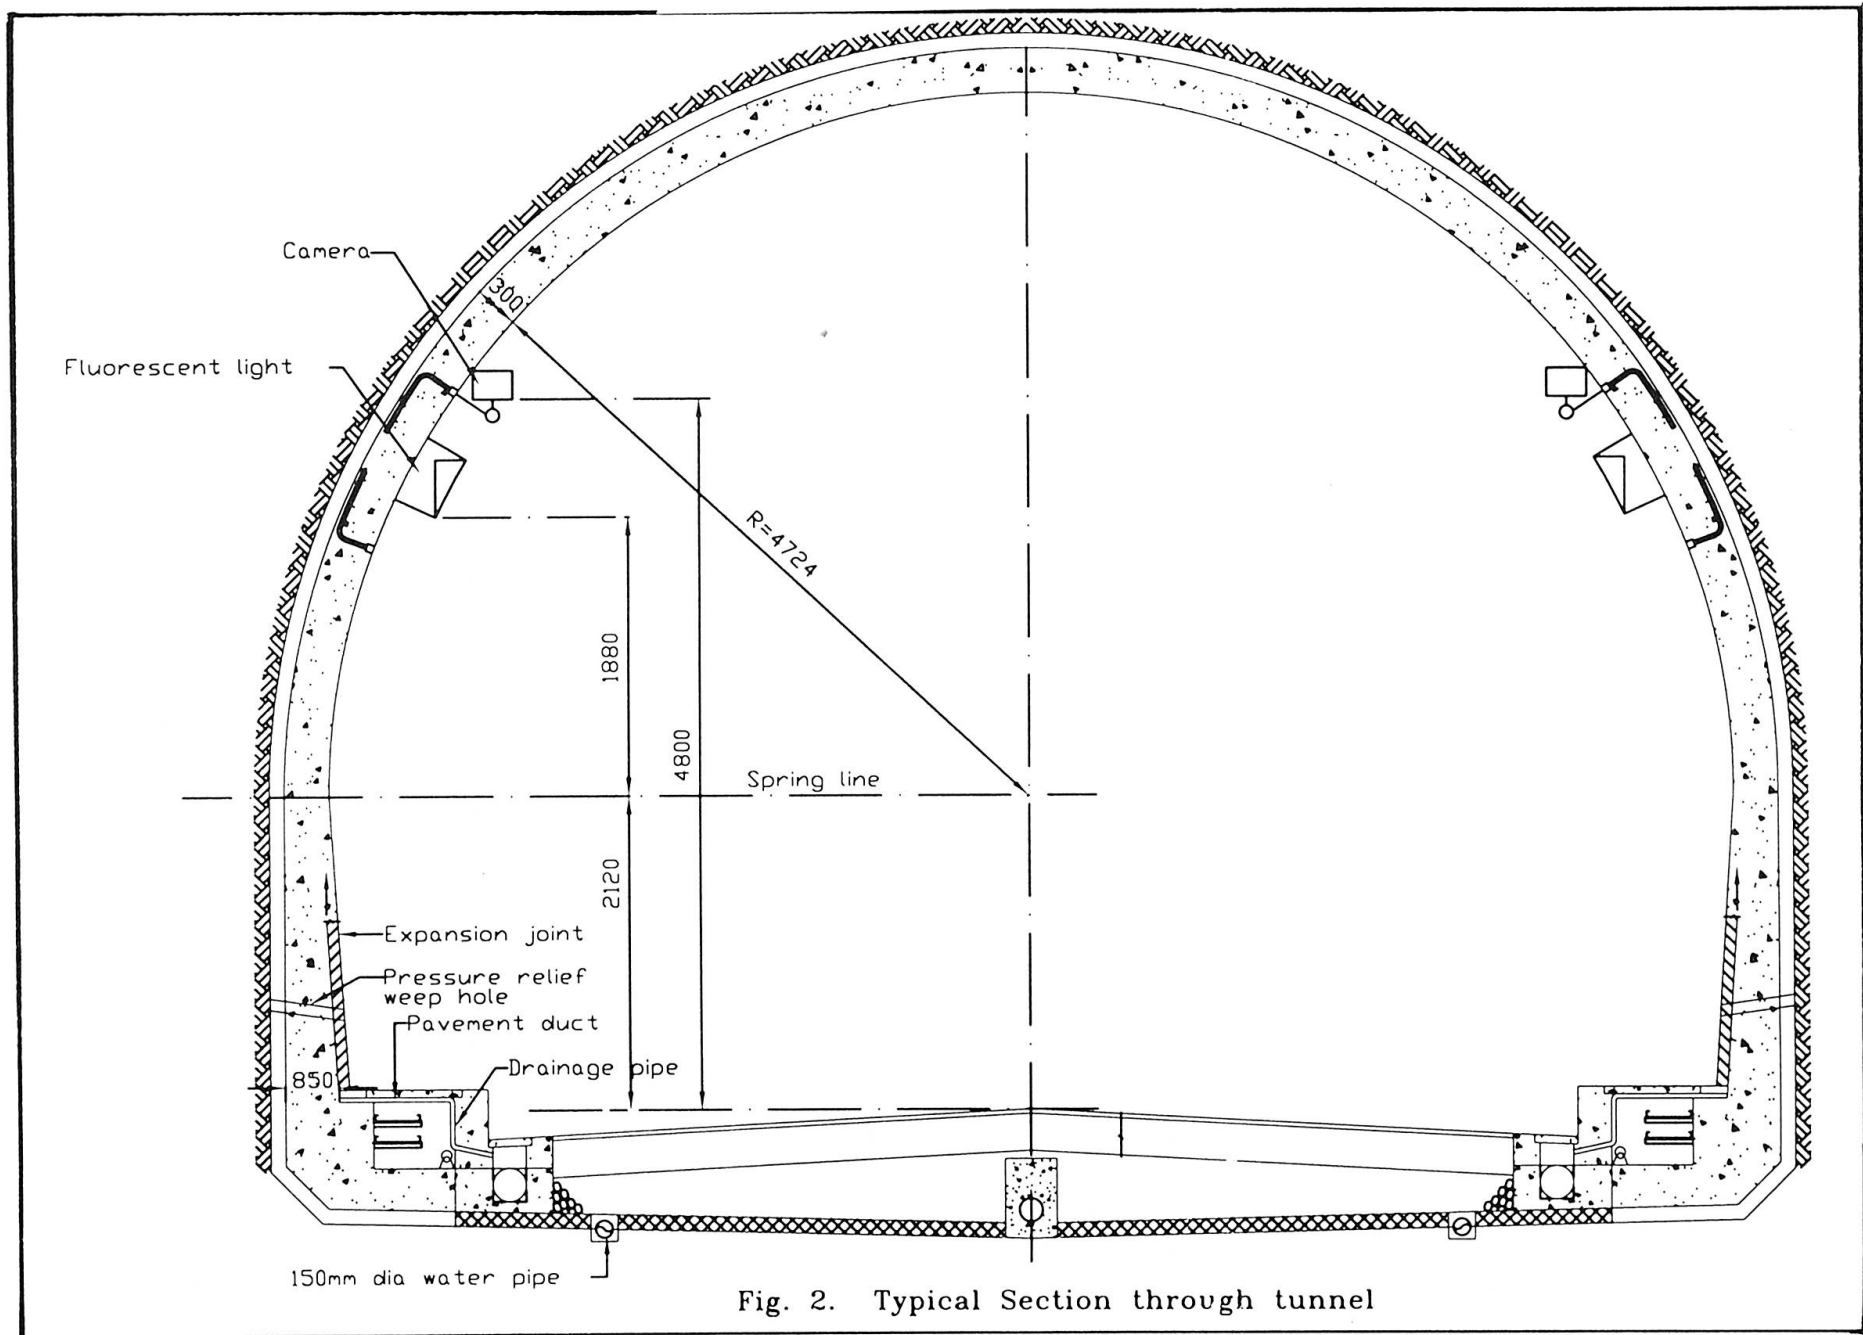
A detailed visual inspection carried out on the cracked concrete did not reveal signs of rust or corrosion of rebars. Localised break-outs were carried out to confirm the absence of rebar corrosion. Leaching of cement through wet cracks was evident in cracks located above the spring line of the tunnel. A detailed crack mapping exercise was carried out to document the extent and pattern of cracks in the lining. This was done by dividing the entire length of the tunnel into chainages and marking individual cracks according to their chainage. The total length of cracks measured for both the tunnels was close to 8500 metres. Most of these cracks were between 0.3mm to 3mm wide.

A detailed inspection was also carried out to determine the extent of damage in the existing expansion joints. It was noted that most of the sealant in the expansion joint was loose and damaged. A separate inspection was carried out to check on the efficiency of the existing fire hydrant system. The inspection confirmed that a section of the existing fire hydrant system in the north bound tunnel was faulty. Further inspections were carried out on the existing drainage system along side the kerbs. This was to ensure that water collected behind the concrete lining could be effectively conveyed into the drainage system via the existing weep holes.
